BEFORE YOU BUY
BEFORE YOU BUILD

NZ Residential Property Inspection Report

Inspection Date: Tue, 20 Jun 2023

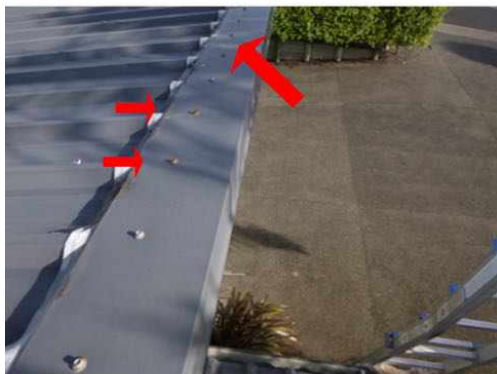
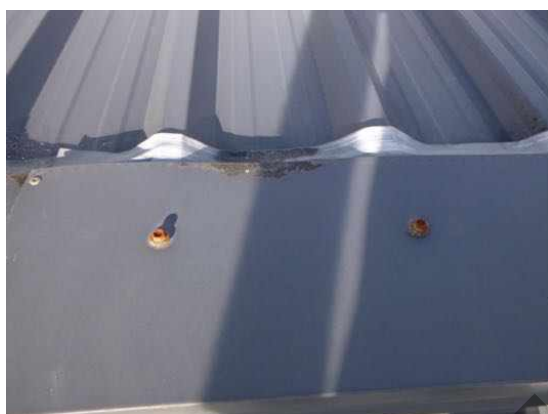
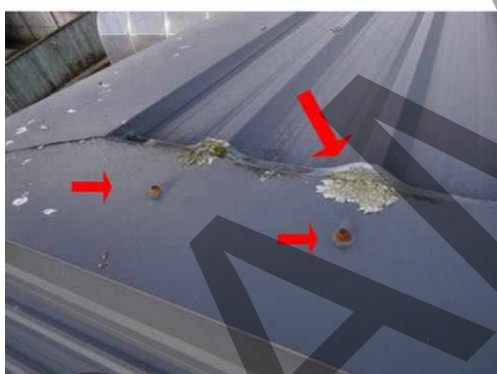
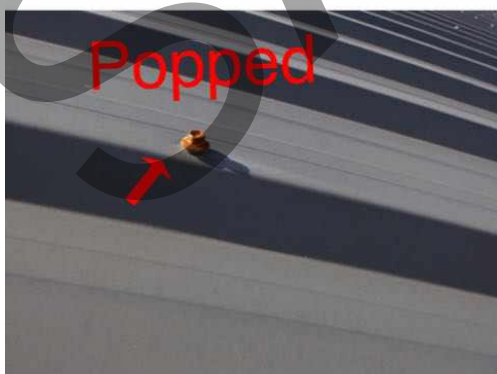
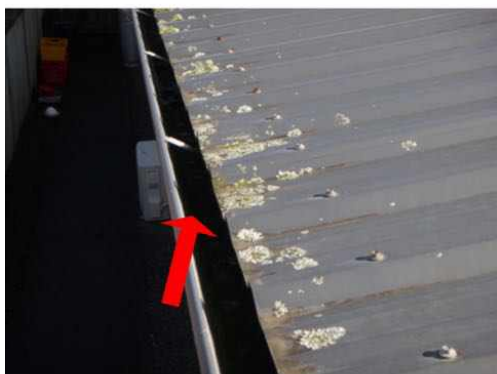
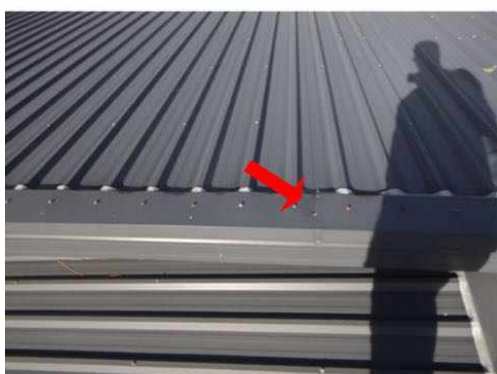
Defects 3.01

Building: Building 1
 Location: Various Areas
 Finding: Gutter & Roof Condition
 Information: At the time of the inspection it was observed that the coloursteel roof guttering and fascia was in good condition, generally clean and appeared to be functioning well and the downpipes were connected to the stormwater system and secured to the building. However there was debris in a few areas of the gutter that may be contributing to minor pooling.

There was a number of screw fixings that have rusted that over time could deteriorate to a point where failure of the fixings could occur. Some screw fixings appear to have popped which can affect the weather tightness of the fixing.

Some missing rivets were found on one of the roof flashings possibly allowing moisture access into the ceiling space where moulds or rots may begin forming.

Lichen, which affects the paint surface and can damage it, was affecting some areas of the roofing.

Roof plumbing structures, such as guttering and downpipes, should be free of all debris to prevent blockages, and gutters should have a fall to the downpipe. Blockages of the guttering and downpipes will lead to pooling and accumulated water overflows, which is likely to subsequently flood eaves and exterior walls. Blocked gutters and water pooling are likely to lead to high levels of moisture in the affected areas. Such moisture will not only cause rust and decay of the associated building materials, but can also provide conditions that are conducive to pest activity. Blockages in gutters should therefore be removed immediately.

It is highly advised that all gutters be maintained on a frequent basis to ensure the condition of roof plumbing. A chemical wash of the roof will help prevent lichen buildup and the screw fixings can be replaced by a Roofing Maintenance Company.

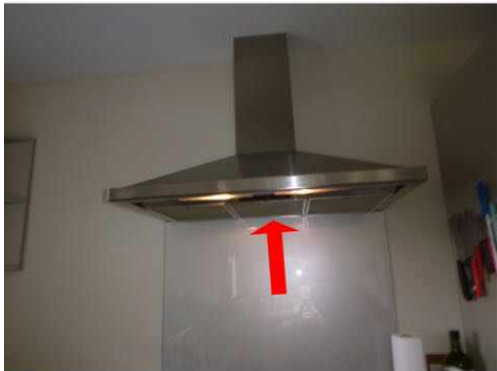
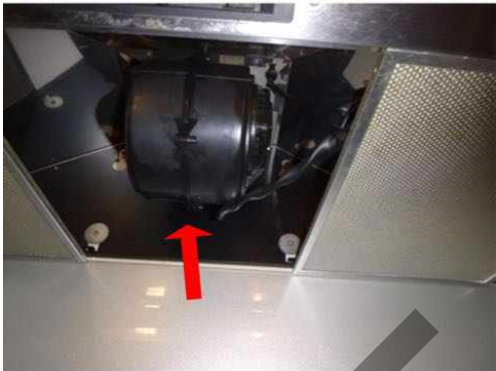
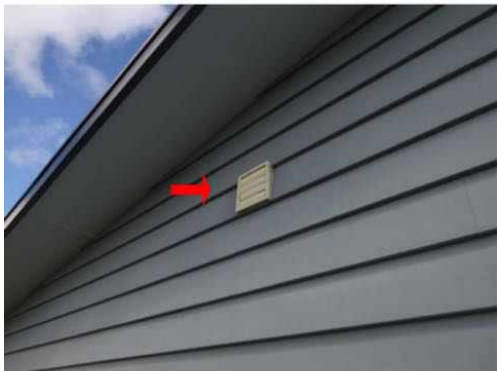
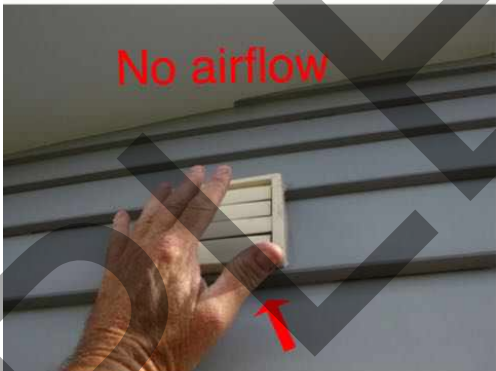
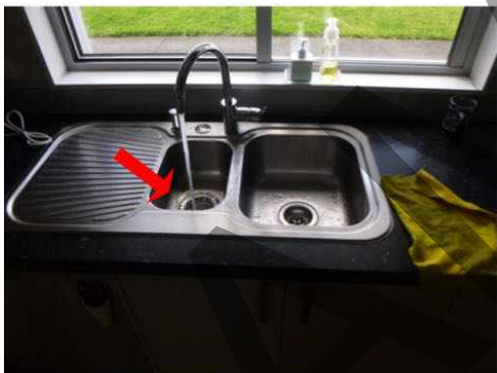
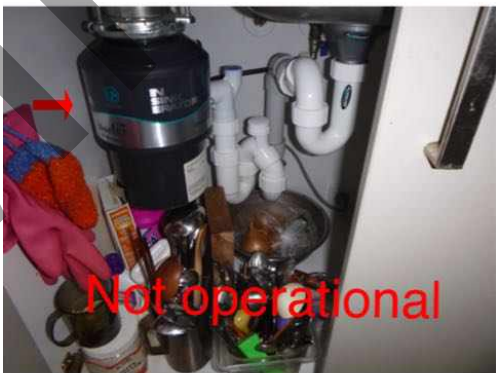
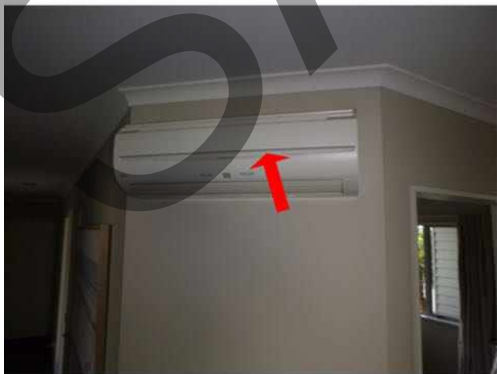
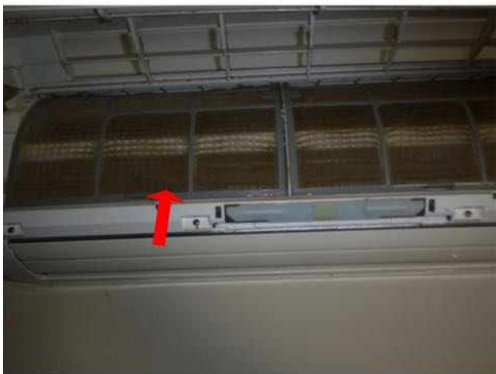
Defects 3.02

Building: Building 1
 Location: Kitchen & Hall
 Finding: Non Operating Features
 Information: The rangehood over the kitchen hob was operating but there was no air discharging to the exterior of the building.

The waste disposal unit in the kitchen sink was also not operational.

The air conditioning unit in the hall has dusty filters and this could be an indication that the unit has not been serviced for a long period of time.

We advise to contact the relevant Tradesperson to check and rectify these items and ensure they are fully operational and efficiently providing their relevant features.

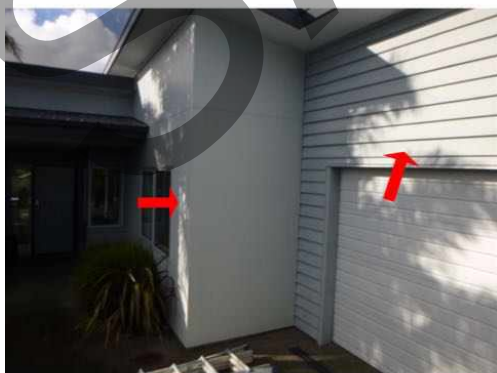
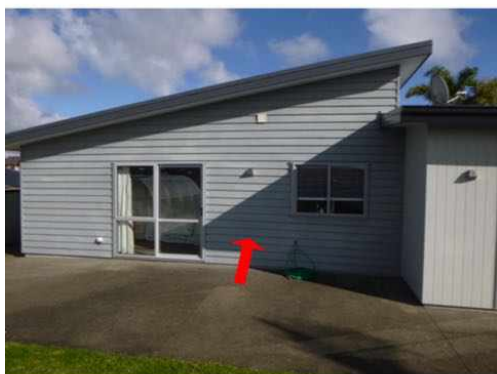
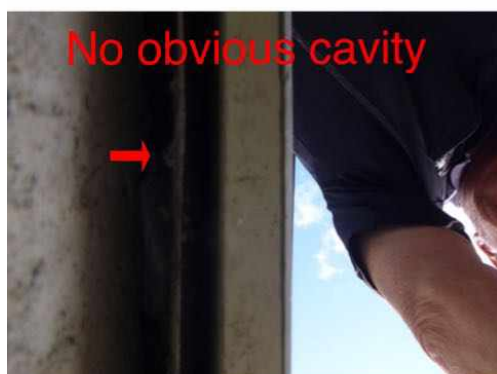
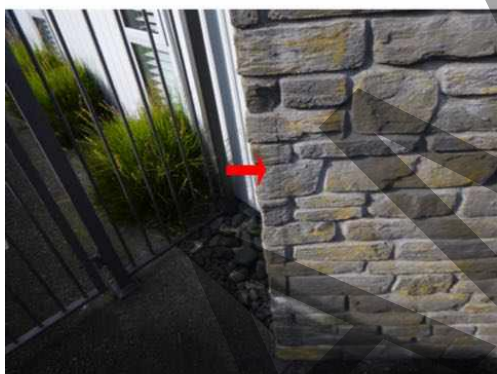
A fibre cement feature sheet has been applied and is fitted over a cavity system. This should prevent any moisture that is able to track past the cladding system to be vented out to the exterior of the building. There was no obvious cracking found on the plaster system of the home.

There was feature stonework around the chimney and front entrance pillars. There was minor cracking identified on the chimney area. We advise to regularly monitor these areas to ensure that the minor cracking does not become larger which could indicate a possible structural defect occurring.

We advise the Client to check the Building Consented plans to verify if the cavity was not required and that Council have approved and issued the appropriate CCC for the building.

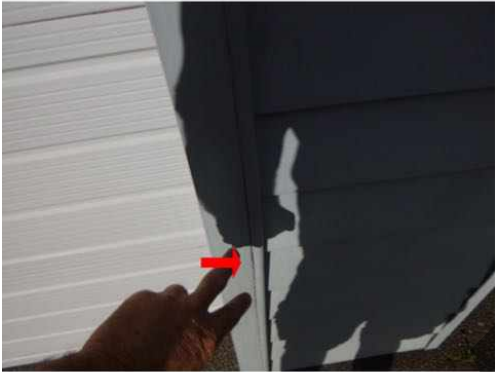
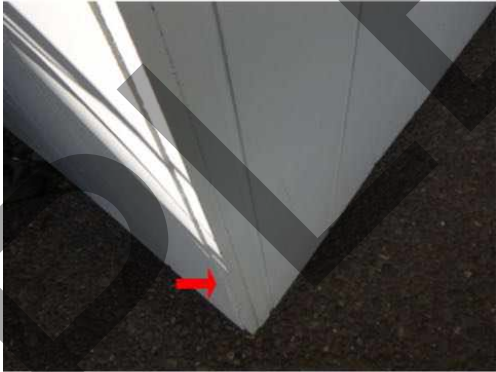
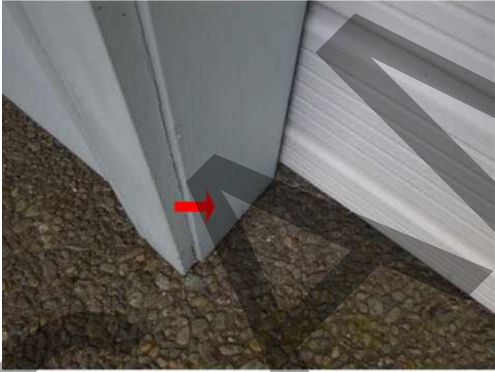
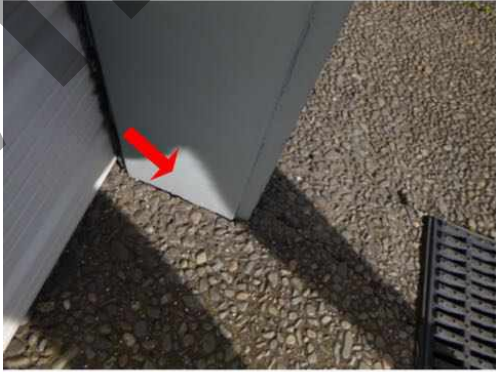
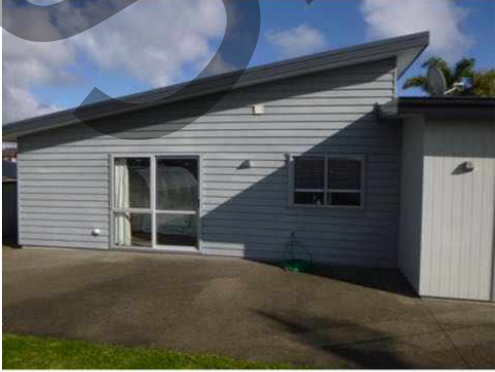
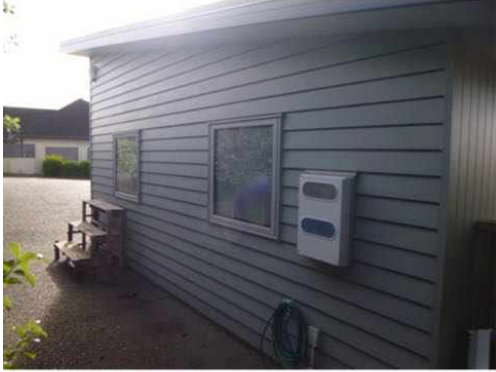
Building: Building 1
 Location: Cladding Areas
 Finding: Paint System- Aged
 Information: The painting on the exterior cladding surfaces was found to be aged. A repaint of the exterior is recommended to ensure the timber is adequately protected from the weather elements.

A repaint of the exterior cladding's and timber is recommended to ensure the weather tightness of the home and preservation of the timber work. A Painter can advise on this.

A Painter should be appointed as soon as possible to perform necessary works to aid the appearance of the affected area and to ensure that the area is protected against any possible deterioration. Alternatively, the homeowner following manufacturer instructions may be able to provide this service.

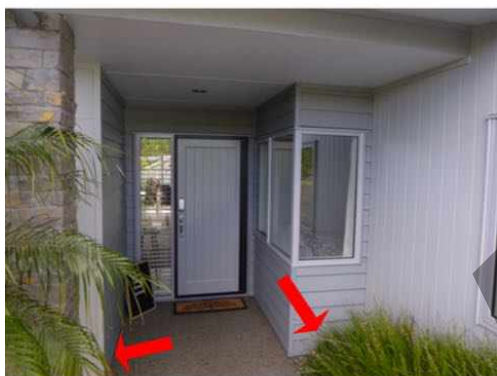
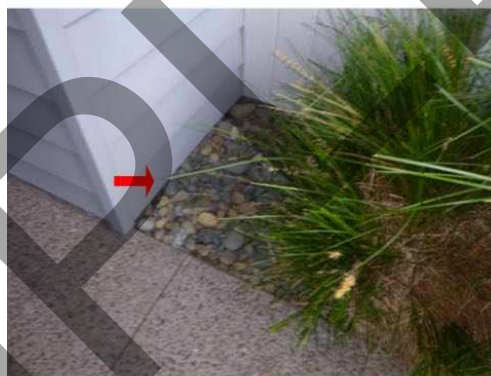
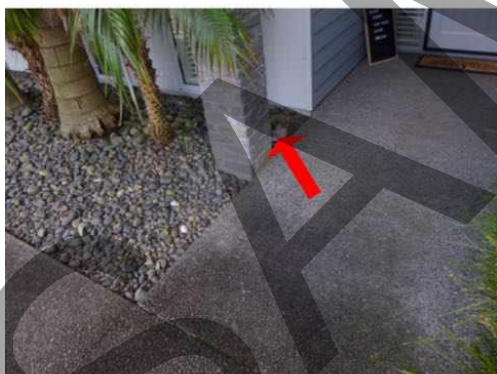
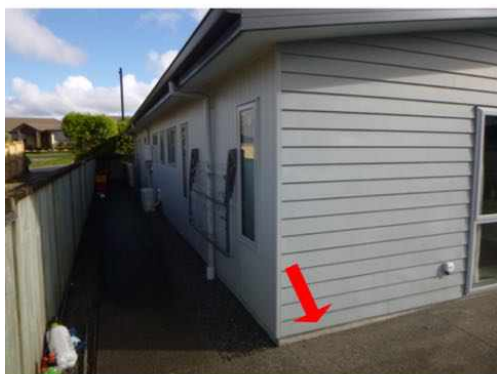
Building: Building 1
 Location: Various Areas
 Finding: Ground Levels
 Information: It was observed that the ground clearances throughout the property were at or more than the minimum requirement as per the Building Code. There were stormwater sumps and the site was well drained.

Ground levels should be 150mm below slab level, while paved areas should be 100mm below slab level. It is important that water does not lie against the base of walls and surrounding paths and that ground levels should be sloped to drain water away from walls.

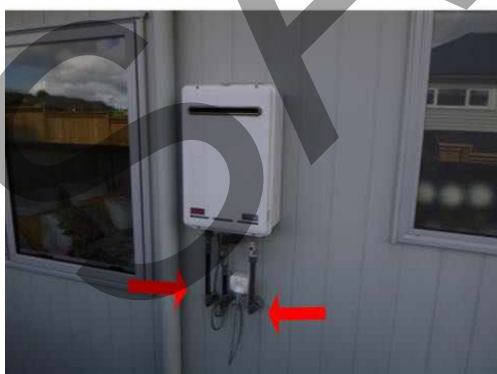
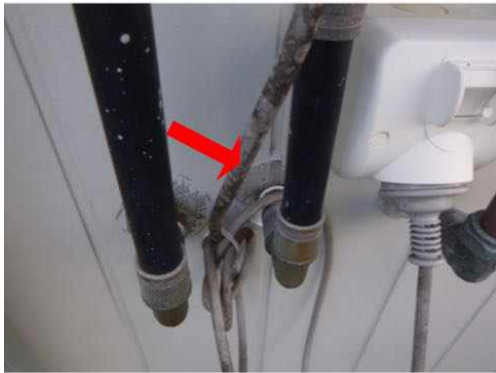
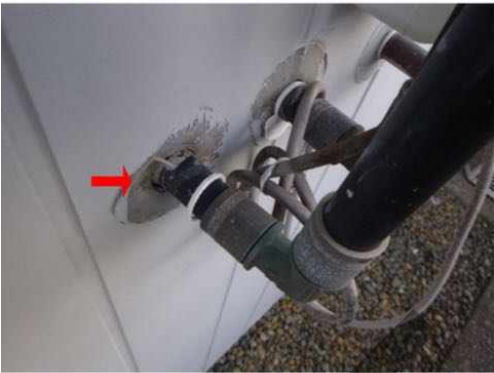
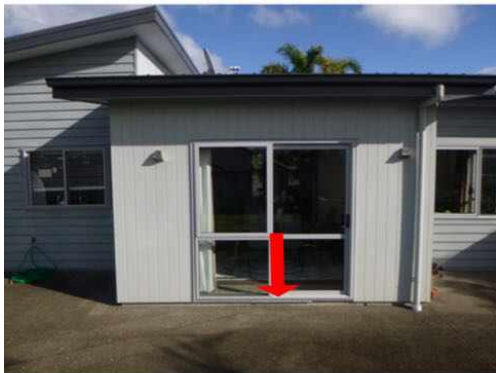
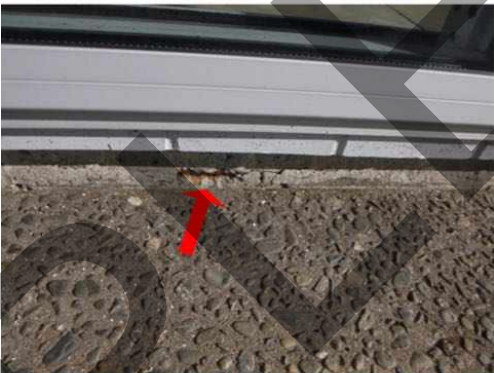
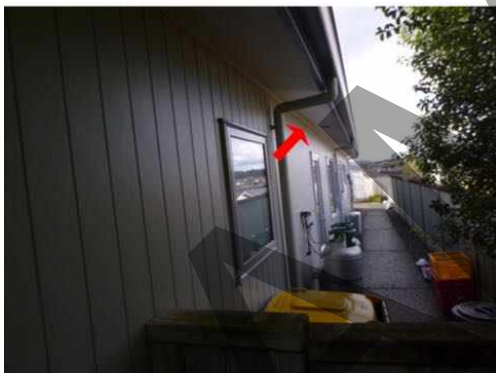
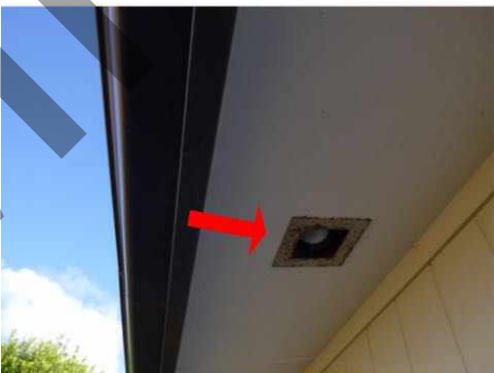
Information: The hot water califont system at the rear of the home was noted to have deteriorated seals around the pipework that was penetrating out from the wall cladding. These should be replaced to ensure the wall is adequately sealed to prevent moisture access behind the cladding. This is on the wall system that has a cavity behind the sheet cladding.

Reinforcing steel was noted to be exposed under the dining room ranchslider. This could over time damage the concrete area from the exposed steel rusting. A Carpenter could be contacted to ensure the steel is cleaned and protected to ensure no further deterioration of the area occurs.

A light fitting outside the rear garage door soffit appears to be affected with rust deterioration. We advise to contact an Electrician to replace the fitting before any further deterioration occurs.

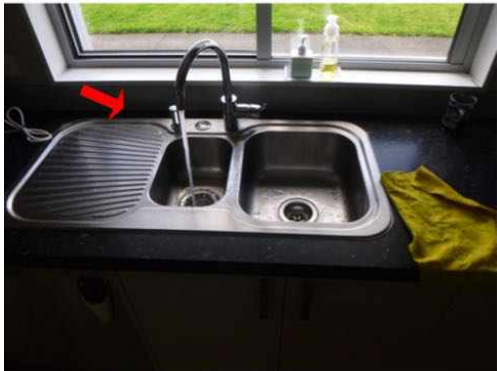
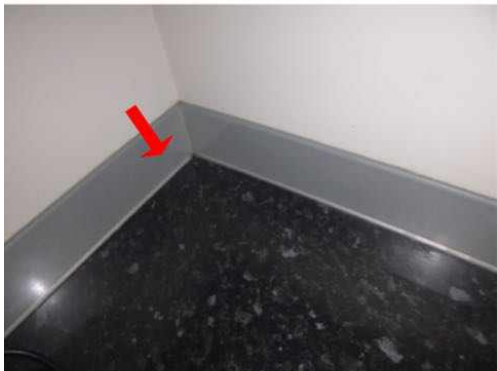
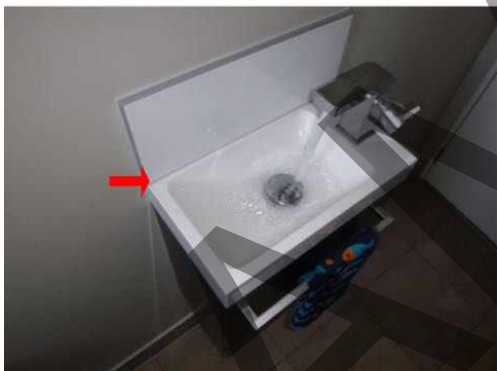
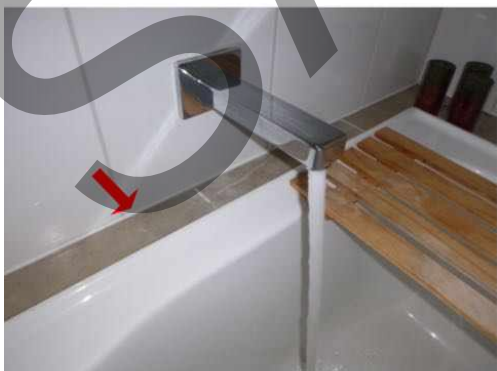
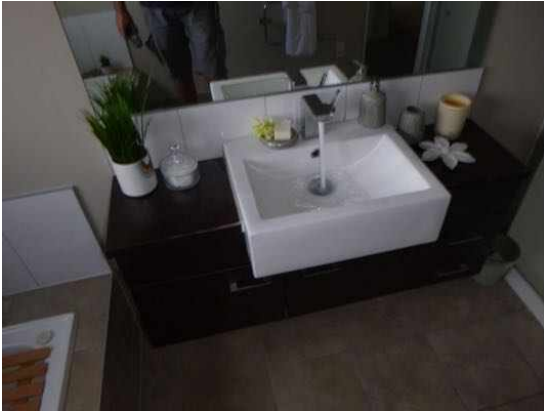
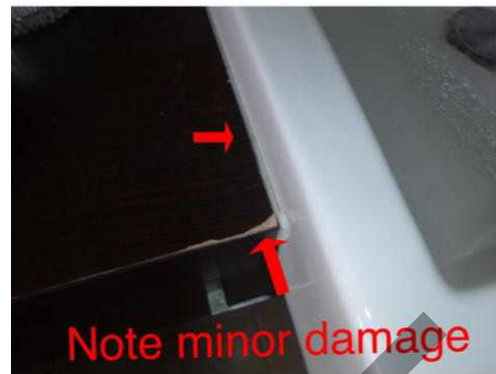
Building: Building 1
Location: Various Areas
Finding: Penetrations & Sealants
Information: Upon inspection the window penetrations were generally well sealed with head flashings and scribes.

Building: Building 1
 Location: Various Areas
 Finding: Sealants- Wet Areas
 Information: The sealants around the shower, bath, vanities and kitchen bench top were generally in good condition.

Moisture behind linings is generally caused by deteriorated, inadequate or missing sealants or flashings, leaking plumbing pipes or fixtures. In extreme cases structural damage may develop due to prolonged water leaks.

A Sealant Specialist or Builder should be appointed to rake out ineffective and old sealants and replace when required.

A Sealant Specialist should be appointed to rake out the old sealants and replace where and when required.

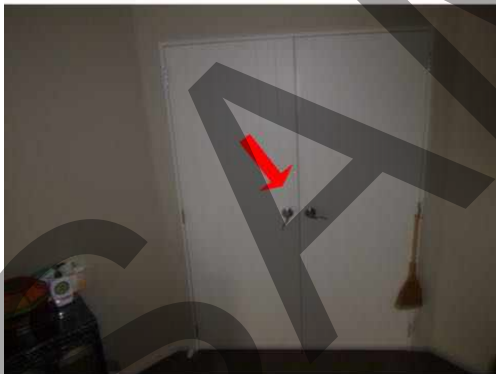
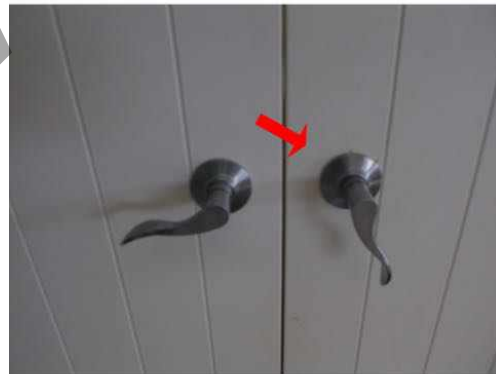
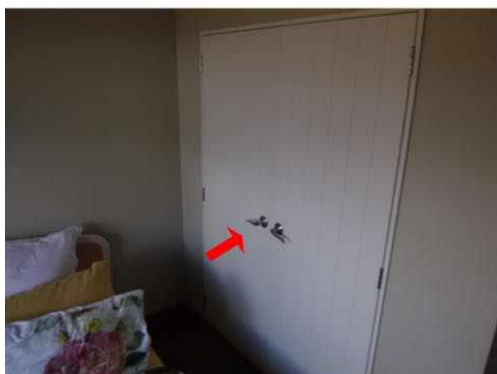
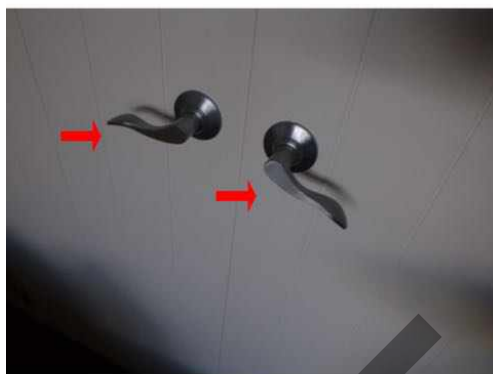
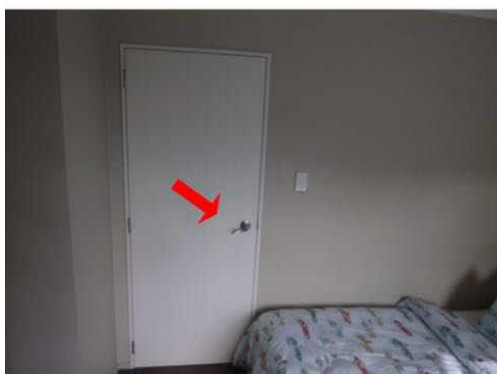
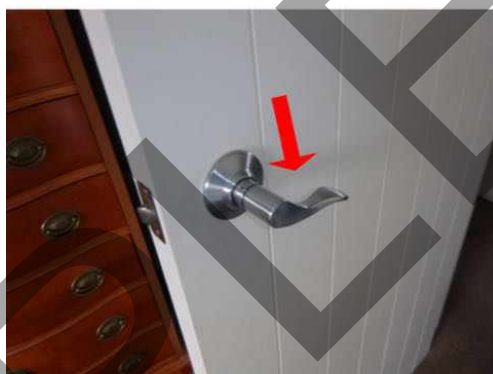
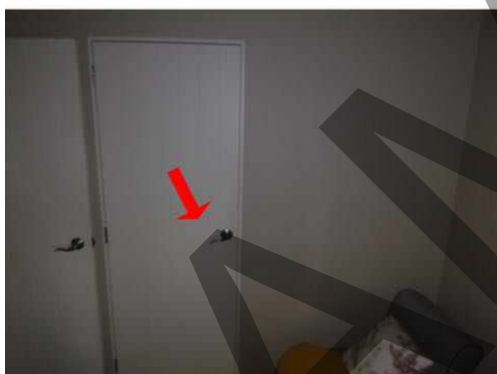
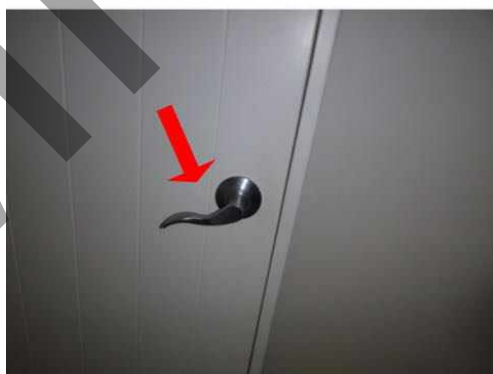
Finding: Doors- Handle Damage

Information: The door handles in the lounge and bedrooms 3-4 were found to be broken. Breakage occurs generally when the building materials have aged and decayed, but may be indicative of impact damage (accidental or deliberate).

Repair and/or replacement of the broken door handle is advised to improve the operational state of the associated door.

A Carpenter could be appointed to repair/replace the door handle at the Client's discretion.

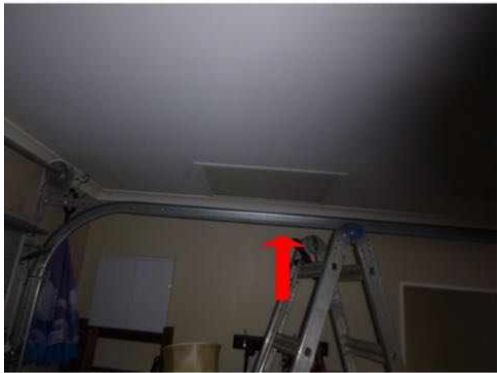
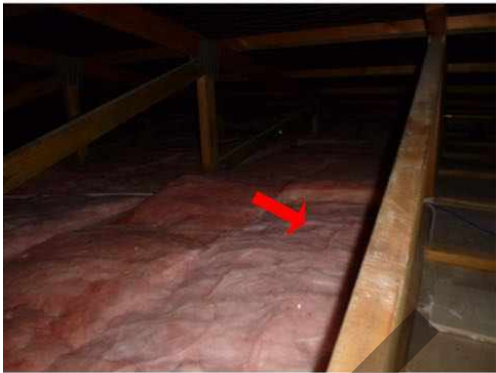
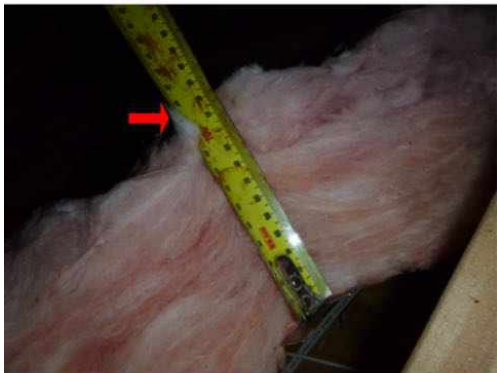
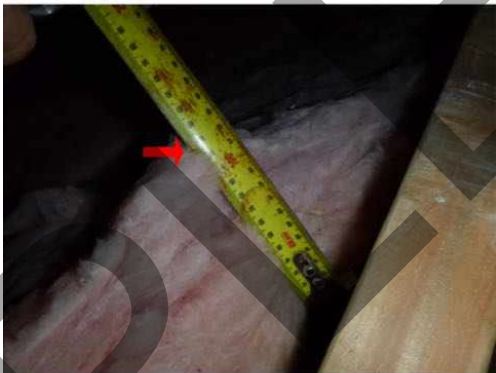
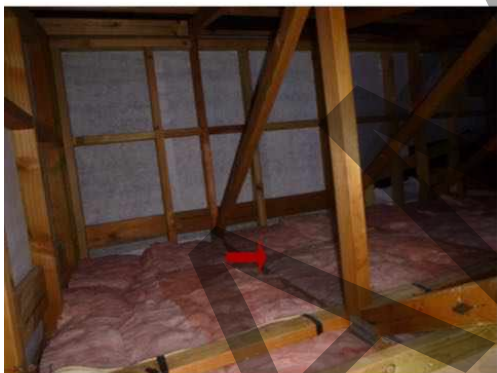
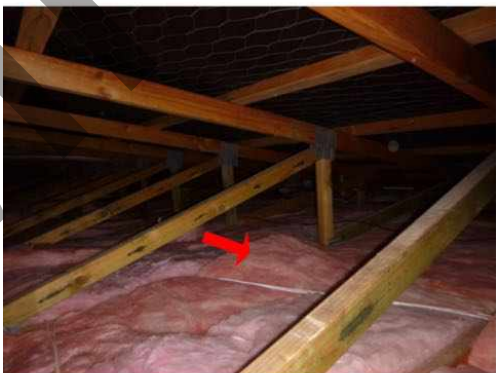
Building: Building 1
 Location: Ceiling Space
 Finding: General Notes
 Information: The ceiling space in the areas able to be inspected were Dry at the time of the inspection.

The insulation is a blanket fibre material that is approximately 120mm thick. This was possibly compliant with the regulations at the time of construction.

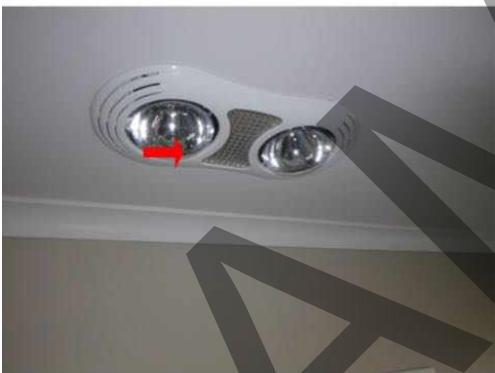
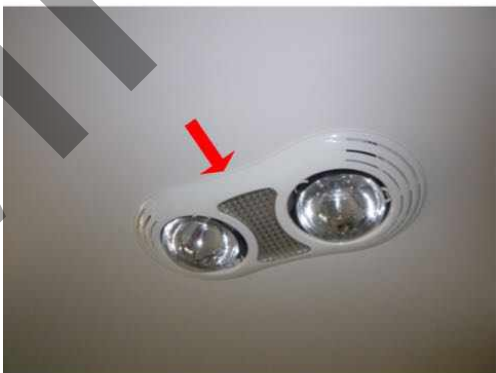
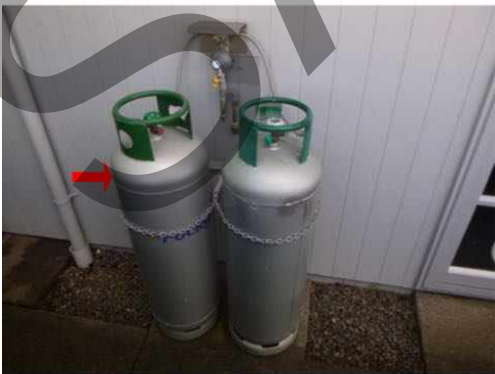
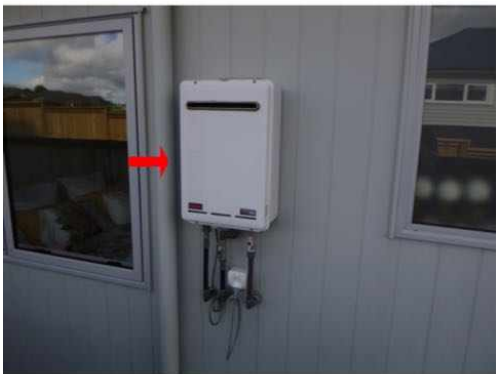
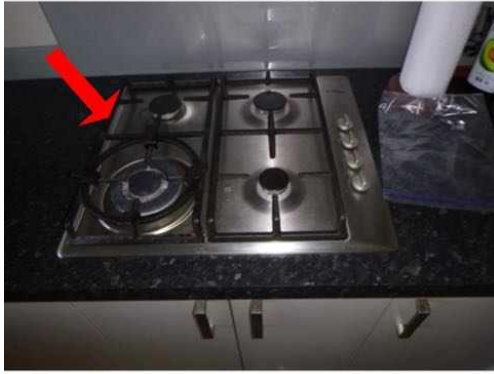
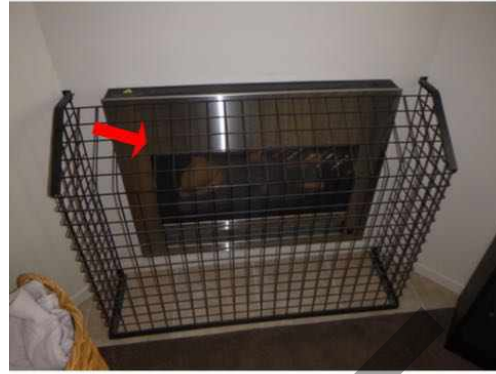
All plumbing fixtures and taps appeared to be in good working order and no leaks were found. Please note that commenting on plumbing works is outside the scope of this inspection.

A Fujitsu heat pump was installed in the hallway but was not tested. The heat pump system needs to be maintained and serviced annually with filters cleaned or replaced.

The bathroom and laundry moisture extractors were operational and vented to the exterior. The extraction systems need to be maintained and serviced annually.

At Clients discretion, please engage an Electrician, or Plumber or Gas fitter to further inspect the property.

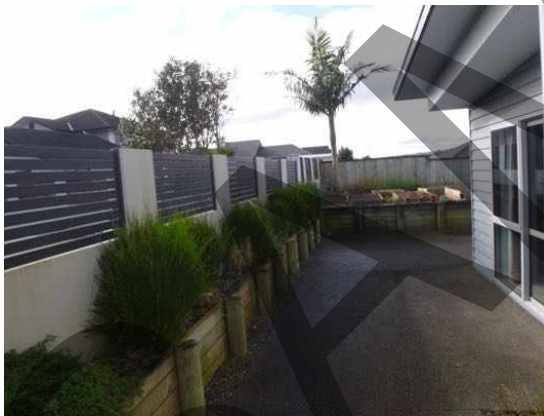
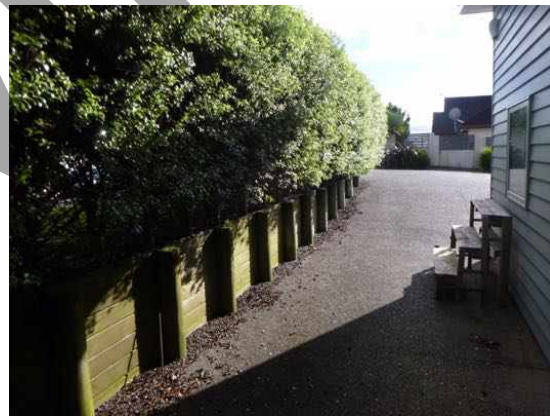
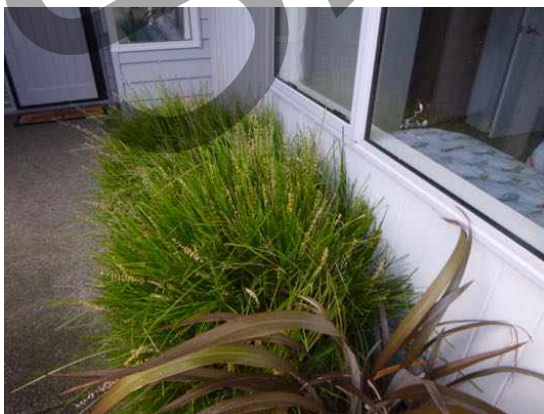
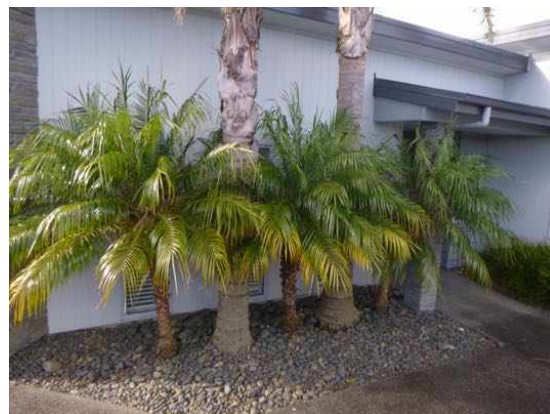
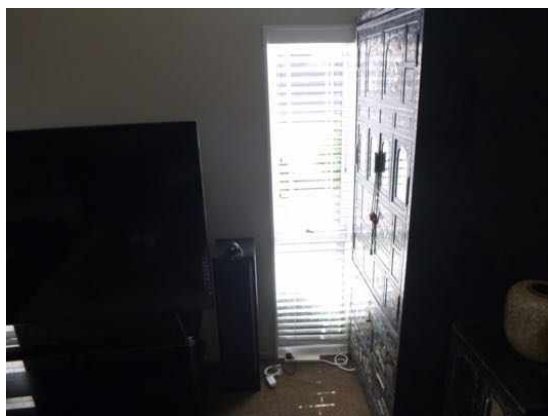
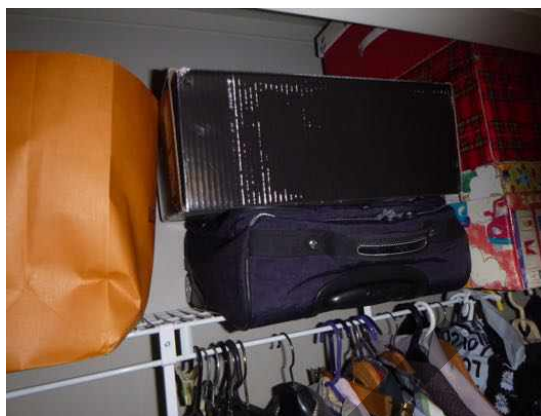
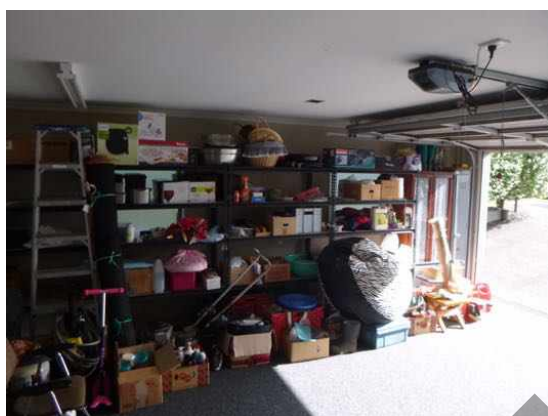
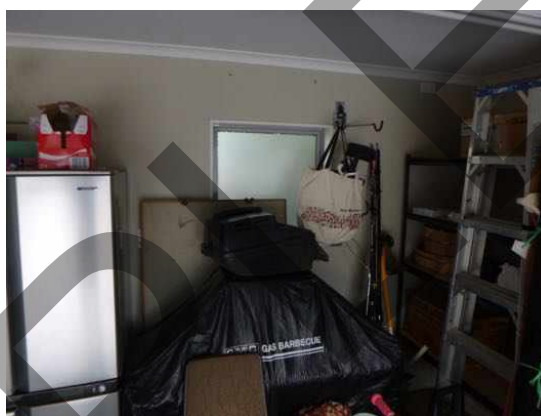
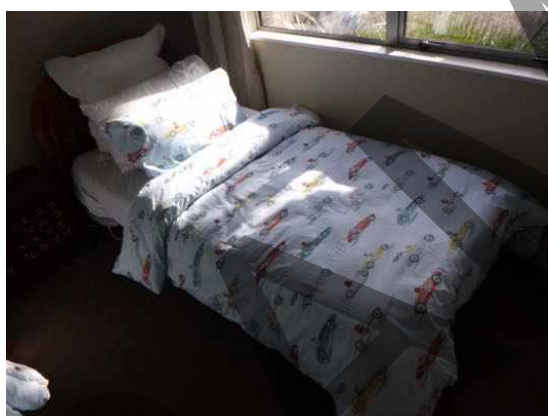
These obstructions can hide an array of defects and should be removed to allow a full inspection to be carried out.

A re-inspection is recommended once the areas are made accessible.
