NZ Residential Property Inspection Report

Inspection Date: Wed, 30 Oct 2019

Company Name: Jim's Building Inspections (Rolleston)

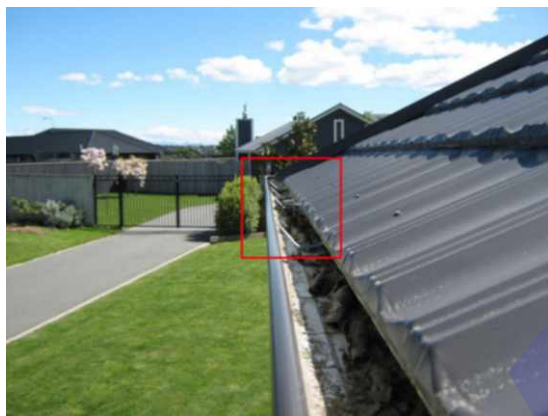
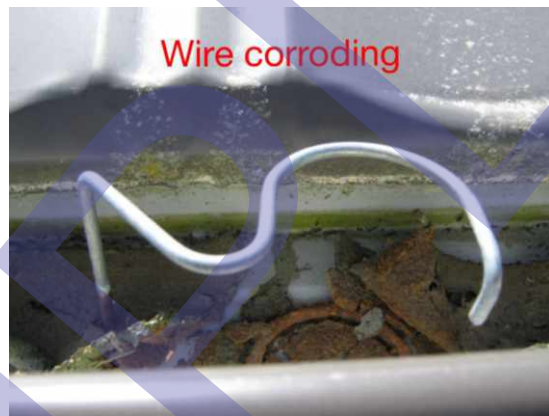
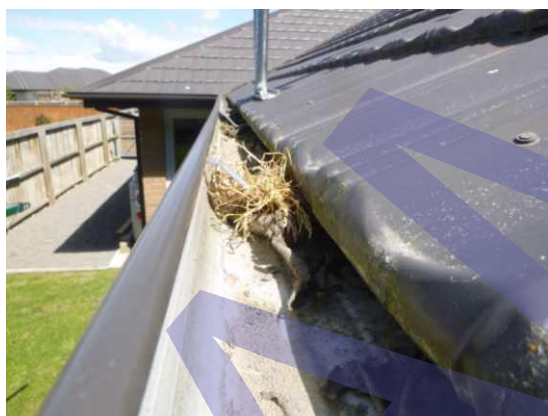
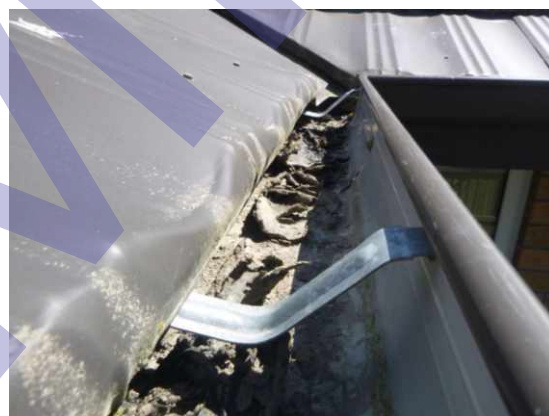
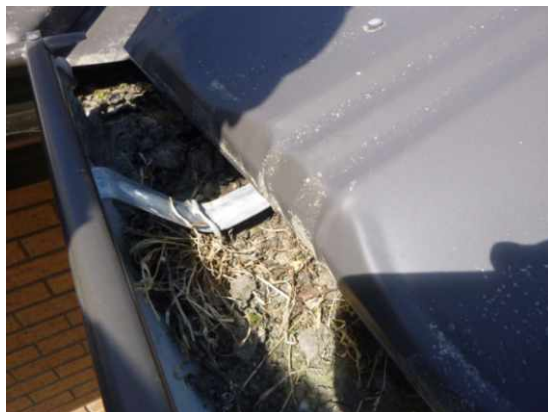
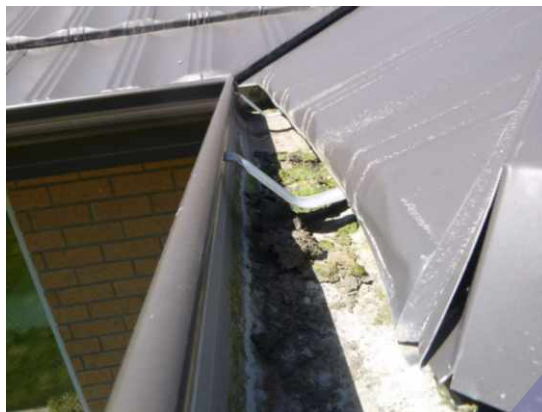
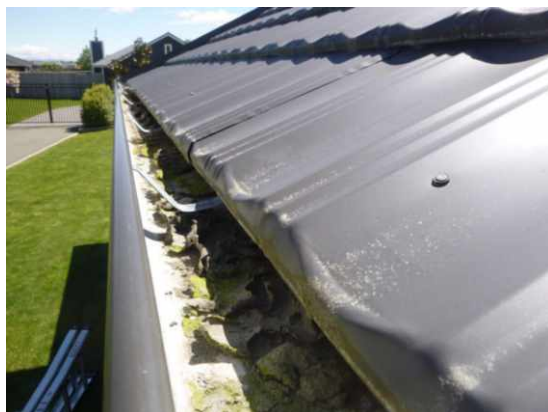
Defects 3.01

Building:	Main Building
Location:	Roof Exterior > All Areas,Rear
Finding:	Roofing/Gutters - Condition
Information:	Gutters direct water away from the structure and should remain clear in order to prolong the life span of the metal gutters.

Debris in the gutters was evident at the of inspection. Providing it is done safely, any debris and construction waste should be removed by a contractor or handy person at the cleints discretion.

Gutters will need cleaning as there was debris through out. It is recommended that the gutters are cleaned regularly in order to prolong the lifespan of the associated materials.

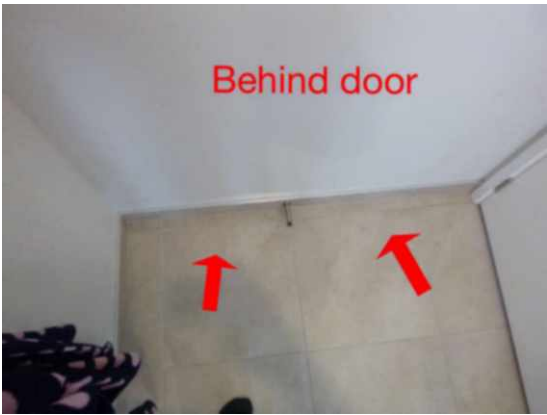
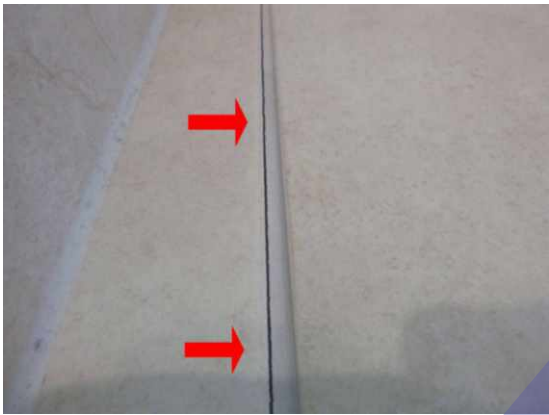
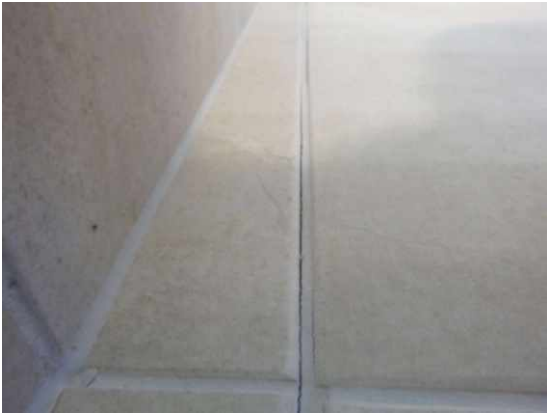
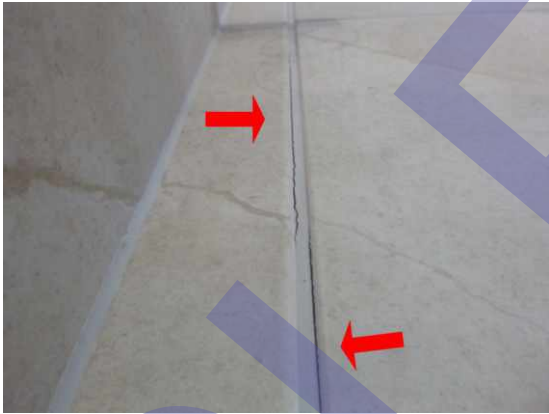
Defects 3.02

Building:	Main Building
Location:	Ensuite - Master > Front Right
Finding:	Grouting - Minor cracking
Information:	Different materials and floor areas move at different rates, which can typically cause the separation of sealant or grout from tiles.

It was noted during the inspection that grout was degraded or has separated from the tiles behind the ensuite door. There were no other cracks noted anywhere else in the ensuite during this inspection. It is suspected that due to the joint being located inline with the door jamb, excessive movement or possible door slamming has caused slight movement of the grout in that area causing separation.

Grout can separate from tiles when slight movement occurs. This is the case in the ensuite behind the door. This isn't considered to be a structural defect.

A tiler could rake out the old grout and replace it at the client's discretion.

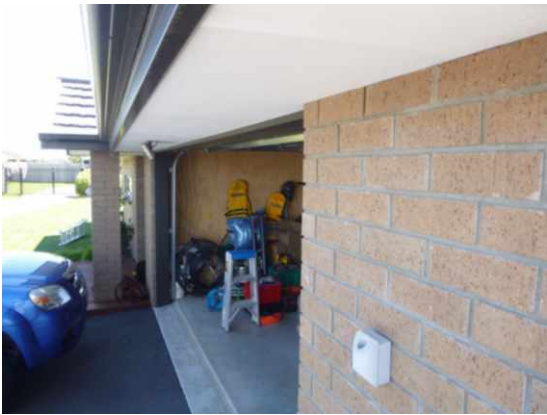
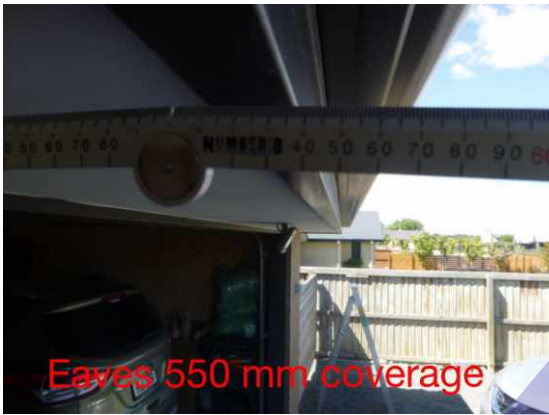
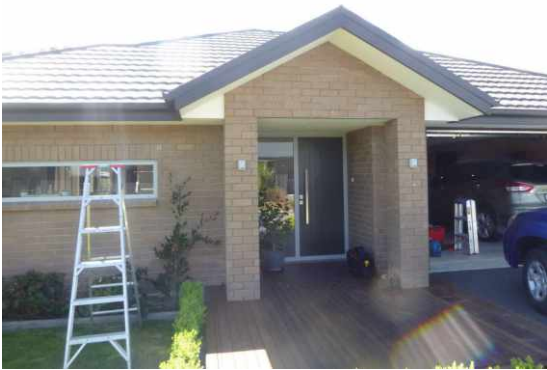
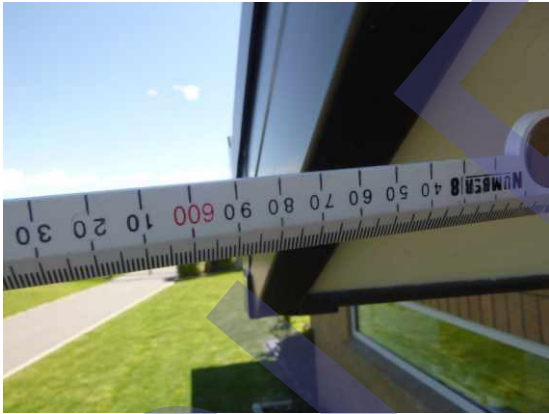
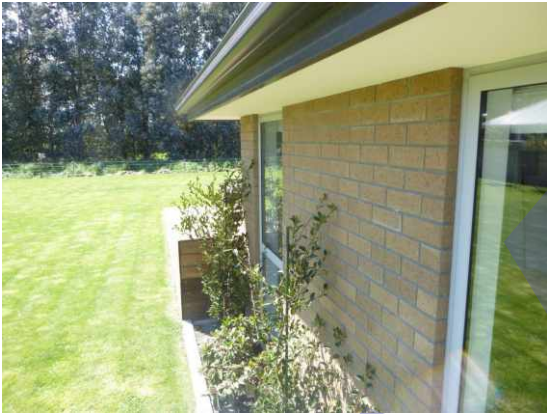
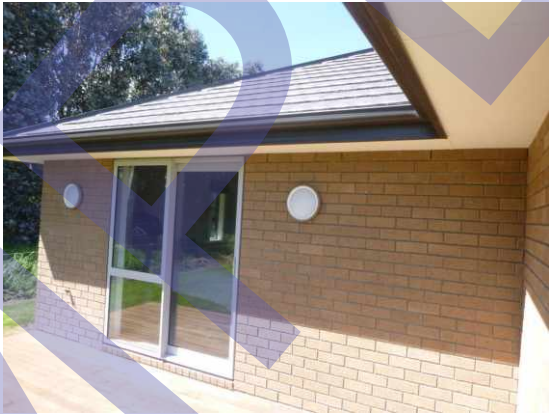
Building:	Main Building
Location:	NZ Only > All Areas
Finding:	General Weathertightness Risk - Low
Information:	<div><div>A. Wind Zone - Your risk rating is HIGH RISK</div><div>B. Number of Stories - Your risk rating is LOW RISK</div><div>C. Roof/Wall intersection design - LOW RISK</div><div>D. Eaves width - Your risk rating is MED RISK</div><div>E. Envelope complexity - Your risk rating is LOW RISK</div><div>F. Deck design - Your risk rating is LOW RISK</div></div>

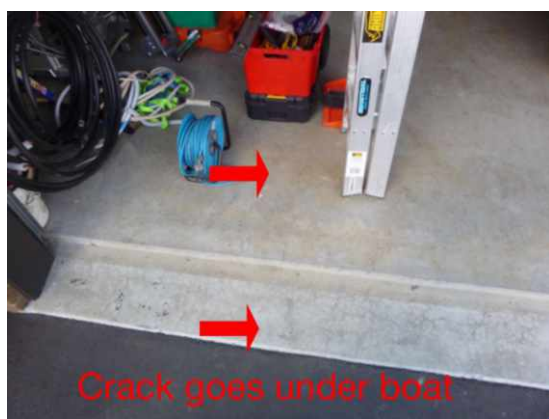
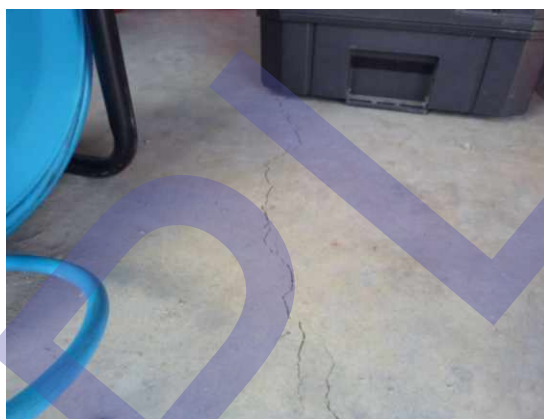
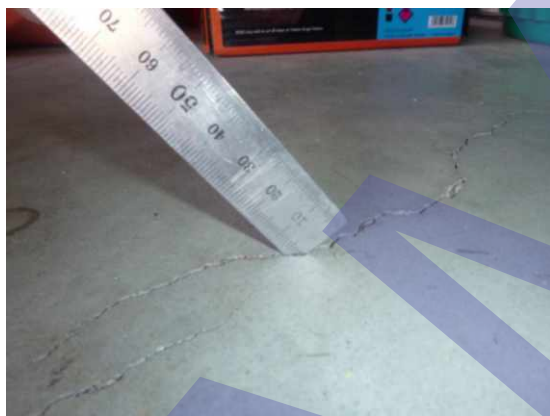
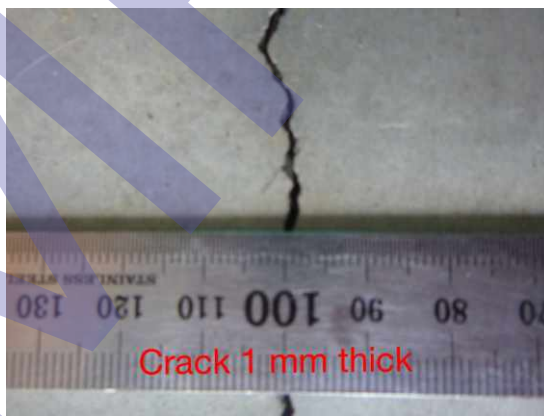
There was minor cracking observed to the garage flooring. It does appear to terminate near the centre of the floor but the boat was covering this area. Cracking like this can occur as part of the natural expansion and contraction process as the concrete cures.

Building: Main Building
Location: NZ Only > All Areas
Finding: Historical Earthquake
Information: There have been earthquakes in this area. Long term effects will only be visible over time, however no evidence was observed at the time of inspection. Verification of a building being "earthquake proofed" is outside of the scope of this inspection.

There was minor cracking observed on the garage floor which appeared to terminate towards the middle of the floor. The boat covered most of the crack. This type of crack can be typical of expansion and contraction where concrete will shrink post pour.

These are not considered structural defects, however, these cracks should still be monitored over time for any signs of lengthening or widening.

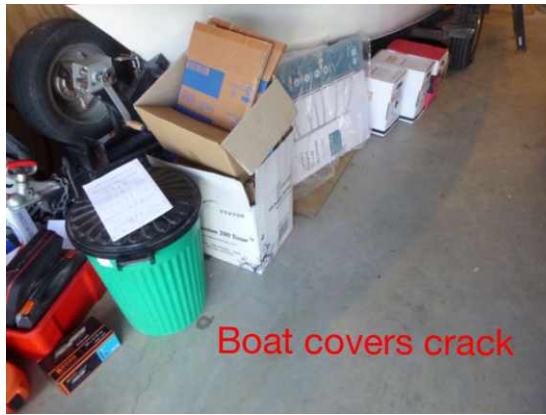
Boat covers crack

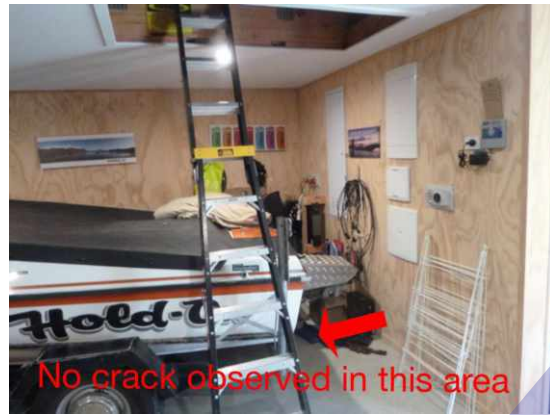
No crack observed in this area

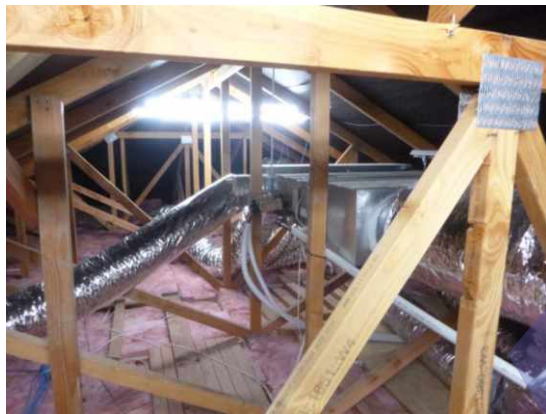
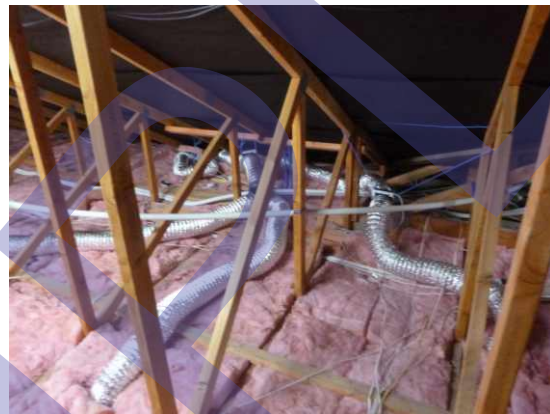
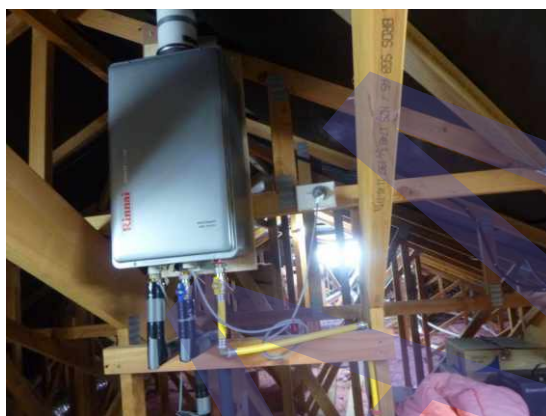
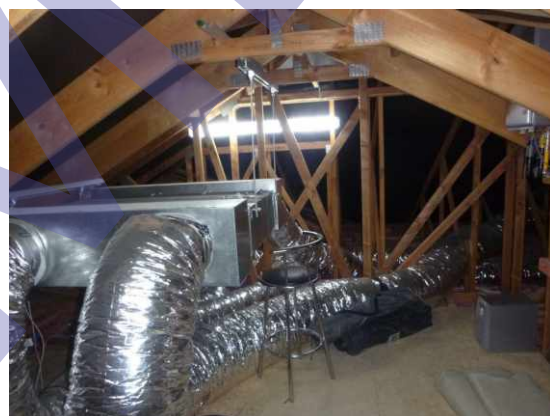
The roof space was in excellent condition and all ductings were secure and there were no signs of historical or active leaks.

Building: Main Building
 Location: Roof Void > All Areas, Centre
 Finding: Roof void - Condition
 Information: At the time of inspection the roof space, all ductings were secure to the heating units and the insulation was in good condition throughout.

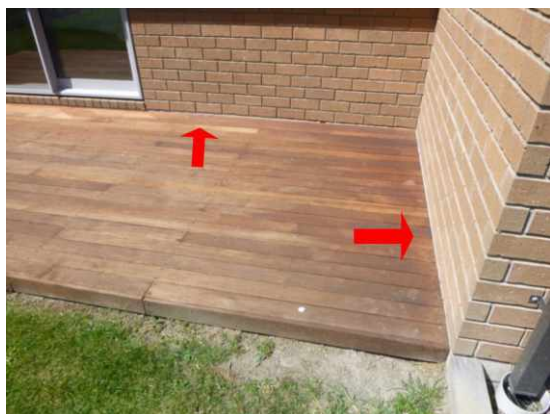
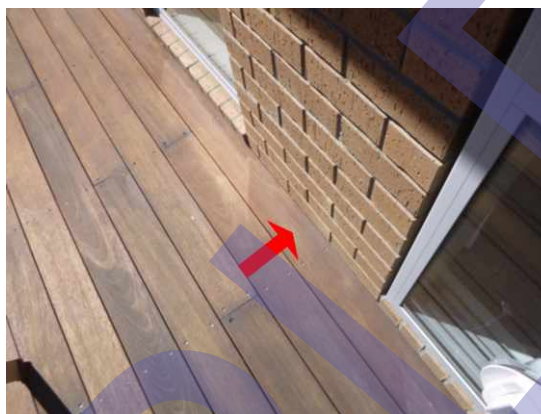
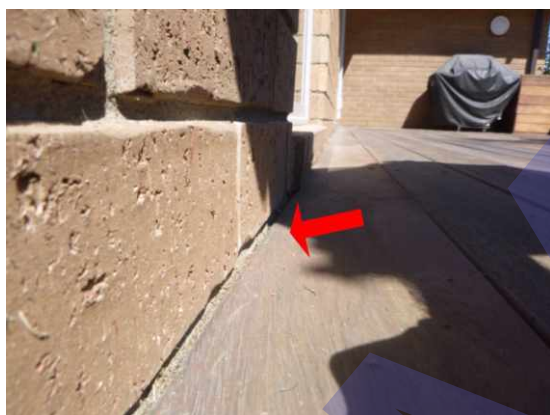
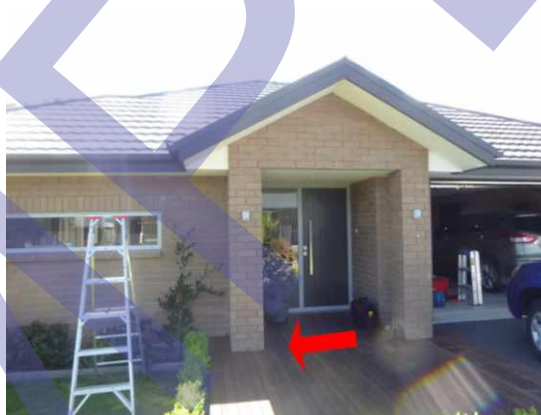
Finding: Deck - Insufficient gap

Information: At times owners like to have a seamless egress out on to the deck by butting the edge to the house.

Although this may appear to be aesthetically pleasing, this is contrary to the building standard where a 12 mm gap is required in order to allow water run off thus allowing the edge to remain dry. It is impractical to create this gap post construction therefore it is recommended that the decking remains clear and this edge is regularly cleaned.

This will ensure there is enough airflow keeping the decking timber along the buildings edge dry.

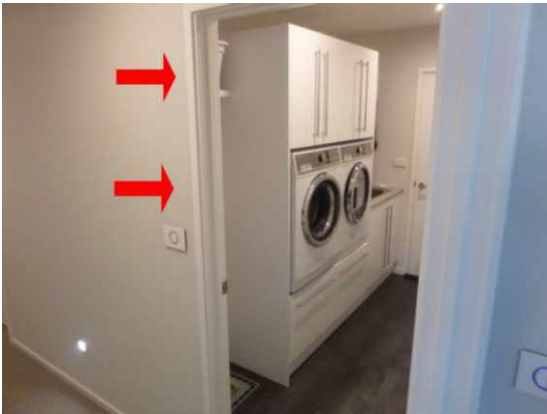
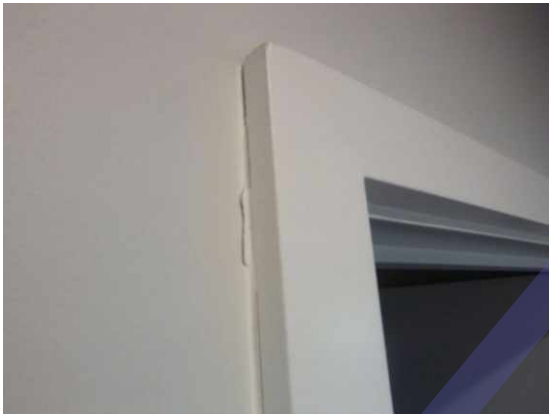
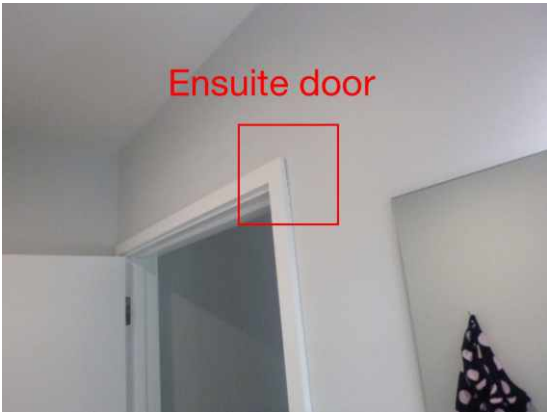
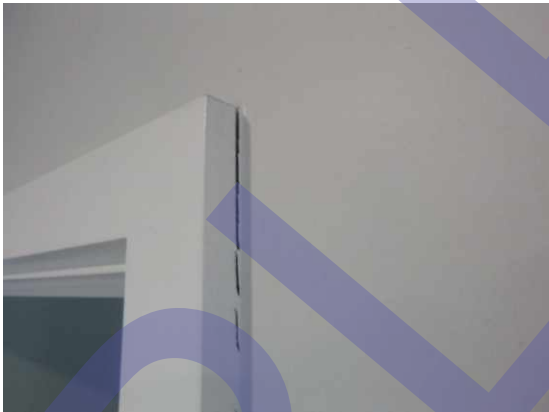
Minor paint cracking or separation was evident at a couple of door architraves. This can be typical when timber shrinks post construction.

Finding: Door Paint - Cracked

Information: At times paint can crack or peel away from it's surface especially near junctions like corners of architraves.

The timber can shrink as it dries over times which pulls paint away from the surface.

This is only an aesthetic defect and can be sanded back and painted by a decorator

or handy person at the clients discretion.
