NZ Residential Property Inspection Report

Inspection Date: Mon, 08 Oct 2018

Property Address: Sample Inspection

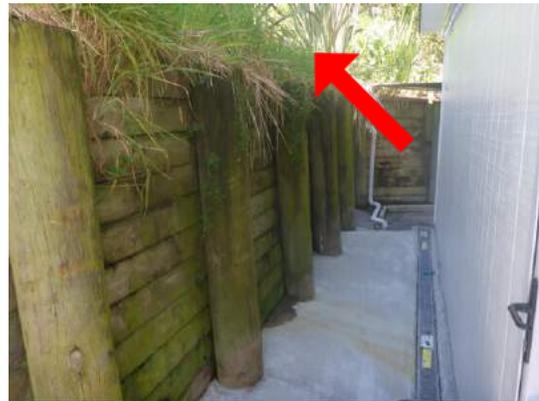
Defects 1.01

Building: Yard
Location: Retaining wall
Finding: Missing fall restriction/barrier - Suspected Non-Compliance
Information: The retaining wall was found to be fairly easily accessible and have no fall restrictions/barriers and found to be less than the present building regulation requirement of 1000mm high.

This defect creates a potential safety hazard and should be rectified as soon as possible to ensure the safety of the area and to meet present building standards and regulations.

A registered builder, carpenter or specialist fencing contractor should be contacted to discuss possible rectification solutions.

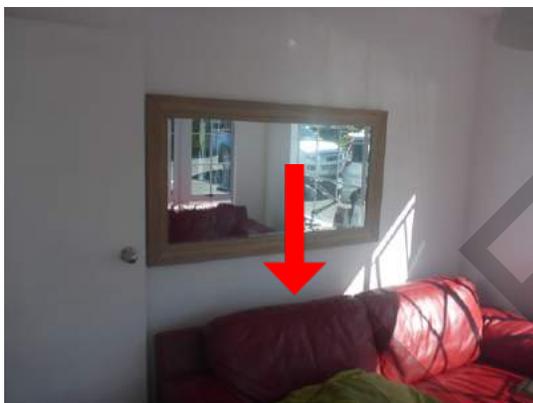
Defects 1.03

Finding: Electrical power point - Broken

Information: The electrical power point in this area was found to be broken at the time of inspection. Breakage occurs generally when the building materials have aged and decayed, but may also be indicative of impact damage to the building element (accidental or deliberate).

Left unmanaged, the fitting is unlikely to cause further damage to surrounding building elements. However, the broken fitting does expose electrical works, and may create a safety hazard if there is potential contact with persons in the area.

Repair and/or replacement of the broken fitting is advised. A Licensed electrician should be appointed to repair/replace the fitting immediately.

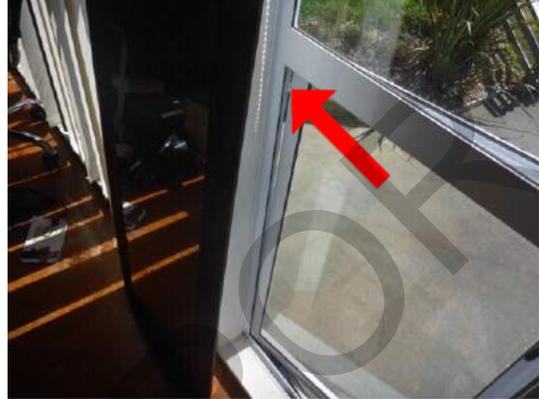
Defects 1.04

Building:	Garage
Location:	First floor - Window openings
Finding:	Unconventional window installation - missing fall restrictions/barriers
Information:	This unconventional installation of the windows on the first floor appears to have been completed to a substandard level and does not comply with regular building practices. The opening of the windows create a safety hazard where someone especially small children could slip/fall trough the window to the ground below.

It is highly recommended that fall restrictions/barriers be installed to prevent falling from the open windows. Other options to limit the opening to a safe opening size can also be investigated. However it should be noted that it is suspected that the unconventional installation of the windows could also allow excessive wear on the hinges as it is suspected that the hinges were not designed for vertical operation. A similar installation of a window on the rear wall above the stairs was installed in a similar manner is not a safety hazard, however it would be advised to install appropriate hinges on this window too to prevent excessive wear.

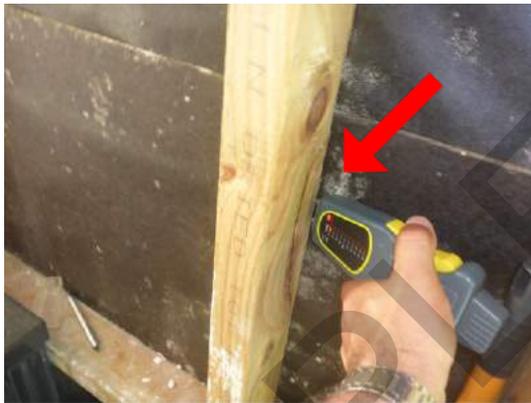
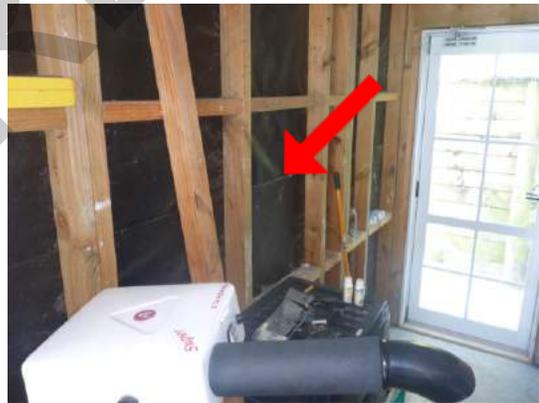
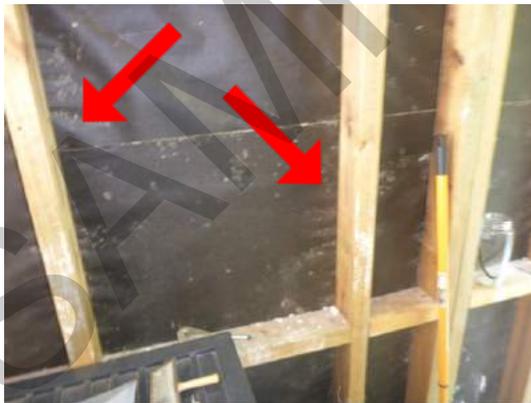
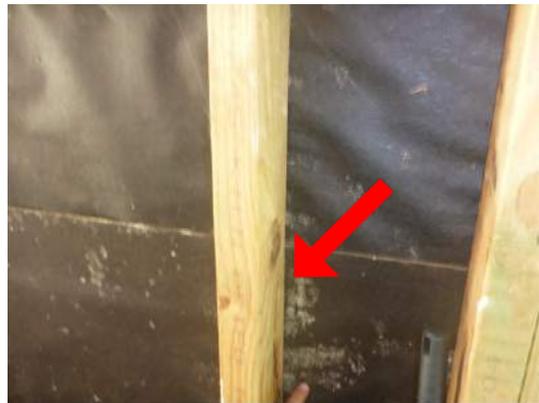
Defects 1.06

Where evidence of mould growth was noted, there may be environmental, biological or health issues associated with the report. A specialist inspection by a suitably qualified environmental health inspector is warranted, where mould is extensive or where any queries regarding air quality spores or other related issues apply.

Generally, the client is advised to ensure that the general environment is free of moisture and humidity to aid in the prevention of mould formation and development. Any mould found during the inspection should be cleaned immediately by a cleaning contractor or the homeowner as applicable.

Please note that severely affected building elements may require replacement by a registered builder or qualified carpenter.

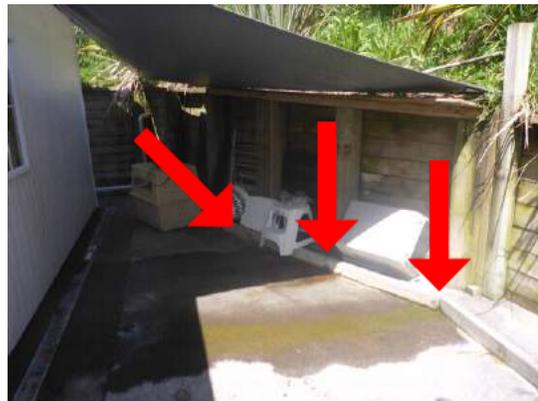
Defects 2.01

Building: Yard
 Location: Retaining wall behind garage
 Finding: Site drainage - Inadequate
 Information: Although significant efforts were made to install drainage, the site drainage in the side of the garage was found to be inadequate at the time of inspection, creating potential for subsequent water damage to associated building elements. The installation of the catchment trench seems to be done fairly well in most places however some moisture was visible between the catchment trench and the garage wall at one place. It would seem that the slope in this area does not allow water to be directed towards the trench but rather towards the wall.

A further solution could be to direct the water before it gets to the trench, by the installation of a further drainage trench adjacent to the retaining wall. Attempts to install a type of barrier seems to be failing as water can be seen seeping through the timber joints.

Where site drainage is inadequate, installation of an Agricultural (Aggie) Drain may be required. A qualified plumber should be appointed to further inspect the property and perform any remedial works as necessary. Water damage and secondary defects are likely to occur if left unmanaged.

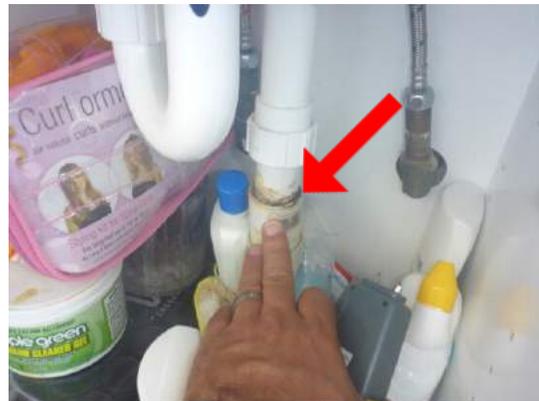
Defects 2.03

Building:	Main Building
Location:	Ensuite
Finding:	Vanity - Swollen, Leaking Drainpipe, Slow discharge
Information:	Swollen building elements generally indicate that the building materials have been affected by excessive moisture over a prolonged period of time, and have swollen as a result. It would seem a likely cause is the drainpipe that are leaking and are loose from its coupling. The delaminating melamine covering of this vanity is further evidence of excessive moisture in this area.

Furthermore the substandard connection joint coupled with a suspected airlock in this part of the plumbing is expected to be the main cause of the slow discharging of the water from the basin.

The structural integrity of swollen building elements can not be guaranteed, and further damage is likely to develop if left unmanaged. Excessive moisture is likely to lead to the development of secondary damage to any associated building elements, which may necessitate major repair works if prolonged.

Rectification of the cause of the water leak should be addressed prior to any remedial works to the swollen building elements. A licensed plumber should be appointed immediately to identify the cause of the leak and provide advice on remedial works as necessary, Repair and/or replacement of swollen building elements should be conducted as a matter of urgency by a registered builder or qualified carpenter.

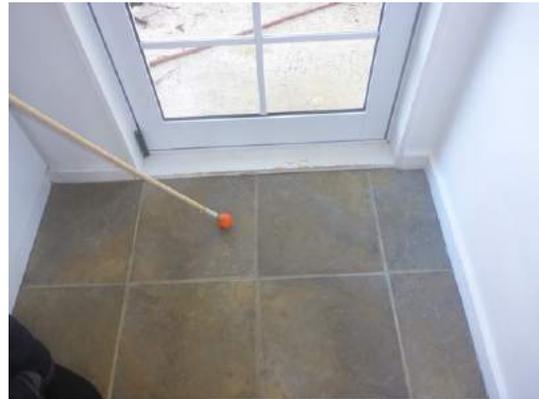
Defects 3.01

Information: Drummy tiled areas were identified at the time of inspection. The term `drummy` refers to tiles that have become detached from their fixing, despite otherwise being in relatively good condition. Such defects are generally caused by physical or moisture damage to the area. Drummy tiled areas may also be a direct result of poor workmanship during the construction process.

Tiled areas may swell and shrink with changes in air humidity if the area has sustained moisture damage. Any exposure to moisture is capable of causing tiled areas to become drummy and/or cracked over a prolonged period of time. Drummy tiled areas generally require removal and replacement of affected tiles, with adequate sealant and grouting.

Specialist trades are available for these types of services. A registered builder may be required to undertake works if damage is extensive or if secondary building defects have resulted. Otherwise, it is advised that a tiling contractor be appointed to perform works as necessary. Immediate action is recommended to ensure that no further damage is sustained in the affected area.

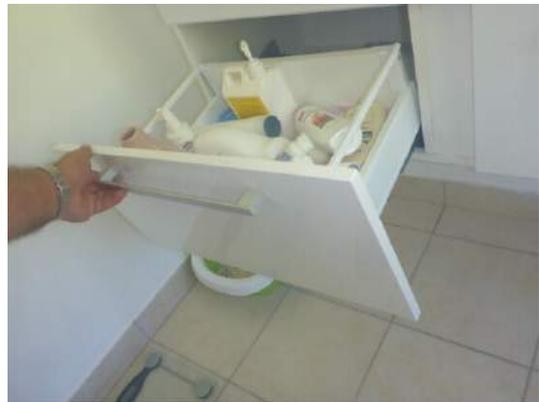
Defects 3.02

Finding: Bathroom vanity - Broken drawer

Information: The drawer of the bathroom vanity was found to be broken at the time of inspection. Breakage occurs generally when the building materials have either aged and decayed, or as a result of damage (accidental or deliberate).

Repair and/or replacement of broken elements is advised to ensure that additional secondary defects do not arise as a consequence. Such works are necessary, as all building elements play a key role in the operation and function of the overall structure and its performance.

A relevant tradesperson should be appointed to repair or replace the affected building element prior to any subsequent damage being caused.

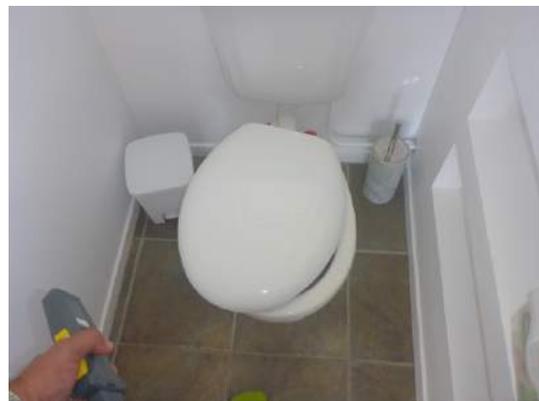
Defects 3.03

Finding: Toilet seat - Loose

Information: The toilet seat was found to be loose and relatively unstable at the time of inspection. It is suspected that this defect has developed due to general ageing of the toilet and associated materials. However, the loose fixing may also be a result of impact damage or have not been maintained.

It is recommended that the seat be replaced/refixed to the toilet pan by a general handyman .

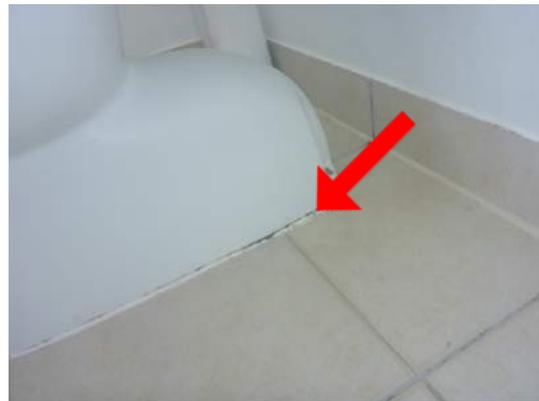
Defects 3.04

Building: Main Building
Location: Ensuite, Bathroom, Toilet, Laundry
Finding: Sealant and grouting - Missing or damaged
Information:

It was noted on inspection that sealant or grout is degraded or missing around the toilets in the ensuite, bathroom, and toilet. The grouting around the toilet basin was found to be missing and the grouting around the laundry basin was very deteriorated and mouldy.

Different materials and floor areas move at different rates, generally causing cracking to grout or sealant at this point. A flexible sealant is required to allow for expected expansion and contraction, while keeping the joint water tight and protective of all associated building materials.

There appears to be excessive mould to the sealant and grout which will likely require scraping out and replacement.

Flexible and mould resistant materials should be applied to affected areas to prevent any subsequent water damage that is likely to occur. Regular maintenance and replacement of damage or missing or damaged sealant and grout is highly recommended to the wet areas, as this is a regular wear and tear defect. Sealant and grouting in areas that come into regular contact with water should be maintained for the long term care of your property.

A sealant specialist or tiling contractor should be appointed to complete these works as soon as possible

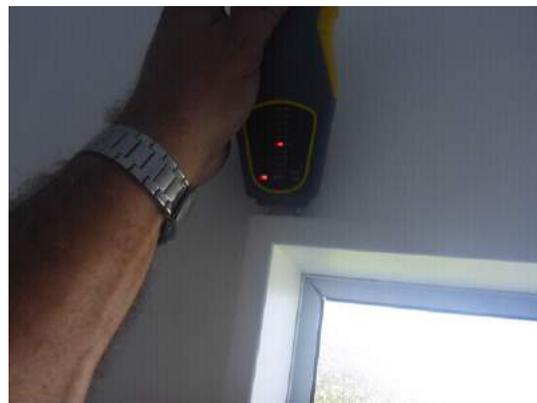
Defects 3.05

Building:	Main Building
Location:	Ensuite, Laundry
Finding:	Damp
Information:	Elevated readings was observed when the wall penetrations were tested for moisture. Damp (or structural damp) refers to the presence of unwanted moisture in the structure of a building, either as the result of intrusion from outside, or condensation from within the structure. Generally, structural damp is caused by rain penetration, rising damp, and leaks from plumbing pipes.

Unmanaged damp facilitates the formation and development of mould, fungi growth and wood rot, decaying associated building materials and compromising their structural integrity. Damage to finishes is also likely to occur, including lifting, bubbling, peeling and staining of paint, plaster and wallpaper.

The first step in addressing damp is to diagnose the cause. The identified cause should be addressed first prior to repairing the appearance and other defects which have resulted from the rising damp. If the original cause is not resolved, further cases of damp are likely to ensue, resulting in secondary defects.

Consultation with a qualified plumber is advised immediately to identify the cause of damp and perform remedial works as required. Where excessive mould growth is present, further inspection by a specialist environmental health inspector should also be considered.

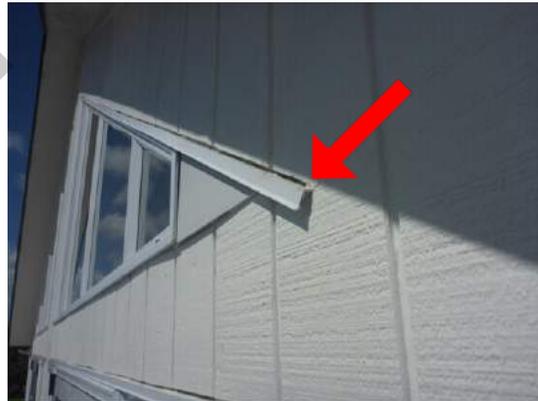
Defects 3.07

Finding: Window/door flashings - Inadequately sealed

As such, associated building allowing water penetration to the cavity wall. are likely to deteriorate at an accelerated rate, and major implications are expected if these defects are left unmanaged. The holes around the flashing should be adequately filled using a suitable sealant or trimmings as soon as possible to prevent any further damage. Such works may be conducted by a general handyperson or registered builder.

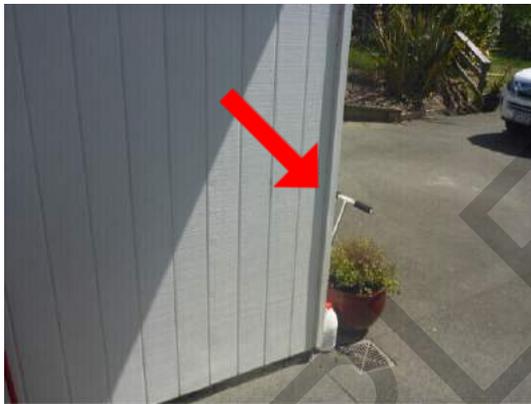
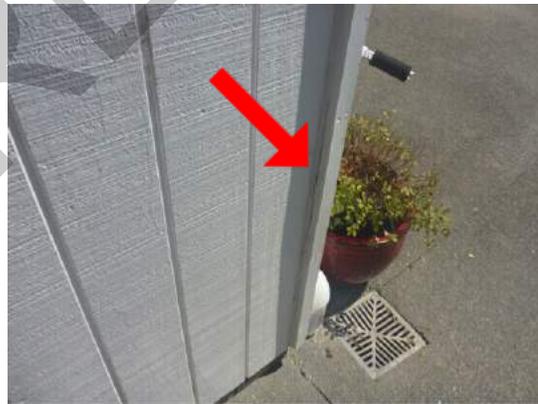
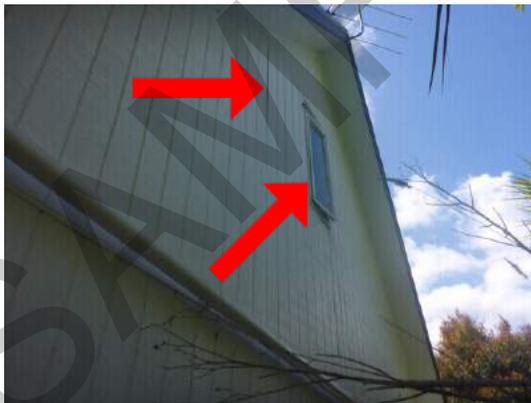
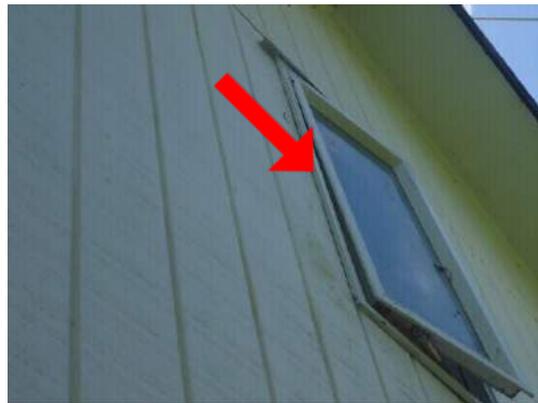
Defects 3.08

Building:	Main Building
Location:	Exterior walls
Finding:	Exterior walls - Cracks, gaps and holes
Information:	Some cracks, gaps or holes were found in the cladding including corner joints, eave flashings, around door and window frames, wall attachments and around wall penetrations for pipes. It is suspected that some of the works was completed to a substandard level of workmanship or is incomplete. Gaps and holes makes the areas susceptible to insect, vegetation and vermin ingress as well as allowing water penetration to the cavity wall.

As such, associated building elements are likely to deteriorate at an accelerated rate, and major implications are expected if cracks, gaps and holes are left unmanaged. All excessive holes, gaps or cracks should be adequately filled by using a suitable sealant or trimmings as soon as possible to prevent any further damage. Such works may be conducted by a general handyperson or registered builder and/or licensed plumber.

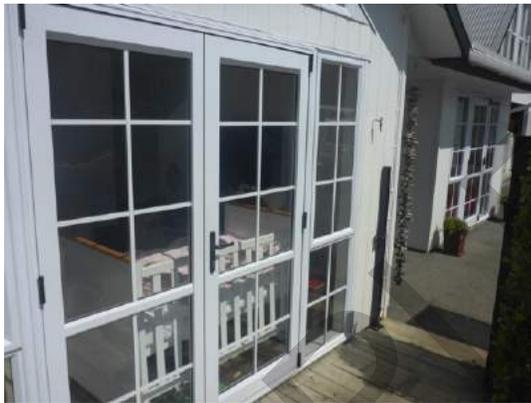
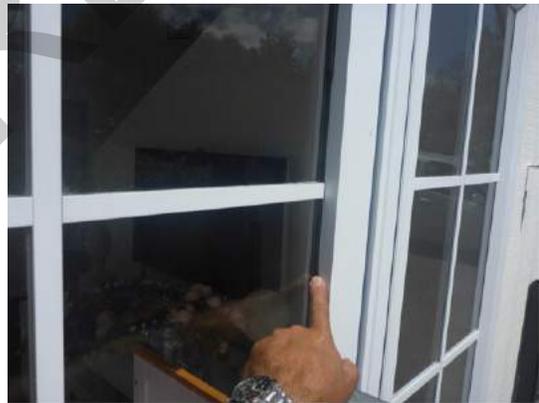
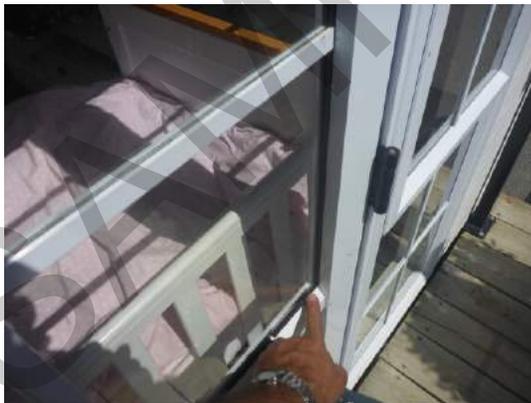
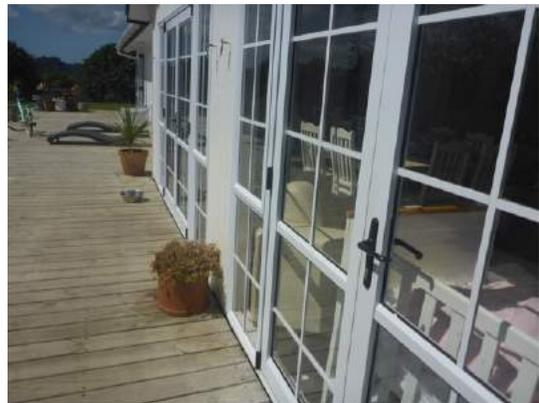
Defects 3.09

Building: Main Building
Location: All Internal Areas - Glass window and doors
Finding: Window/door Glass seals - incorrect installation
Information: Although the window seals does not look like it has deteriorated, it was found that some of the seals were installed incorrectly. Due to frequent exposure to weather conditions and subsequent moisture, deterioration of window seals could cause moisture ingress into the building.

Where window seals have been installed incorrectly, the window is no longer weather-tight; rain penetration and subsequent water damage is therefore likely to ensue. Insulation of the area against external weather conditions will also be compromised.

It is recommended that all the incorrectly installed window seals be replaced by a general handyman or sealant expert to prevent any further damage and to restore the window to a fully functional level.

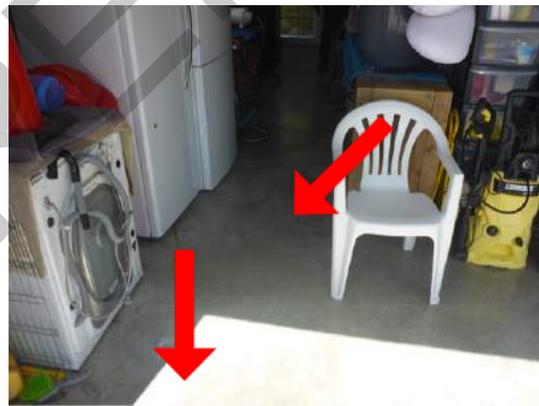
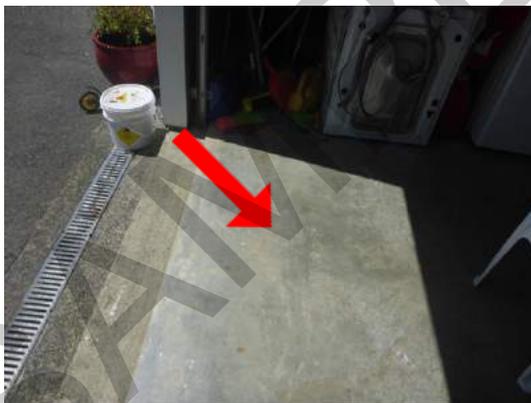
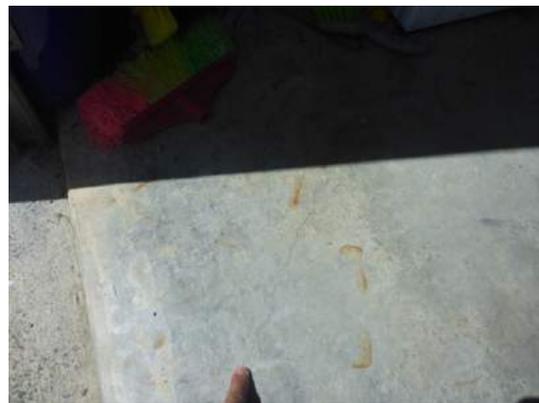
Defects 3.1

Building: Garage
Location: Garage floor
Finding: Crack in concrete slab - Category 1
Information: A crack coded as Category 1 was identified in the slab. A Category 1 crack is described as a fine but noticeable crack, with the slab at an otherwise reasonable level.

Category 1 cracks should be monitored for a period of 12 months. At the end of the monitoring period, identified cracks that are rated greater than Category 2 are considered defects, and require rectification.

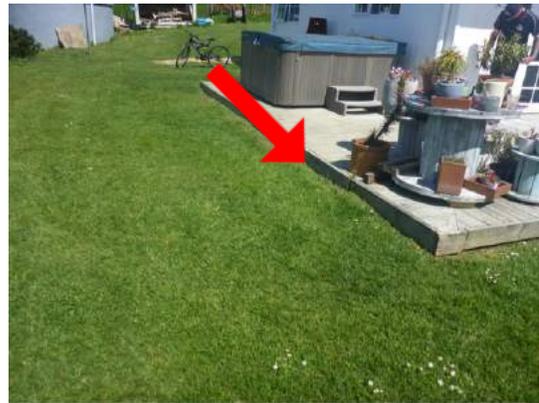
Defects 3.11

Building: Yard
 Location: Deck
 Finding: Deck - inadequate ventilation/trapped water (suspected)
 Information:

Although it is regarded as a minor defect at this stage, if no drainage was installed then the defect should be regarded as significant and the installation of agricultural drainage should be conducted as soon as possible.

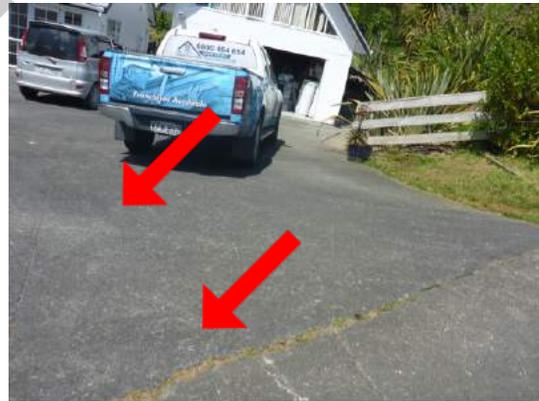
Defects 3.12

Building:	Yard
Location:	Driveway
Finding:	Cracking - External Concrete Paving Damage Category 1 - Fine (less than 2mm)
Information:	Fine cracks were identified in external concrete paving. Although fine cracks are quite noticeable, they are often only considered to be an appearance defect, and usually do not indicate any structural damage. To be considered a Category 1 or fine crack, the crack is found to be <2mm in width.

Monitoring of all cracking should be conducted frequently. Always contact a building inspector should cracks widen, lengthen, or become more numerous.

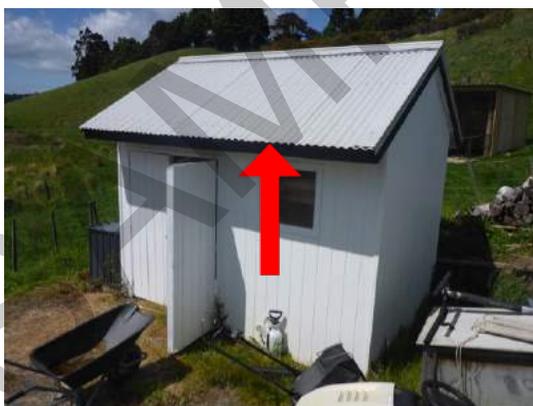
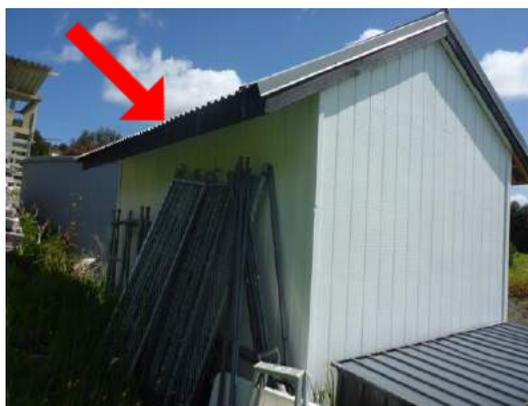
Noted Item

Building:	Yard
Location:	Shed
Finding:	General condition - fair for it age and use
Information:	The shed was found to be in fair condition for its age and use however, no roof plumbing and stormwater management was installed. It would also seem that the ground clearance of the structure is inadequate. It is recommended that the shed only be used for storage items/ materials that won't be effected by moisture/damp/rust.

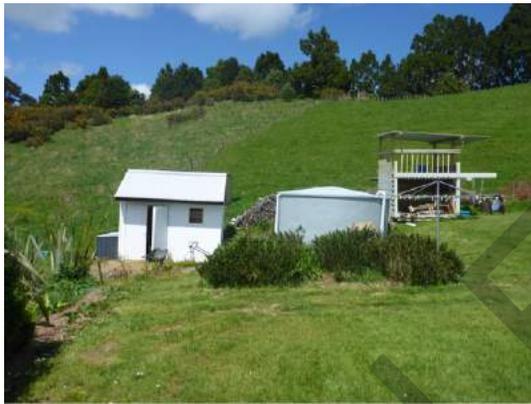
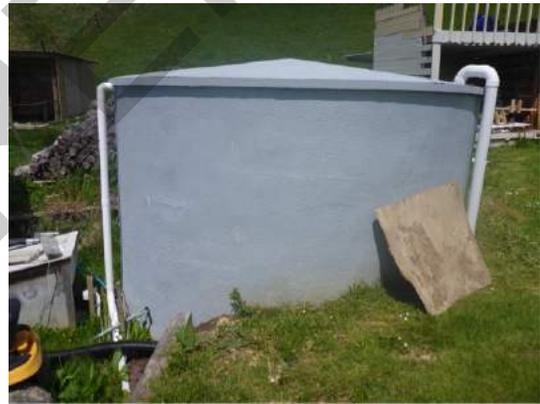
Noted Item

Building: Yard
Location: Water tank
Finding: General condition - fair condition
Information:

The condition of the water and determination if the water is safe for human consumption is strictly excluded from this assessment. Specialist testing by trained hygienists/water technician is required to do further assessments to confirm.
