BEFORE YOU BUY
BEFORE YOU BUILD

NZ Residential Property Inspection Report

Property Address: 1 Sample Way, Rolleston 7614, New
Zealand

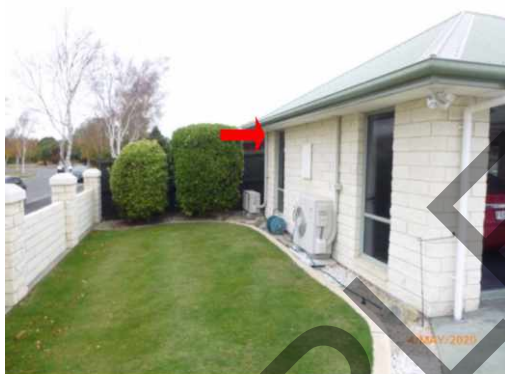
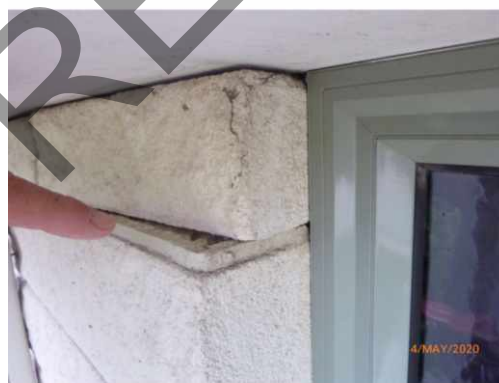
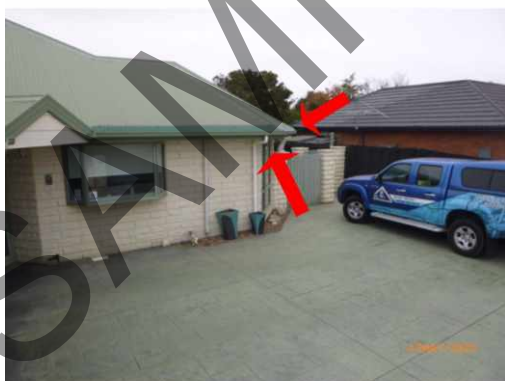
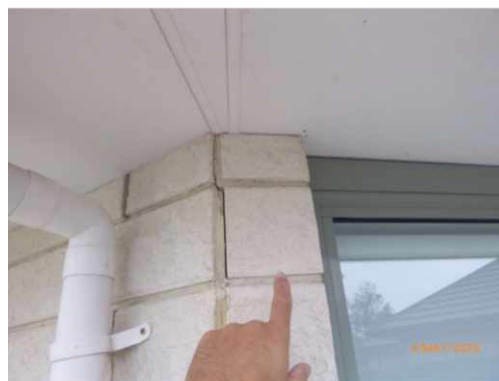
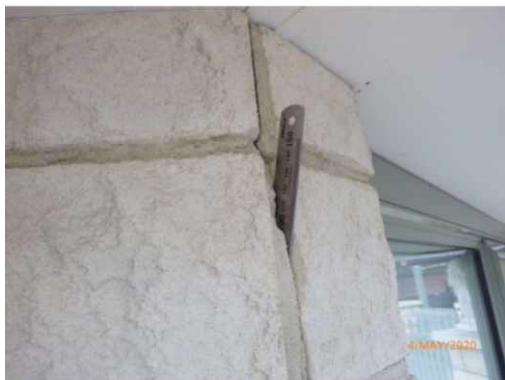
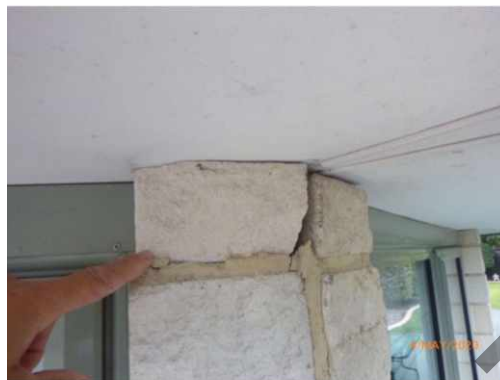
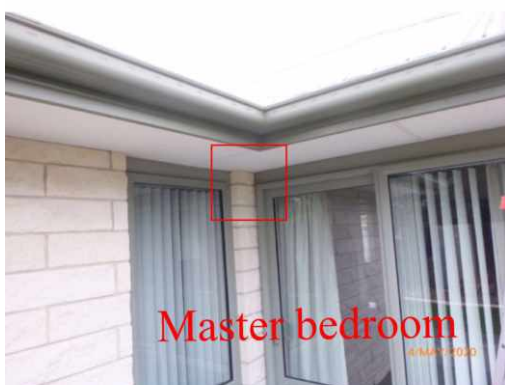
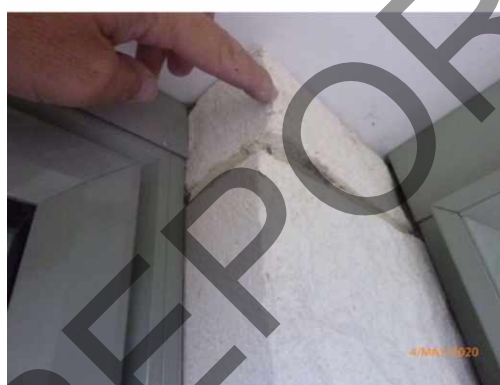
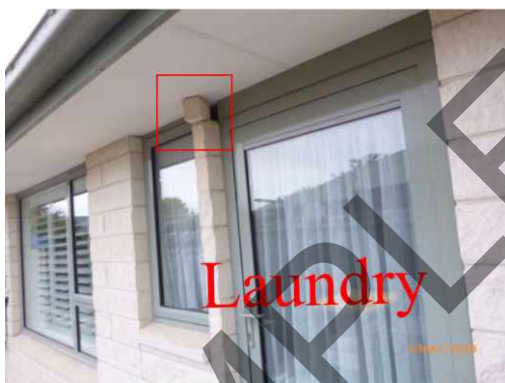
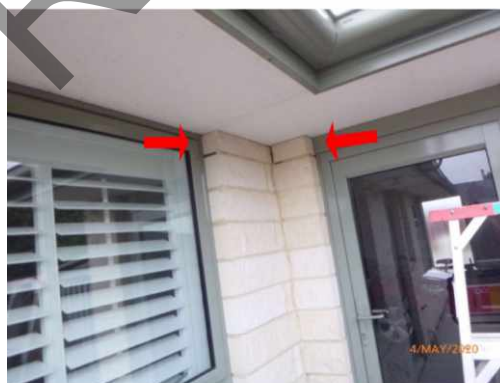
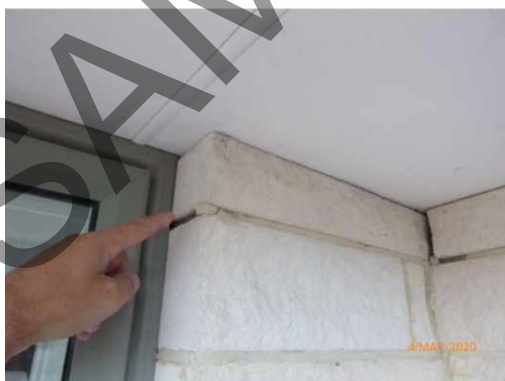
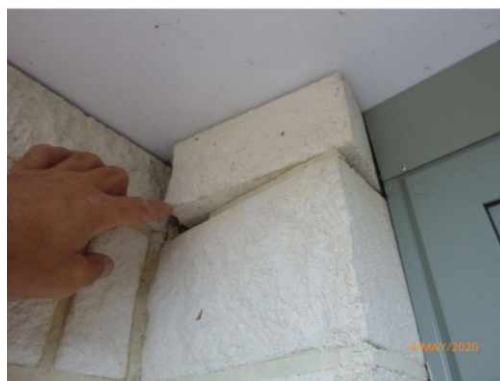
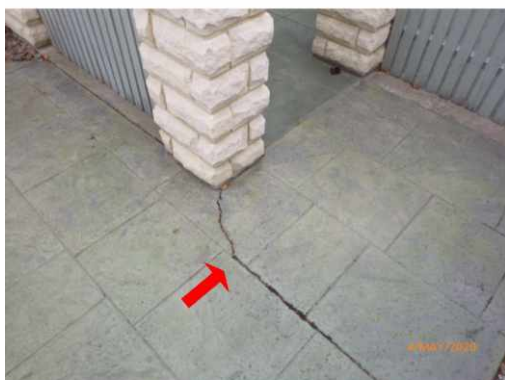
Defects 2.01

Building: Main Building
 Location: NZ Only > All Areas
 Finding: Historical Earthquake
 Information: There have been earthquakes in this area. Long term effects will only be visible over time, however, evidence was observed at the time of inspection. Verification of a building being "earthquake proofed" is outside of the scope of this inspection.

1. The stone work requires attention as loose bricks were identified during this inspection. The stone has failed to adhere to the mortar. 2. Concrete cracking to patios and driveways can occur naturally during the curing process, over time or moisture can get trapped beneath it causing the soil to swell and move, however, it could also be caused by a seismic event.

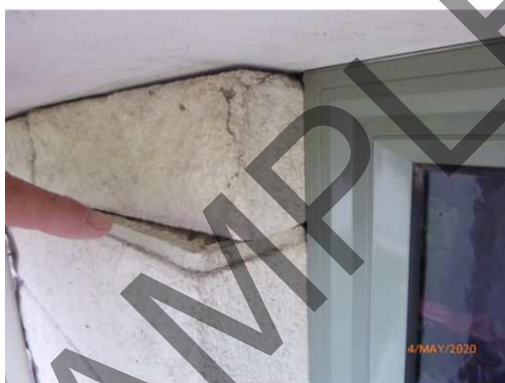
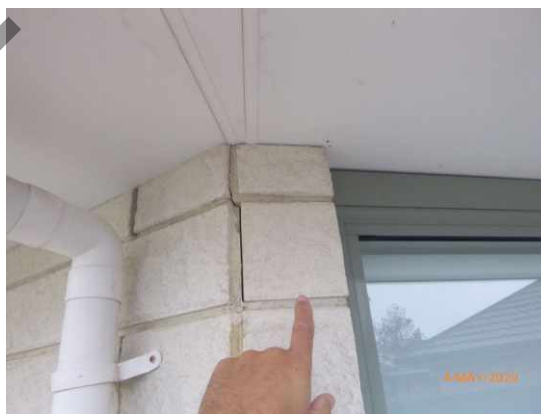
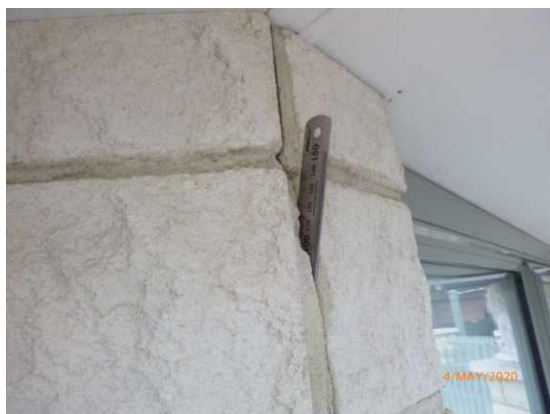
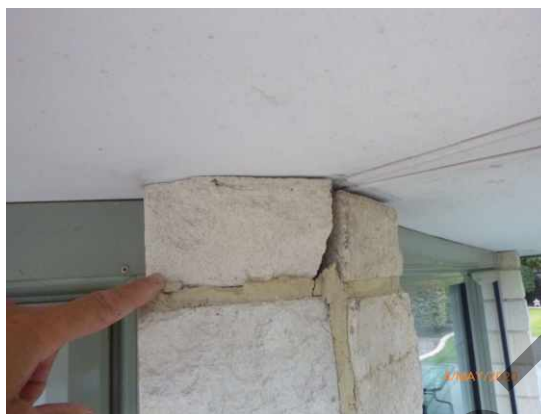
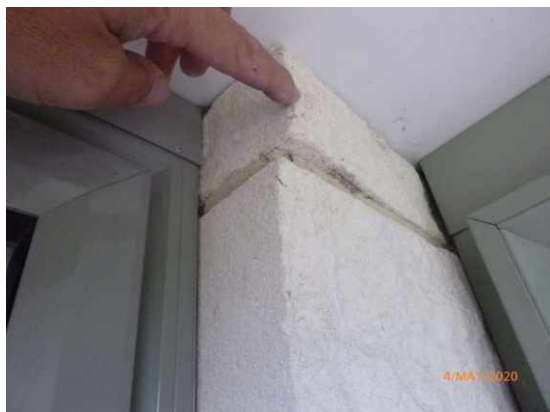
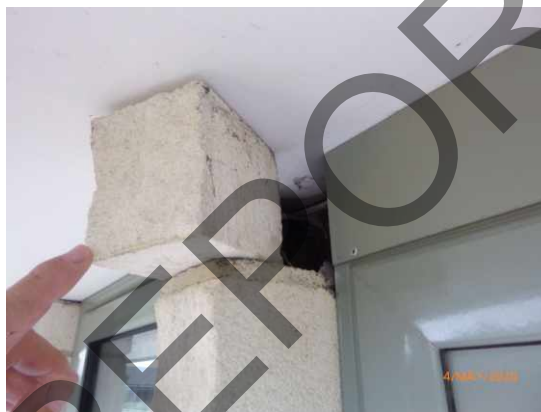
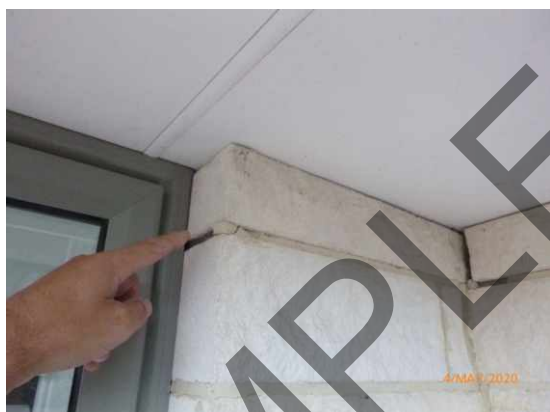
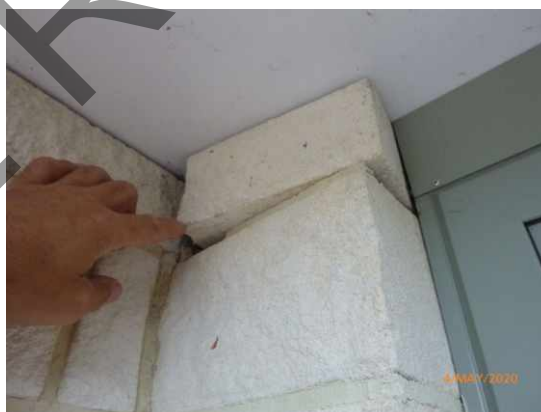
Defects 2.02

Building:	Main Building
Location:	Cladding > All Areas
Finding:	Stone brick - Condition
Information:	At the time of inspection the Stone veneer appeared to be in good condition however there were a few loose bricks observed. It appears that repair work has been carried out as part of the EQC Scope of works C/N0 2010/029201 dated 1 Dec 2010. The mortar has failed to adhere to some of the stone and they were loose. The mortar should be raked out and new mortar reapplied. This will ensure they are secured in place. This is a simple task but a brick layer is recommended so there is a call back option and peace of mind. Despite this, generally the stone veneer was in good condition.

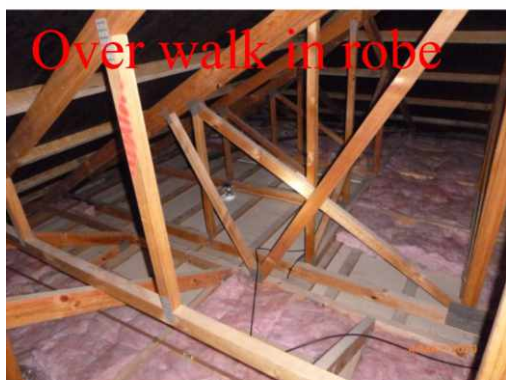
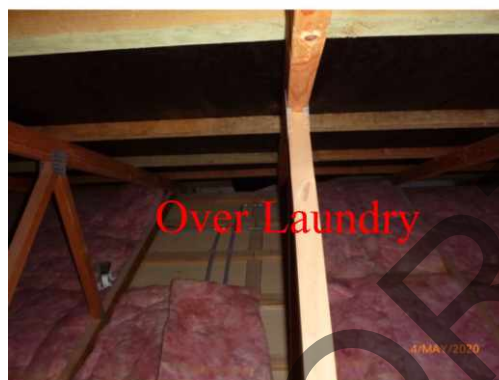
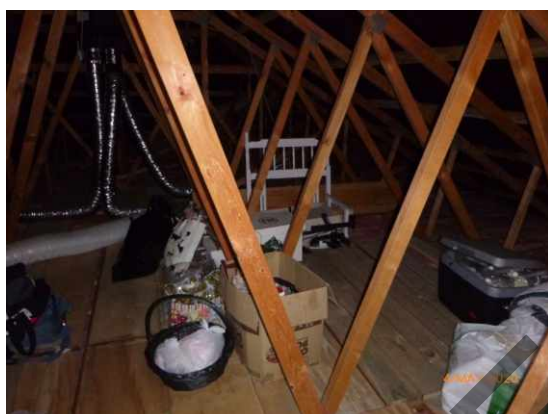
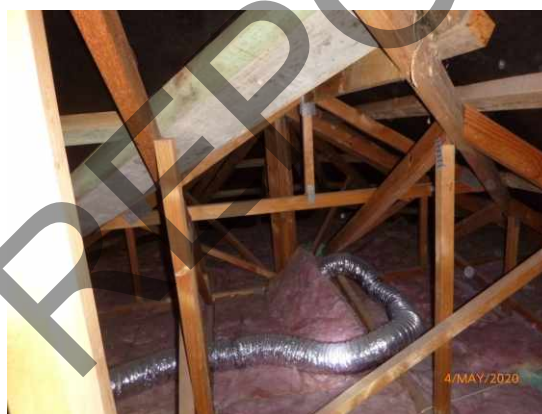
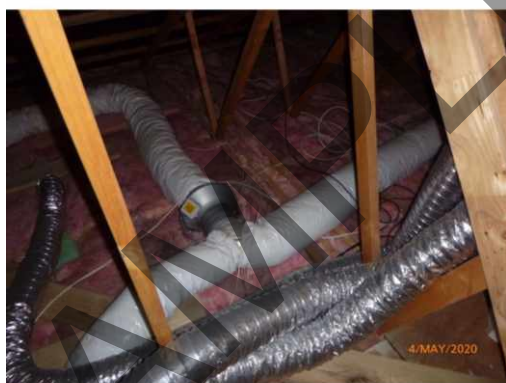
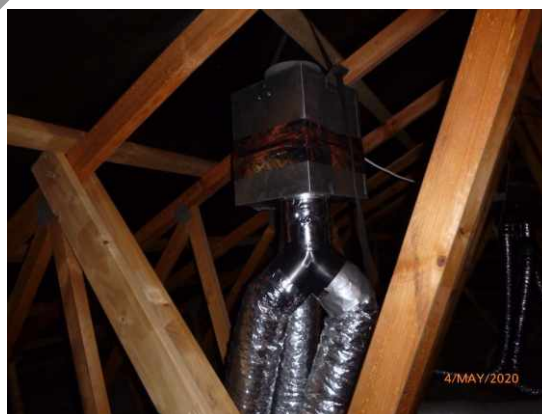
Defects 3.01

Building:	Main Building
Location:	Roof Void > All Areas
Finding:	Roof Space - Condition
Information:	At the time of inspection the ceiling and roof space structure was in good condition throughout. Generally the insulation has been installed to a good standard but insulation was missing over the Master bedroom walk in robe and Laundry areas. These areas should have insulation installed in order for those area to hold the heat in.

This is a simple task and can be carried out by a general contractor or handy person at the clients discretion. There were no historical or active leaks observed in the roof space during this inspection.

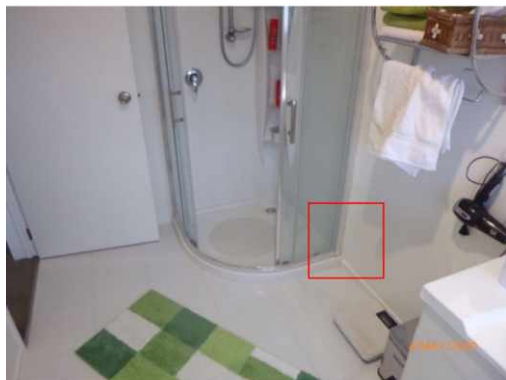
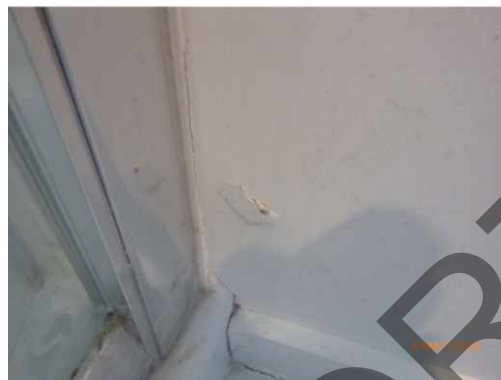
Defects 3.02

Building: Main Building
 Location: Bathroom > Front Right
 Finding: Popped fixing
 Information:

It is was observed that the nail or screw behind the gib lining has popped. This can occur when fixings have been installed too closely to adhesive. At the clients discretion the plaster can be raked out and the fixing can be fixed home or replaced. The area

should then has new plaster and paint applied.this can be done by a painter or handy person at the clients discretion.

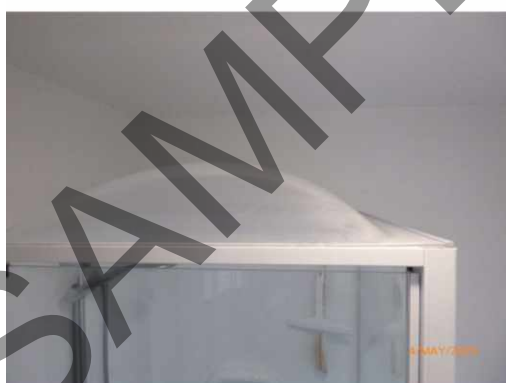
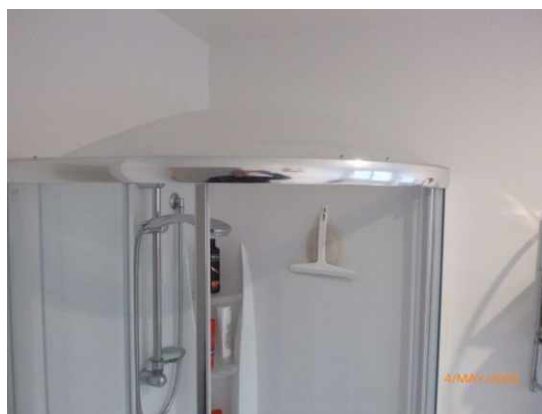
Defects 3.03

Building: Main Building
 Location: Main Bathroom and Ensuite - Master > All Areas
 Finding: Exhaust fan - Missing
 Information: An exhaust fan has not been installed in this area.

Inadequate ventilation in internal wet areas create an environment that is conducive to the formation and development of mould. However, there are shower domes installed which will go along way to mitigate any steam getting out providing the shower doors remain closed after use.

At the discretion of the client a licensed electrician could be appointed to retrospectively install an exhaust fan To further enhance the shower domes.

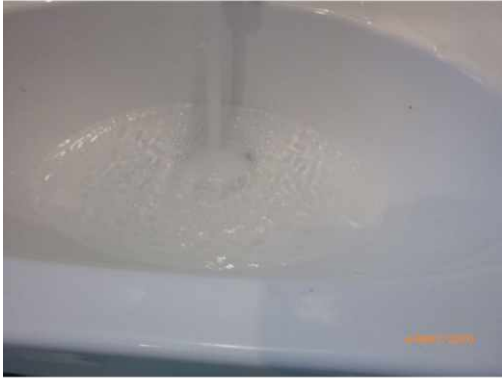
Defects 3.04

Building: Main Building
 Location: Ensuite - Master > Centre
 Finding: Basin - Slow draining

Information: The basin drain was slow to drain during this inspection. At times the drain can become blocked from, hair, debris or soap.

There are many ways to clear drains ranging from natural home made solutions to engaging a plumber. Despite this the drain is functional. At the clients discretion, a plumber could be engaged to use a plumbing snake or spin tool to snag any foreign debris that maybe in the S bend.

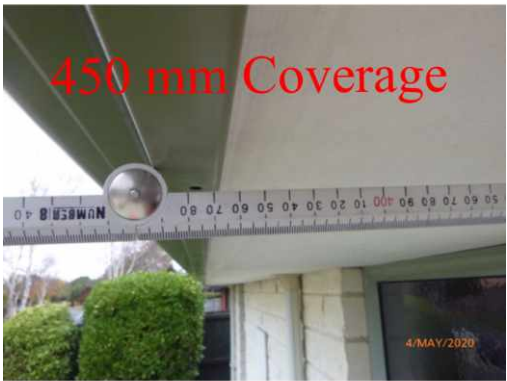
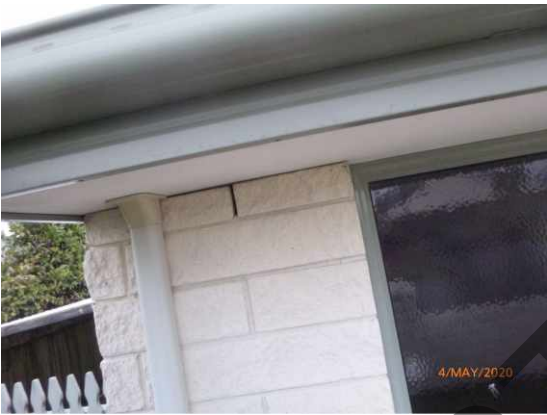
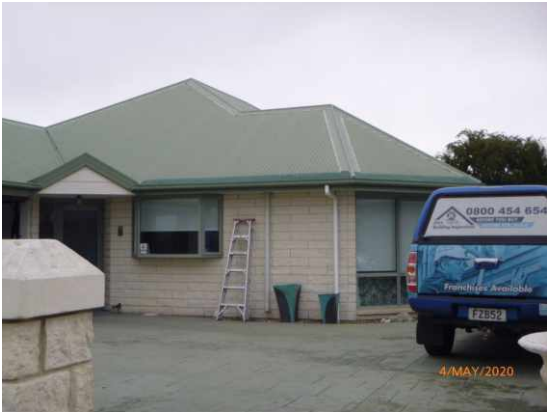
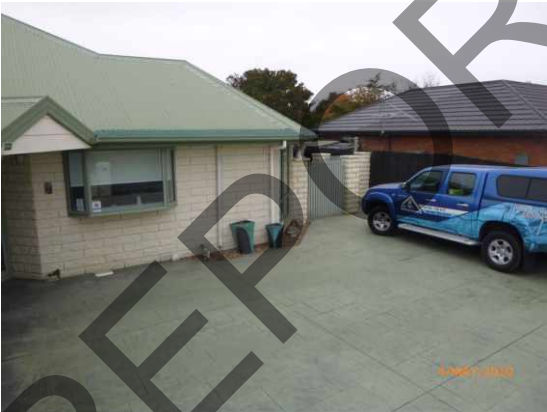
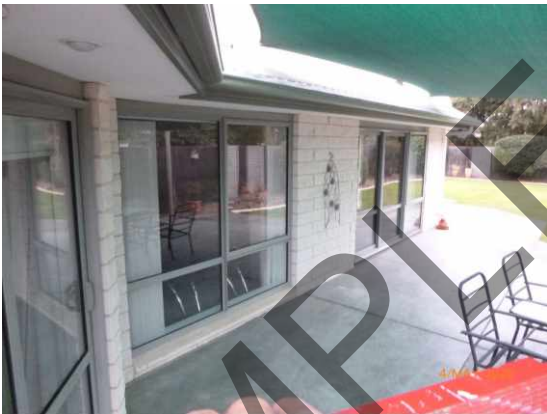
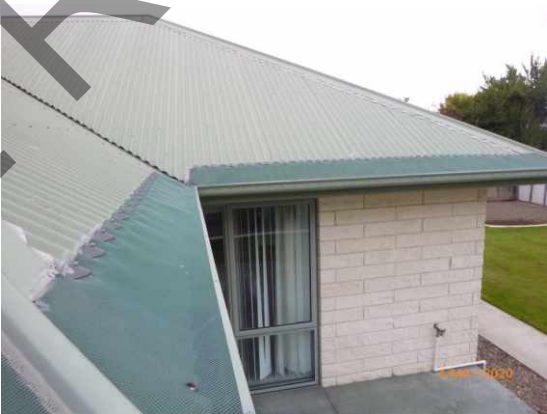
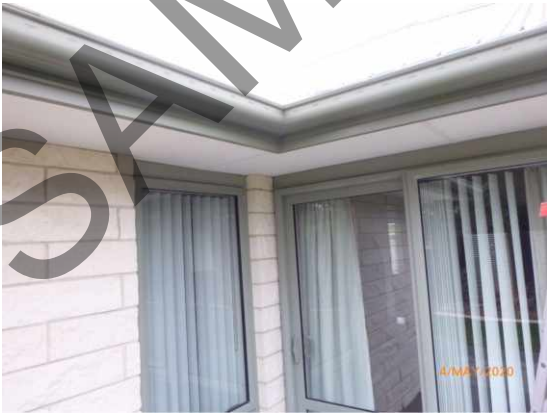
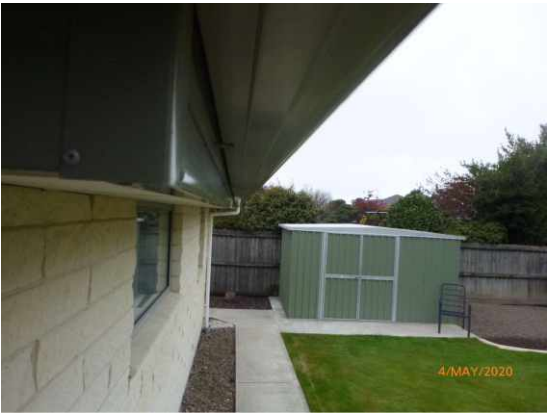
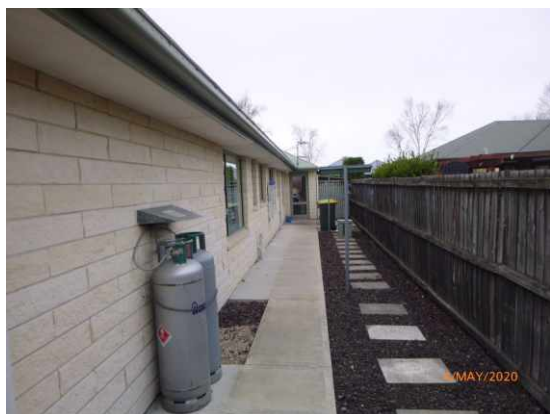
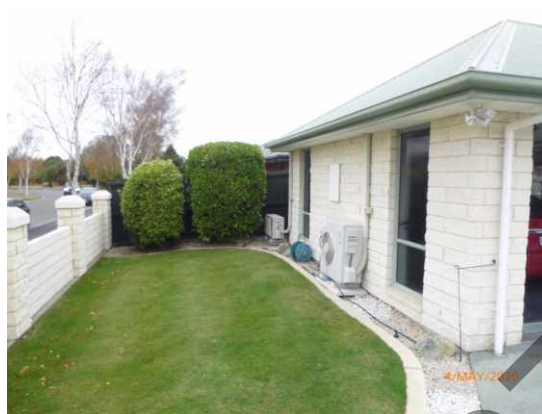
Finding: General Weathertightness Risk - Low

- Information:
- A. Wind Zone - Your risk rating is med
 - B. Number of Stories - Your risk rating is low
 - C. Roof/Wall intersection design - Your risk rating is low
 - D. Eaves width - Your risk rating is med risk
 - E. Envelope complexity - Your risk rating is low risk
 - F. Deck design - Your risk rating is low risk

For individual elevation risk scores the stamped plans and specifications should be consulted. There were no historical or active leaks observed during this inspection.

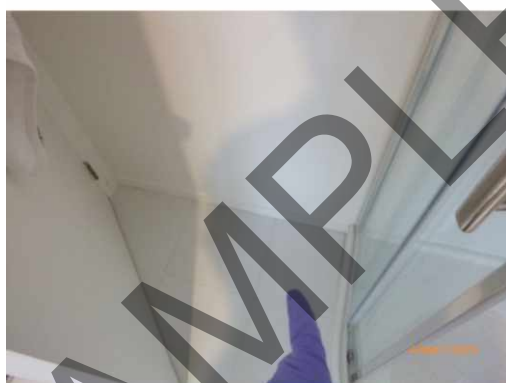
Building: Main Building
 Location: Ensuite - Master > Front Left
 Finding: Door stop - Missing
 Information: The door stop is missing or is inadequate to stop the door handle from damaging the wall. Although some building elements may seem irrelevant or unnecessary, all building elements play a key role in the operation and function of the overall structure and its performance.

Re-installation or replacement of the door stop is advised in order to prevent any subsequent damage to the door or associated structures. A general handyperson may be appointed to perform these works at client discretion.

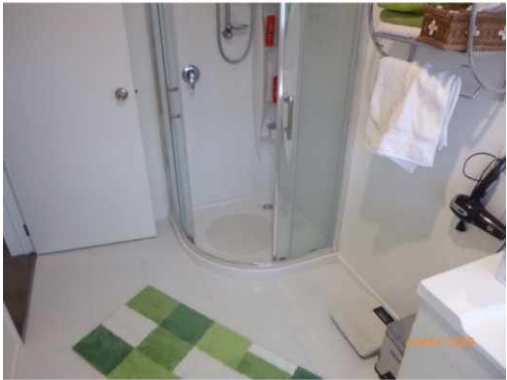
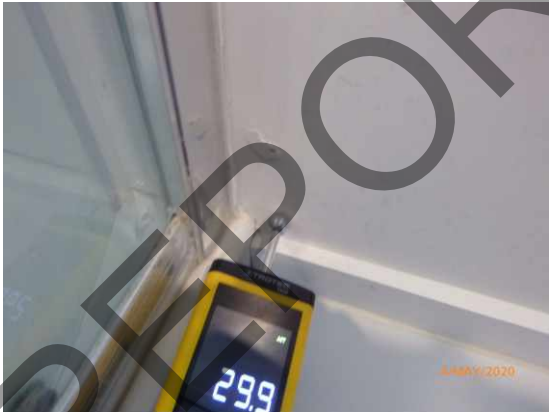
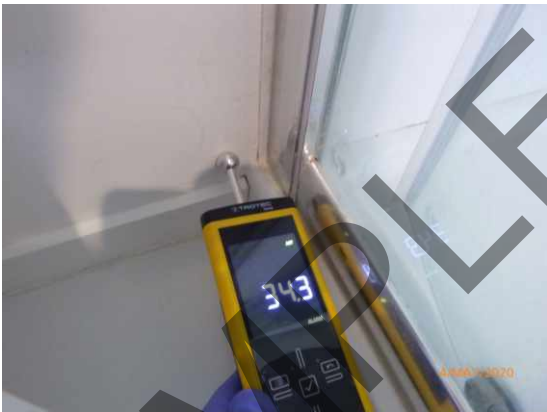
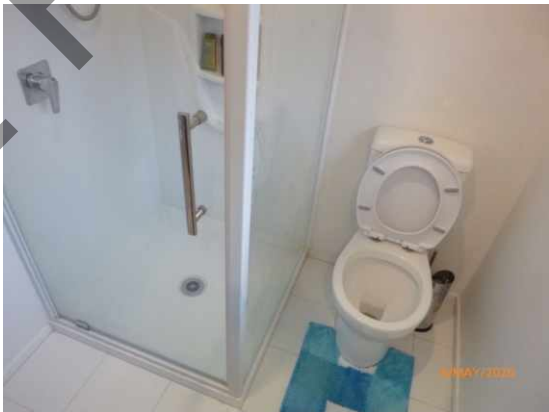
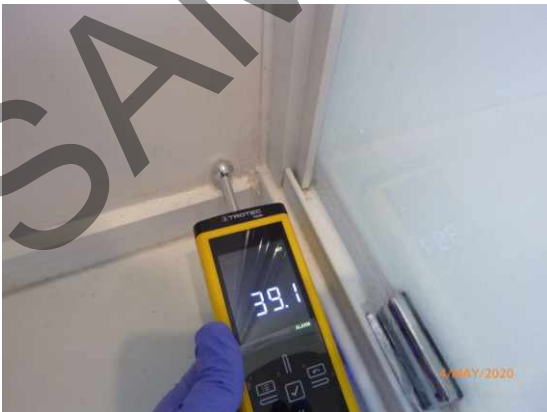
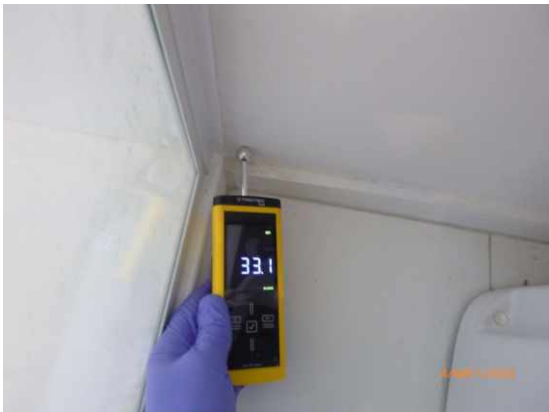
Building: Main Building
Location: Moisture checks > All Areas
Finding: Moisture checks
Information: At the time of inspection the external openings and wet areas were checked for moisture. There were no signs of moisture damage throughout the home and the moisture meter indicated dry readings only.
