# NZ Residential Property Inspection Report

Inspection Date: Mon, 19 Aug 2019 Property Address: Christchurch, New Zealand

Original Inspection Date: Mon, 19 Aug 2019

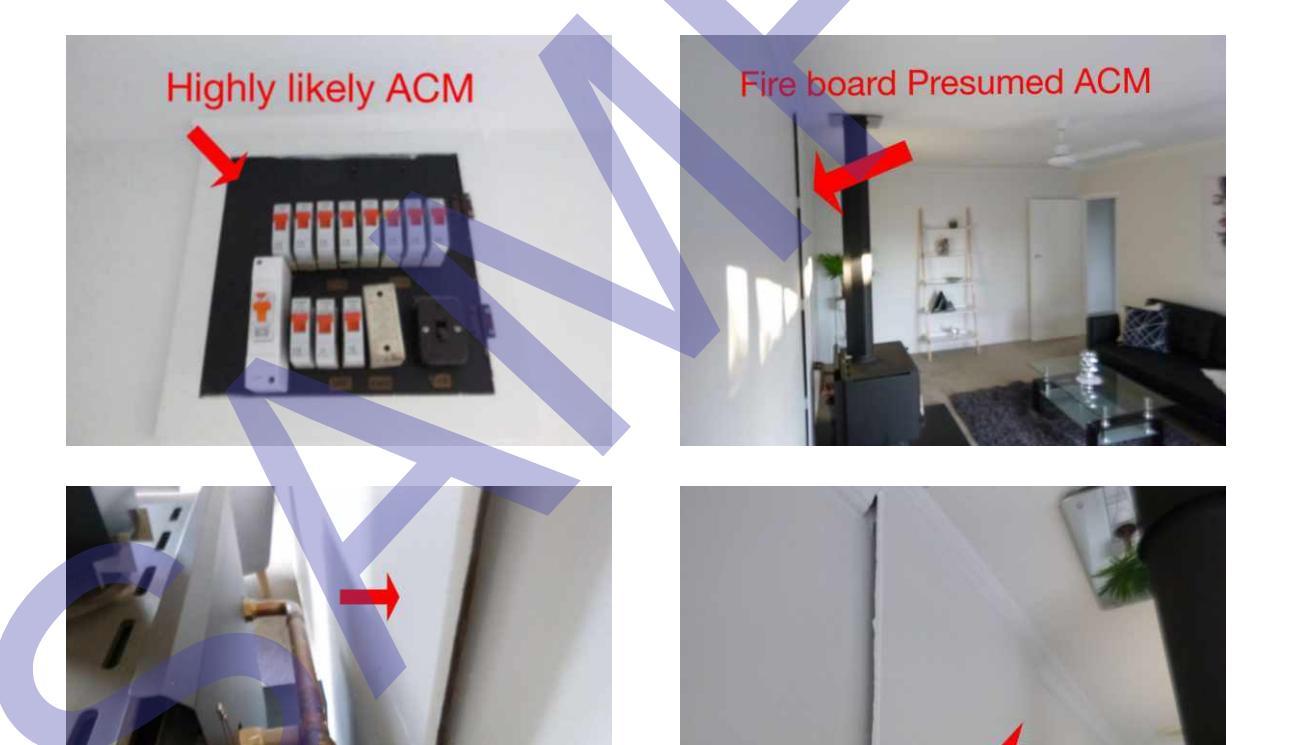
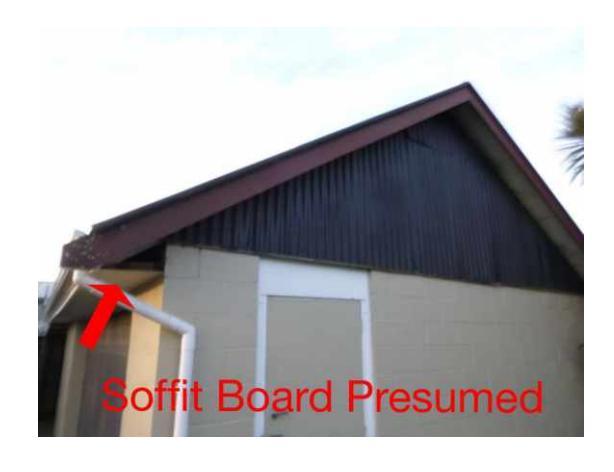
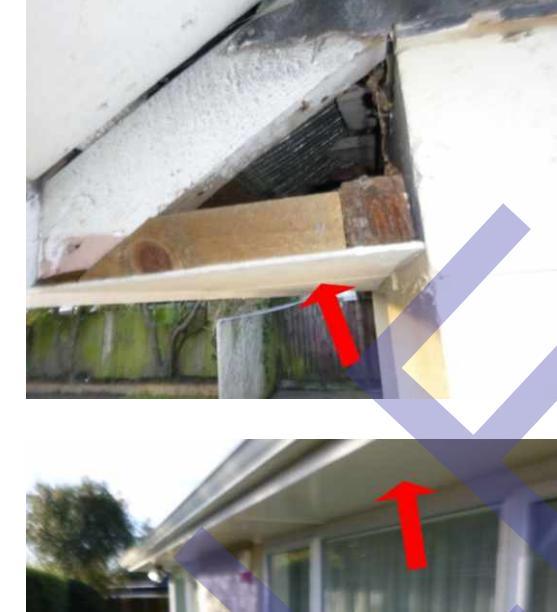
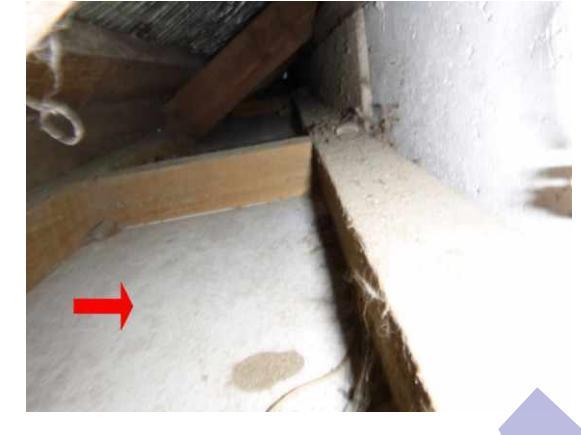
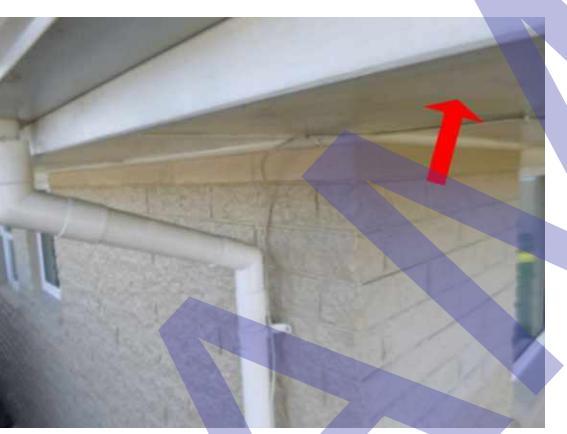
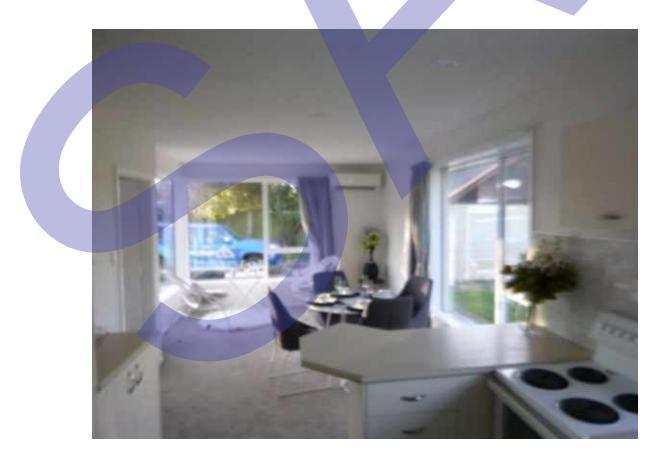
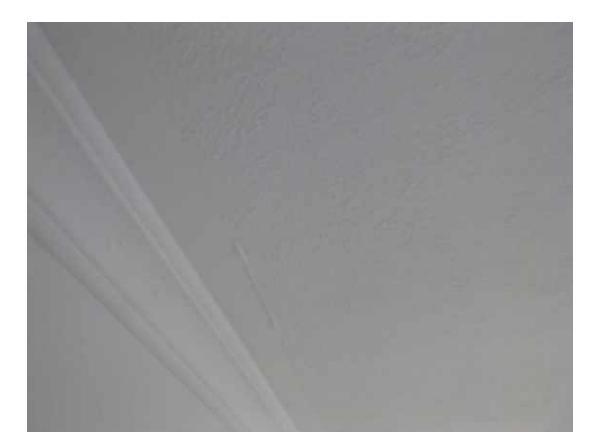
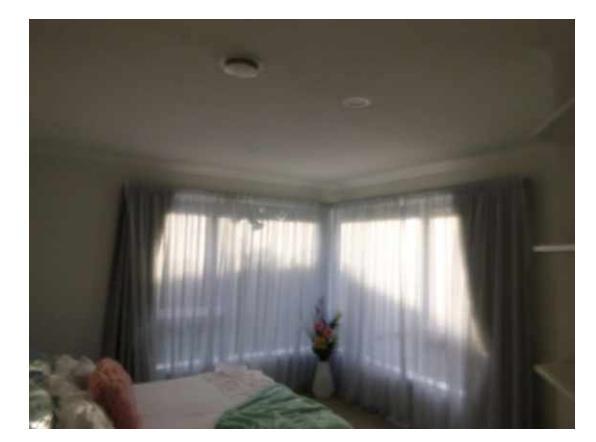
#### **Defects 1.01**

Building:Main BuildingLocation:Hall > CentreFinding:Asbestos - SuspectedInformation:Reporting on Asbestos is outside the Scope of this Report. This suspected defect is<br/>highlighted as a caution only. We suspect, based on our experience in the building<br/>industry, that there is a higher risk of the identified building element containing<br/>asbestos.<br/>As Asbestos Reporting is outside the scope of this report, we advise that you consider

Ceiling presumed All areas

Suspected ACM is present in the fuse box located in the hallway, the soffit linings, the fire board in the lounge and the stippled ceilings. As long as it is in good condition and sealed, it is safe.

a separate Asbestos hepoting is outside the scope of this report, we advise that you conside a separate Asbestos Inspection and Condition Audit, which can include the taking of samples for definitive confirmation of the presence of Asbestos. In the interim, the client is advised to get the material sampled in order to provide the client and any contractors with a course of action as to the removal of the material by a Asbestos removalist company.

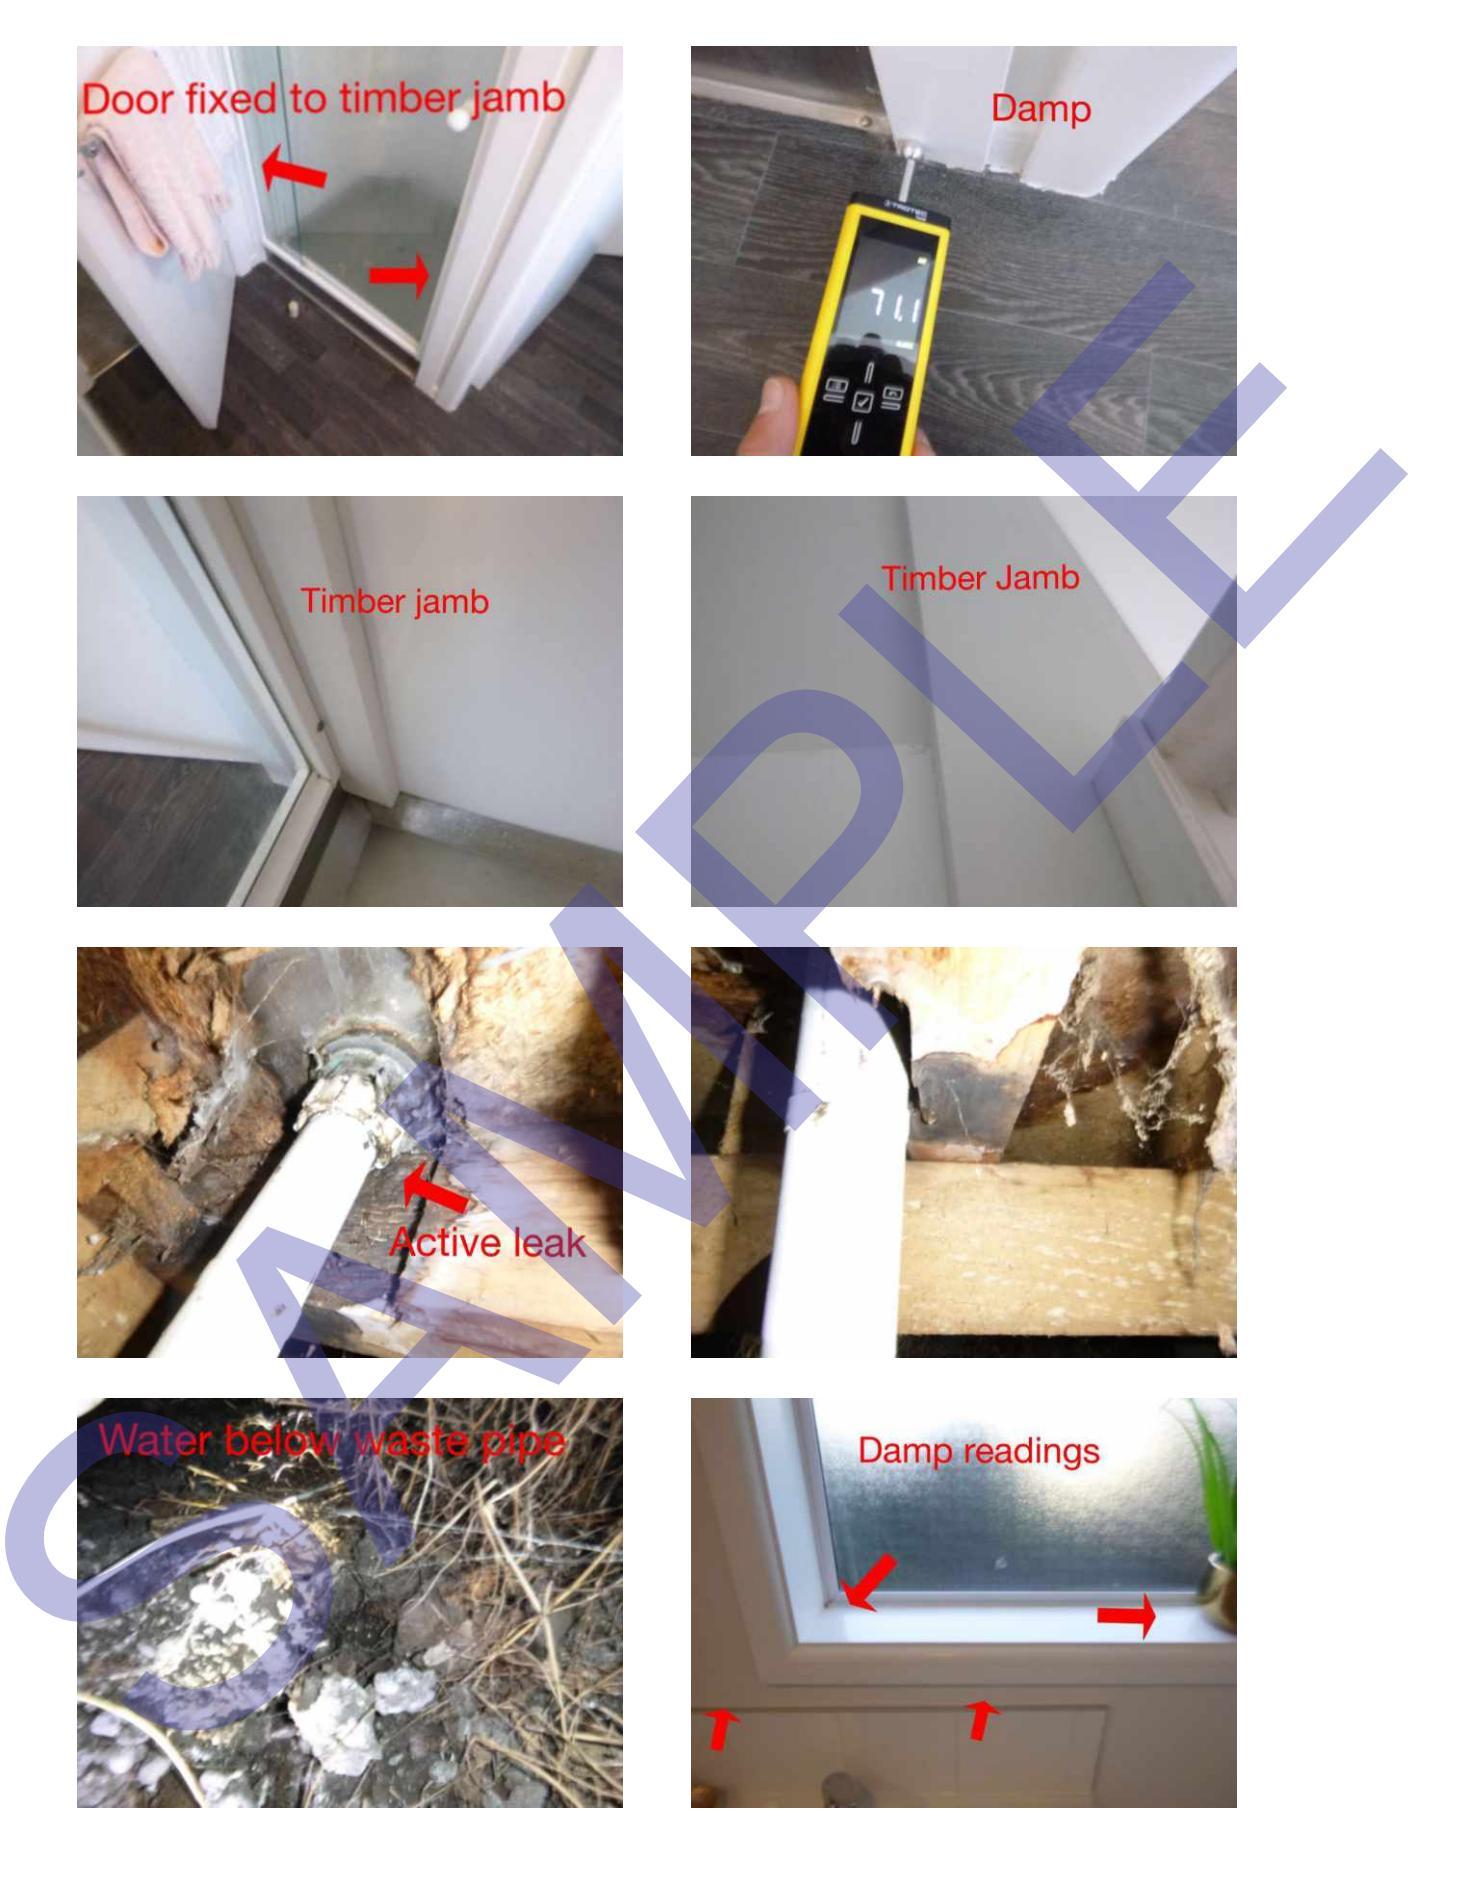
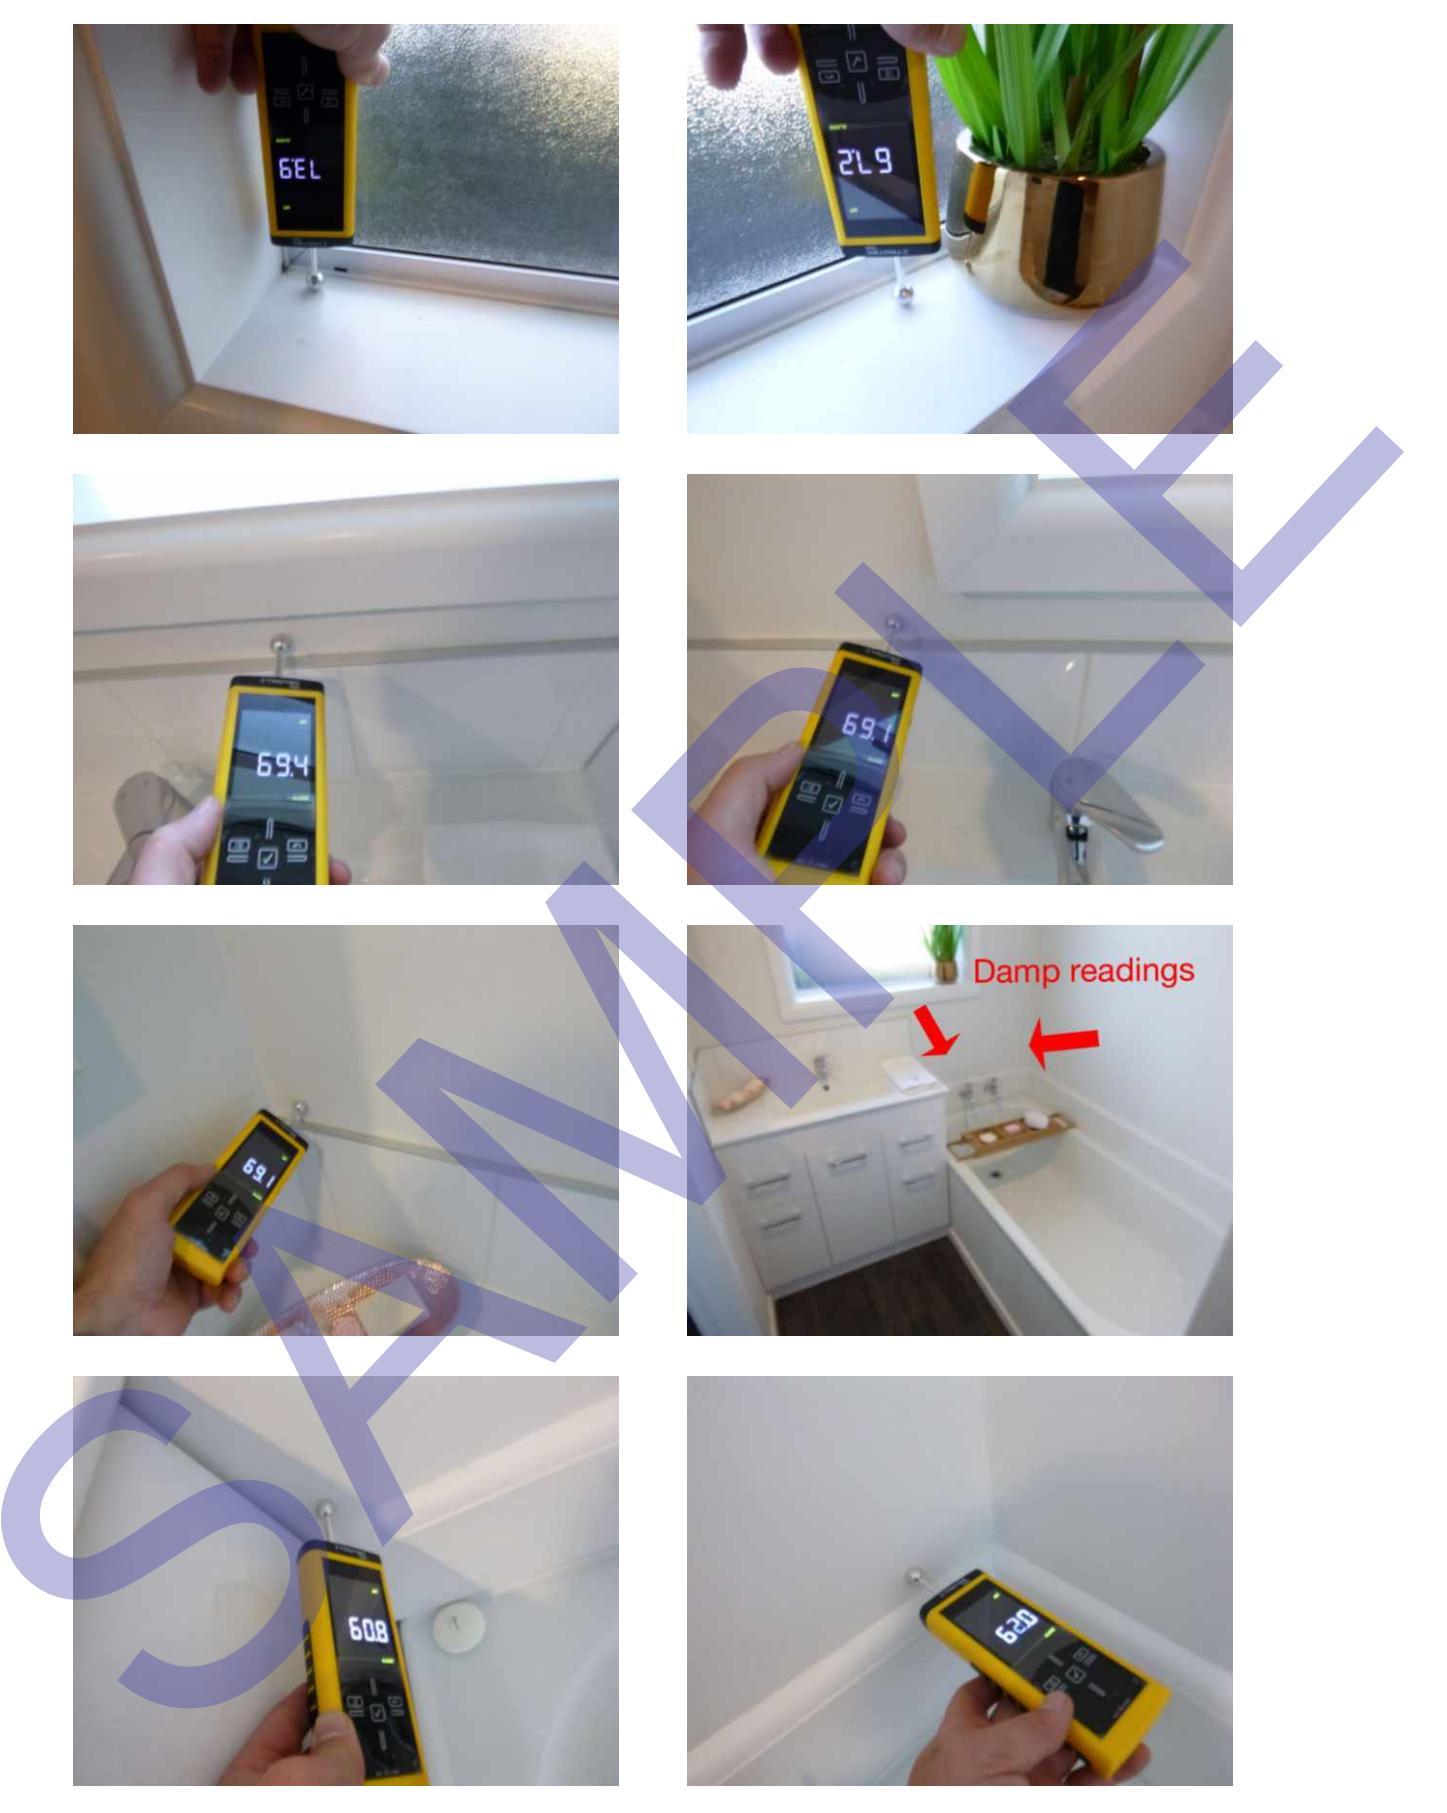
#### **Defects 2.01**

Location: Finding: Information: Main Building Shower/Bath > All Areas Shower/Bath - Condition

It was observed that the shower door is fixed to the a timber jamb/trim. This is not conventional as the timber is exposed to water when the shower is in use. There is a gap between the timber and lining and this should have silicon applied to it in order to prevent water getting in behind the timber causing damage. If ignored over time, the timber will move and gaps will become more pronounced allowing moisture ingress to the surrounding linings and detail. A shower installer or licensed builder should be consulted to assess the shower construction and provide profesional advice. Below the shower, the waste pipe was actively leaking. A licensed plumber should be engaged to remedy the defect.

There were damp readings indicated below the window sill and near the bath taps. The flooring below is in good condition and there were no signs of any active water leaks. The assumption for these areas is that this maybe due to an historic leak or there was a problem with condensation and water being consistently splashed against the wall by children. These areas should be monitored for any further signs of deterioration in the future. If paint starts to flake or the area becomes soft, a licensed builder should be engaged to assess the area.

The shower door has been direct fixed to the timber jamb/trim which exposes the timber to moisture. The assumption is the timber will deteriorate at an accelerated rate. The window sill and bath tap areas also indicated elevated readings with the moisture meter. The above recommendations for a re test at a later date also apply here.

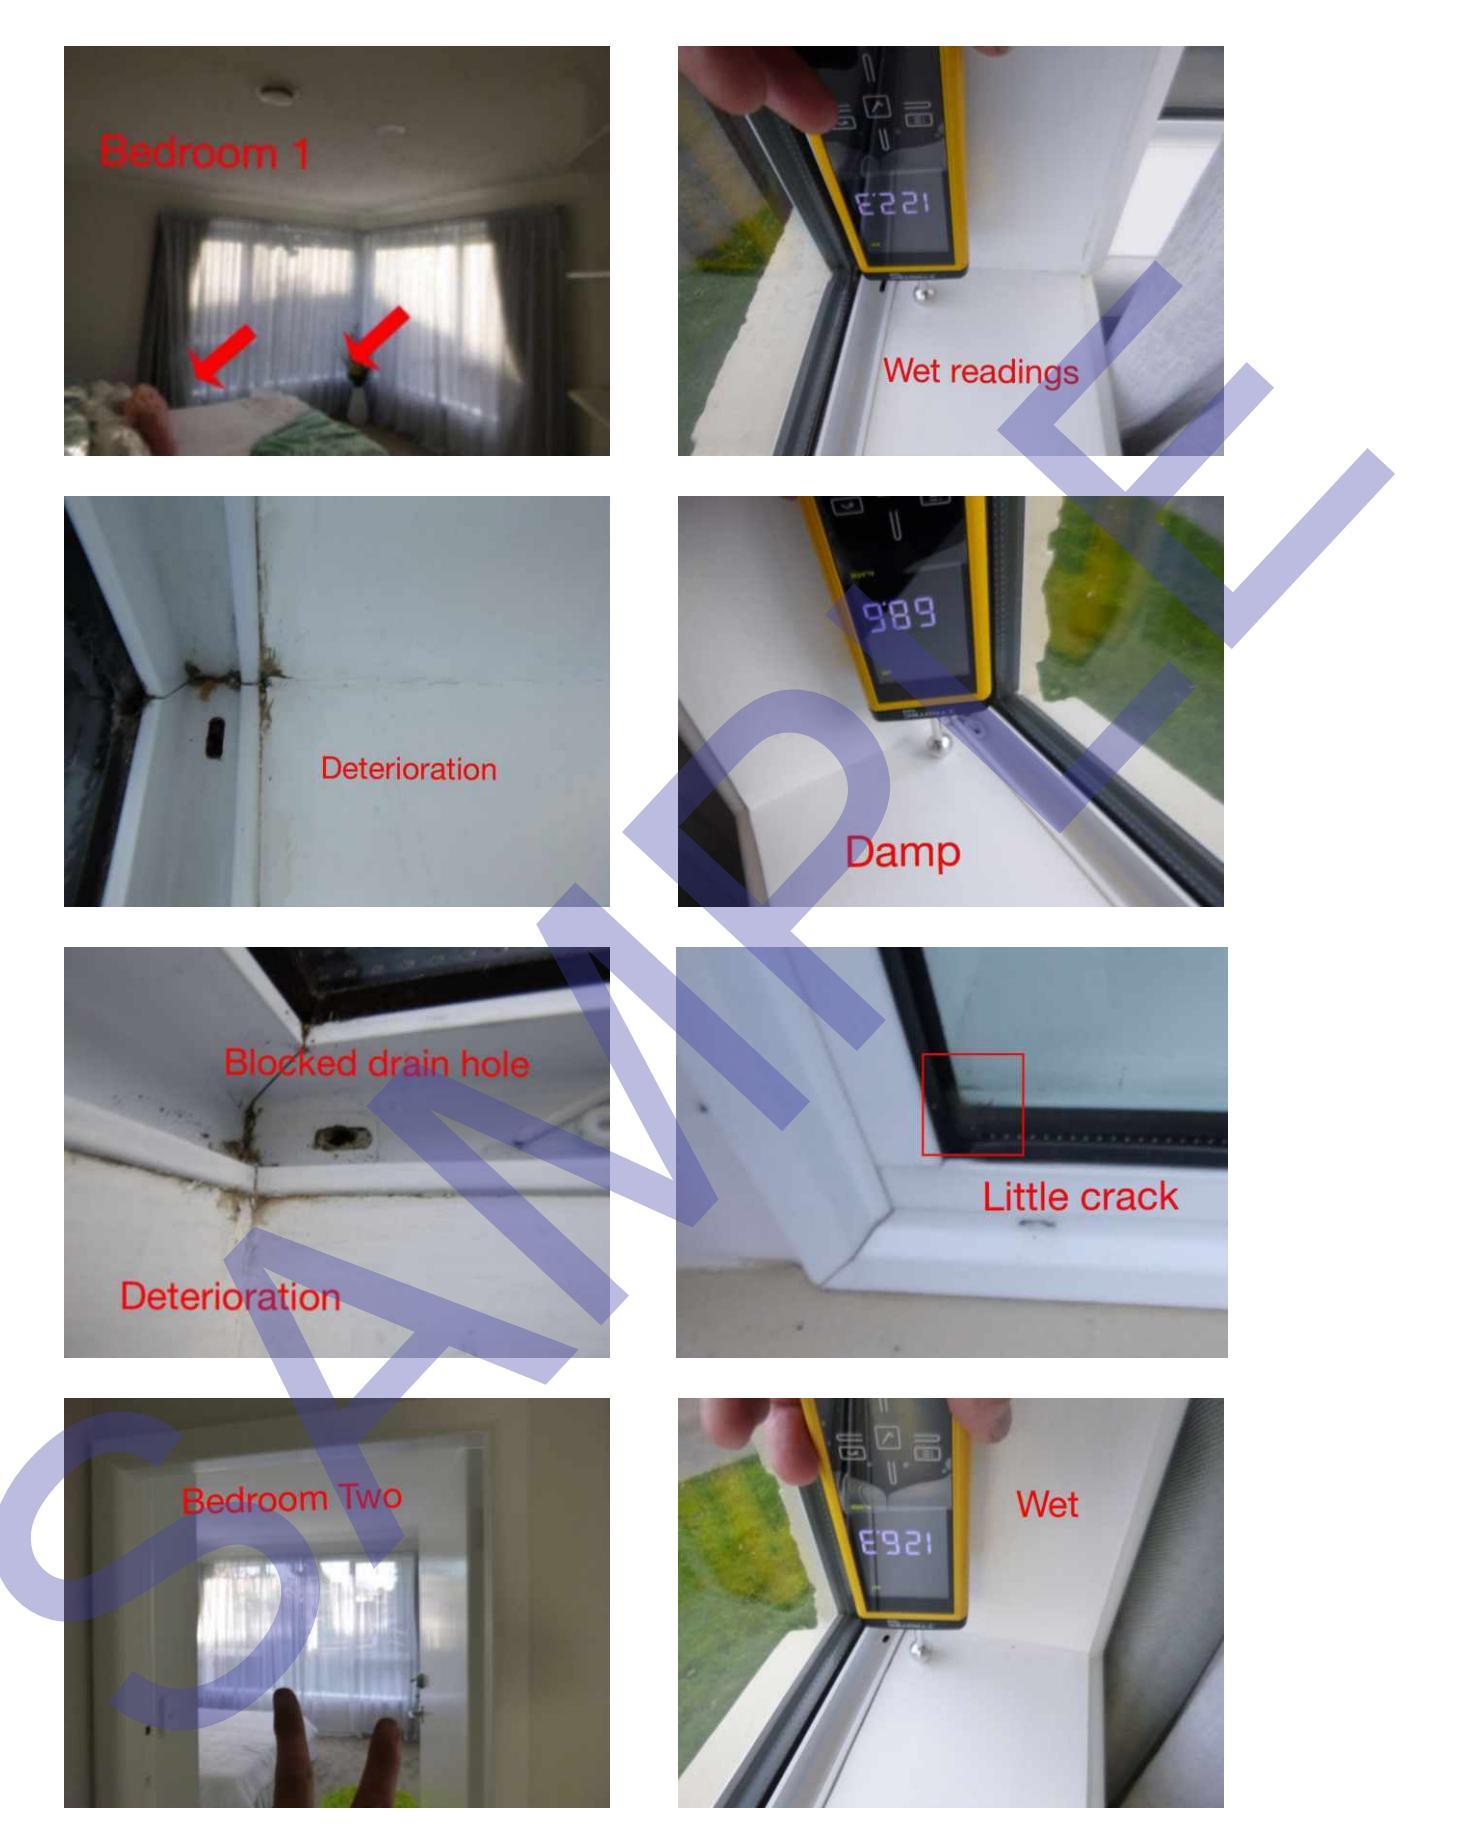
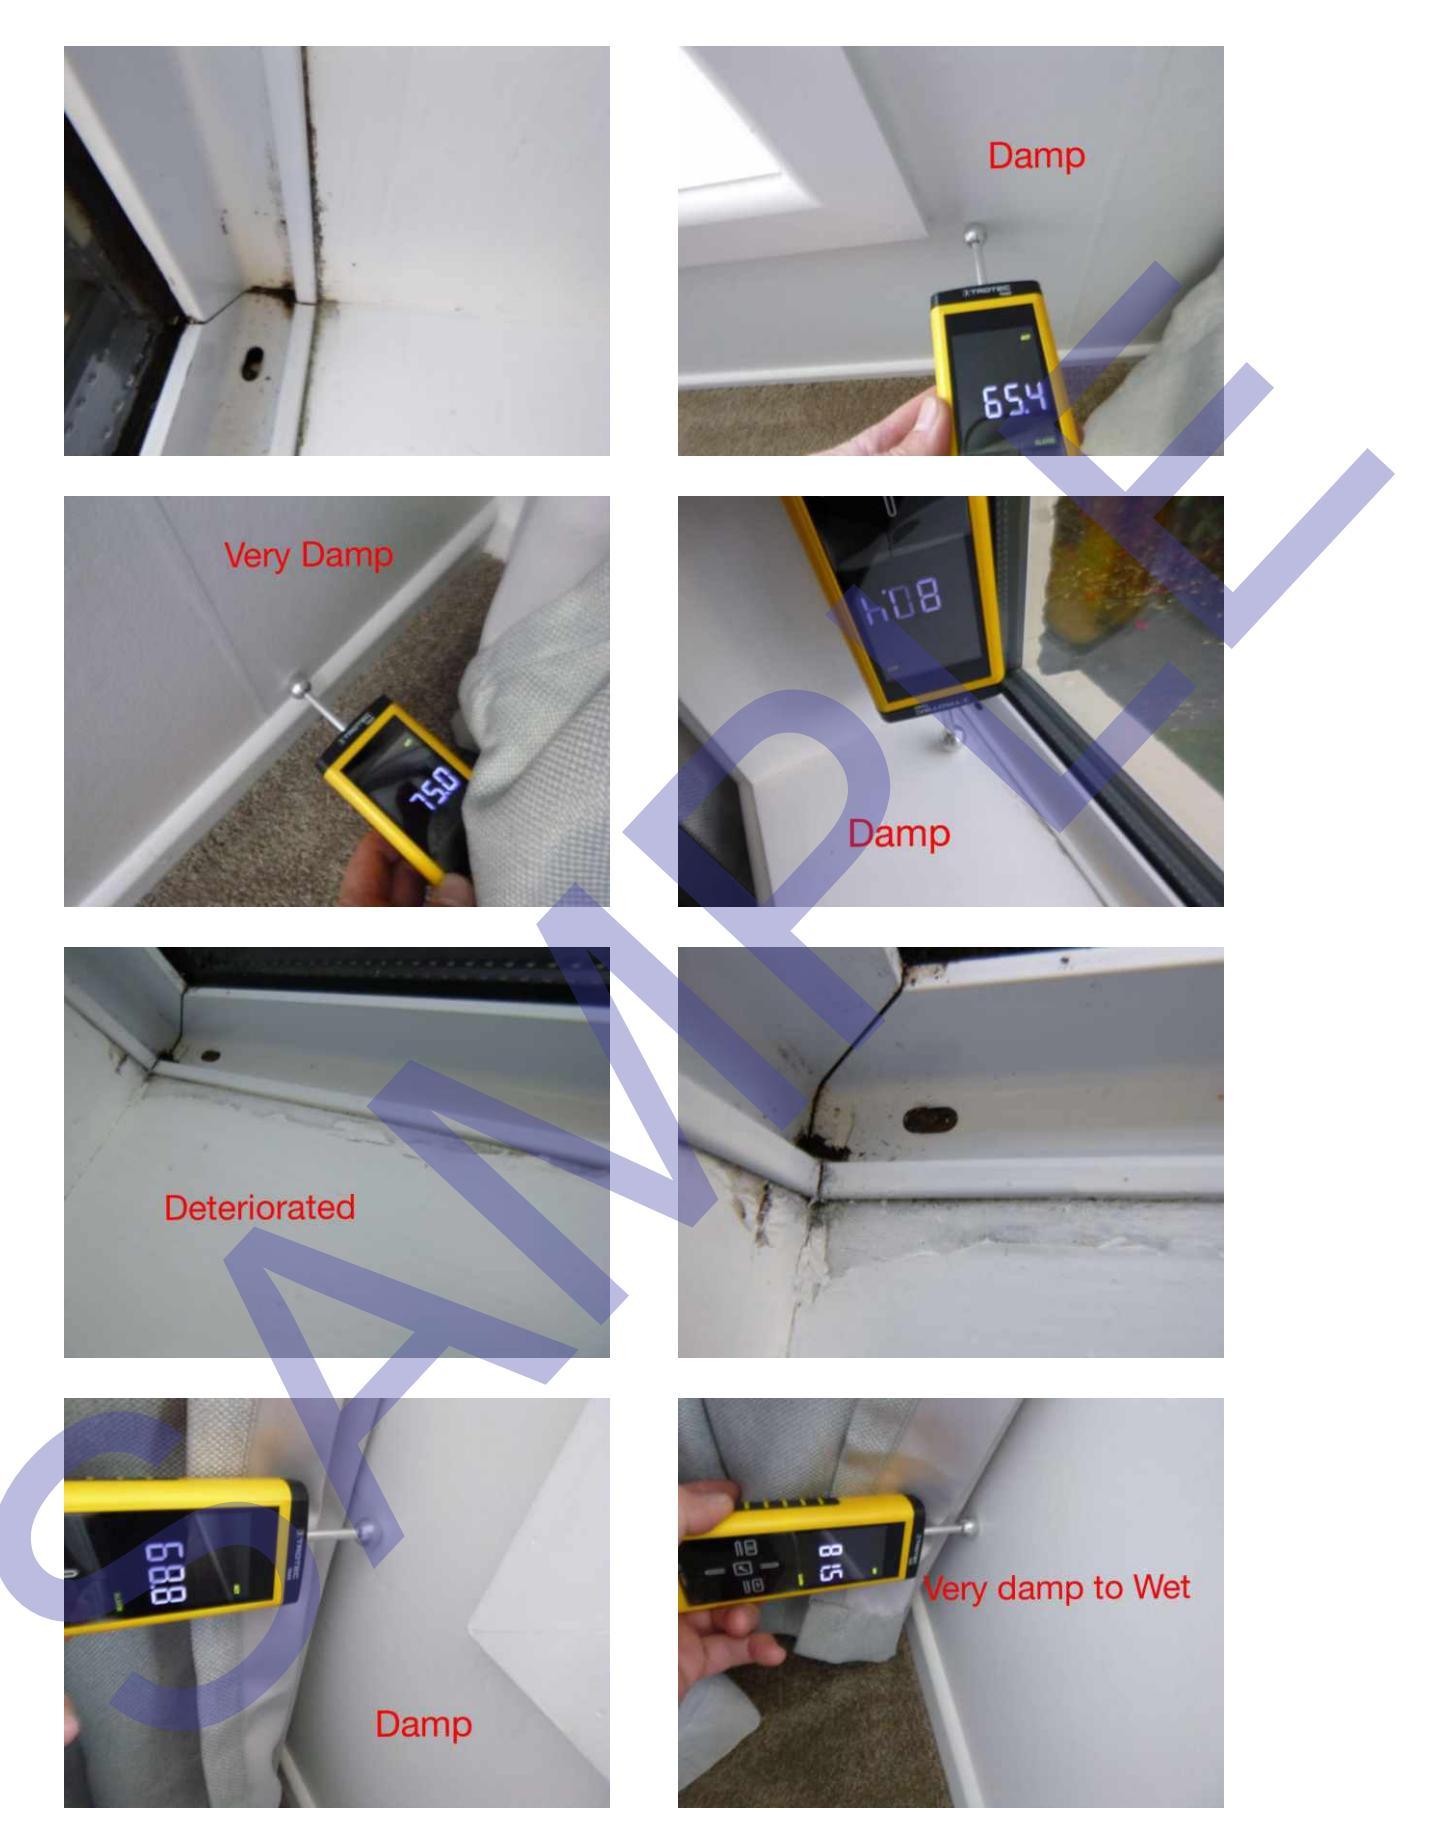
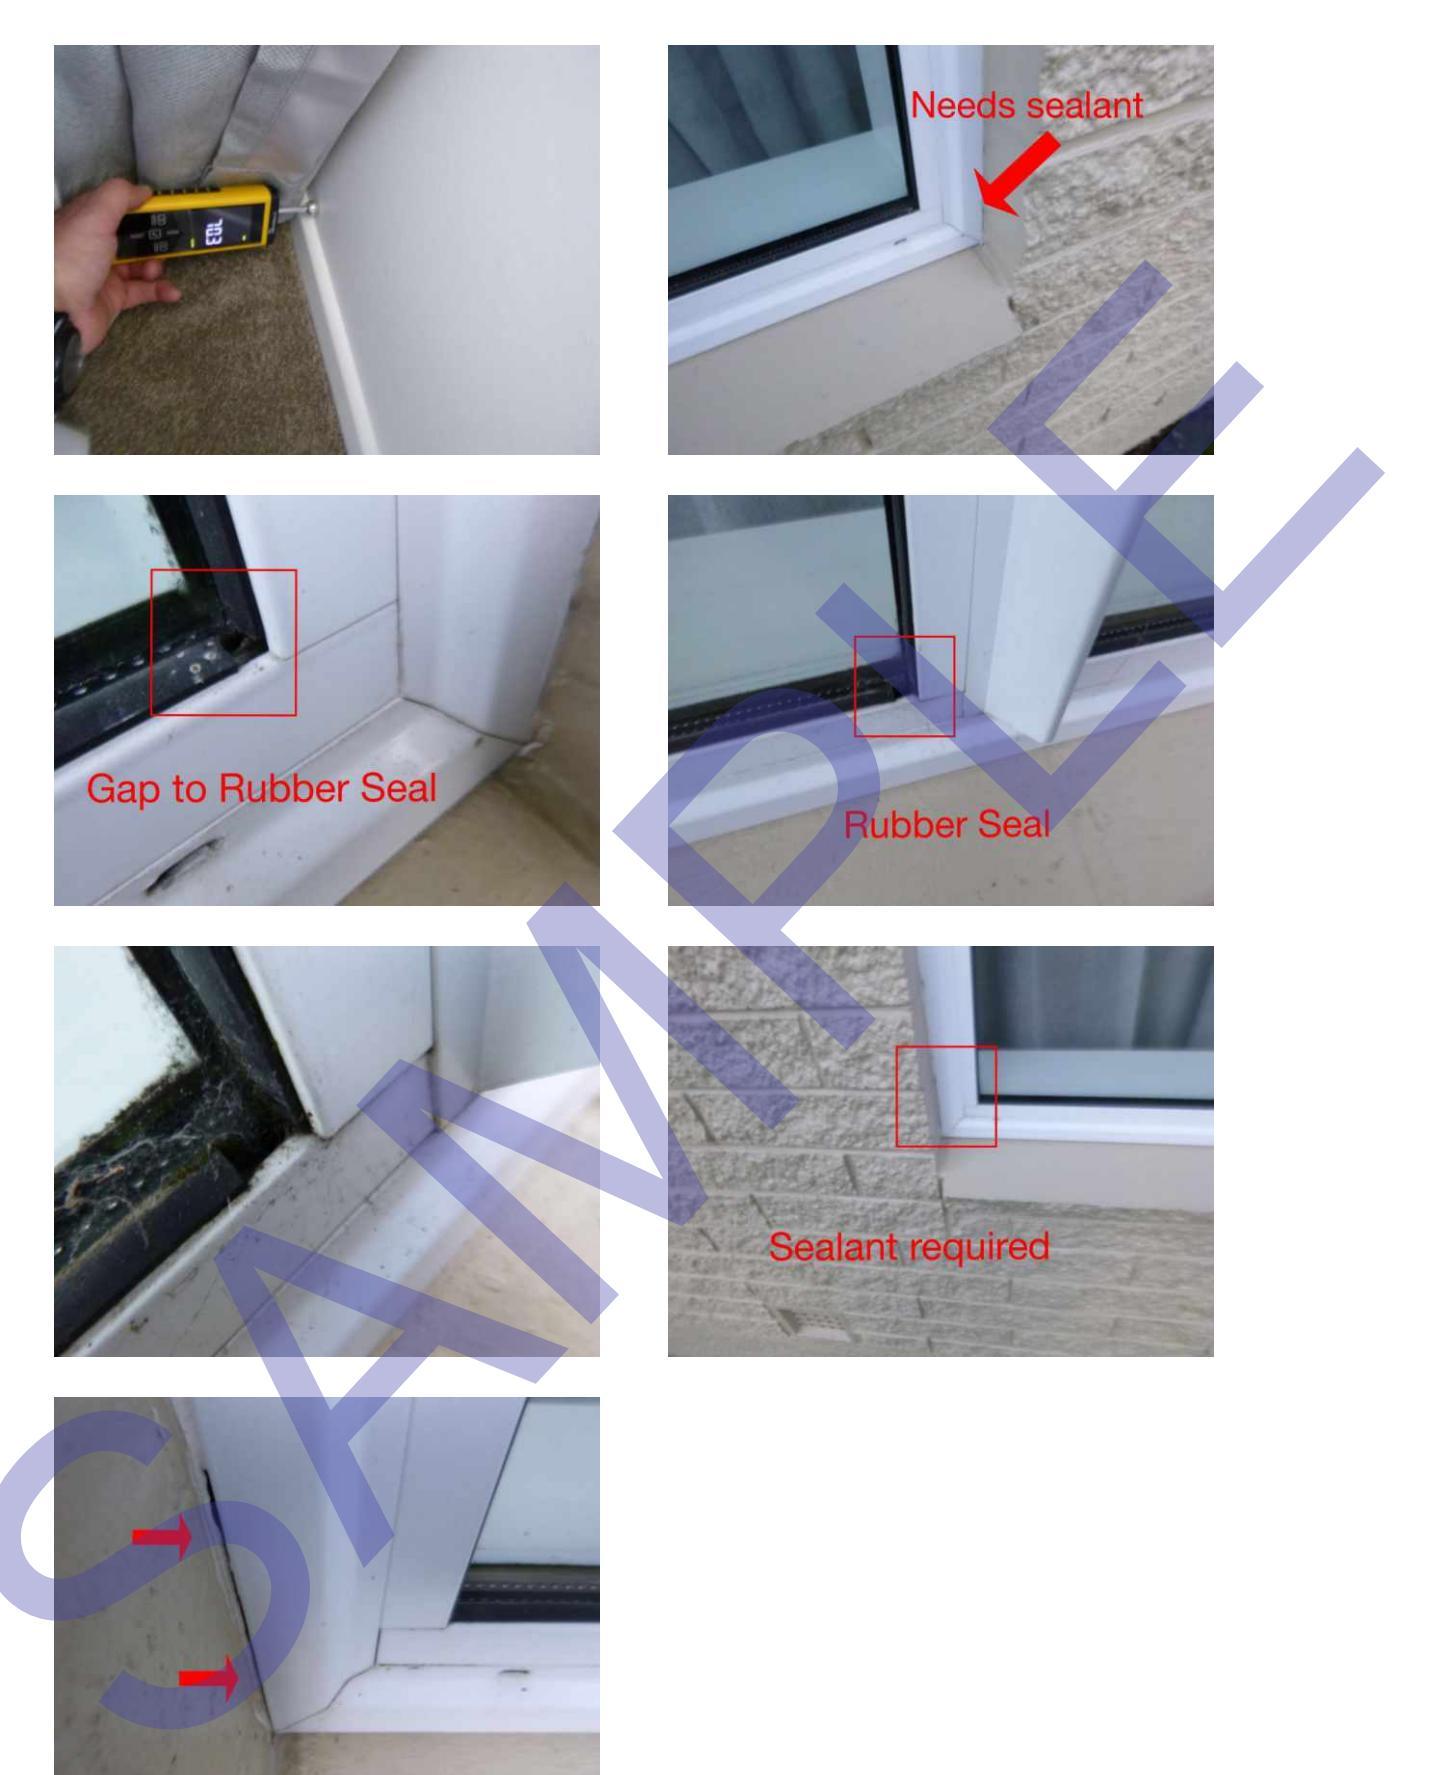
Defects 2.02

Building: Location: Finding: Information: Main Building Bedrooms 1 and 2 > All Areas Windows - Sills wet/Candesation

At the time of inspection, visually the window sills appeared to be in good condition. There were signs of deterioration and elevated readings with the moisture meter were indicated. Some times home owners replace single glazed windows with double glazed in order to address condensation. This could be the historical cause of the elevated moisture readings. However, currently, the left drain hole appeared to be slighty blocked. These holes allow excessive moisture to drain away. Double glazing does not prevent condensation on it's own. A combination of air conditioning, good airflow and regular cleaning is required. At times if this strategy does not address the condensation, underlying issues such as water ingress in behind claddings or damaged window seals or joinery could be the cause. Some of the gib linings in Bedroom 2 appeared to have deteriorated and repaired. Damp readings were indicated around these areas with the moisture meter also. This may indicate that the previous windows had significant issues and as a consequence have been replaced. These areas should have had the gib linings pulled off and replaced instead of being patched and re decorated. This would have revealed he condition of the timber behind the gib linings.

There are also issues to the external condition of the windows and seals. There are minor gaps to the rubber seals in places and there has been impact damage (Minor crack) to the bottom left corner of bedroom 1. The rubber seals should be replaced by a glazier as soon as practicable. Also, any deteriorated sealant to the window and brick junctions should be replaced as well.

There was evidence of high moisture readings to the window sills in bedroom 1 and 2 with bedroom 2 having high readings to the wall linings also. There are a few things that could be addressed that may remedy the cause. This is only an assumption though. If an invasive inspection is carried out to the wall linings in this area, it will reveal the current condition of the timber framing in behind the lining. If the external sealant and rubber seals are addressed and coupled with good airflow and condensation managment, this may help to reduce the moisture readings. A re test for moisture at a later date will confirm if this has had the desired effect. The use of a dehumidifier will accelerate the drying process.

With the installation of the double glazed windows and heat transfer units in the bedrooms, combined with regular maintenance and good airflow could go along way to addressing the damp issues. However, this is dependent on whether the source of the ingress is fixed.

Now there is a base line moisture reading, a re measure at a later date may indicate if the moisture issue remains or is drying out. This could negate an invasive inspection. However, if an invasive inspection was to be carried out by the client now, it would confirm the condition of the framing timber at present in order make an informed decision.

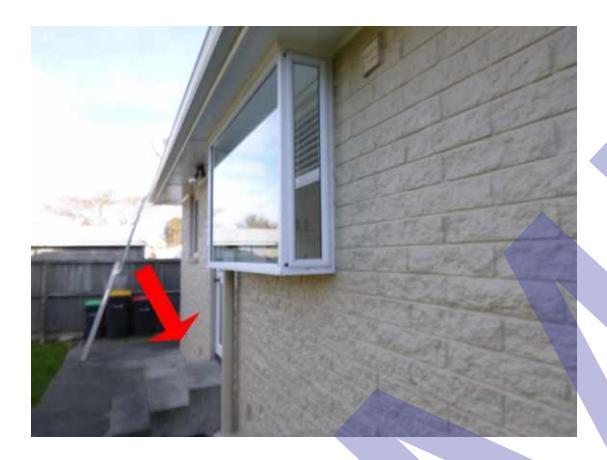
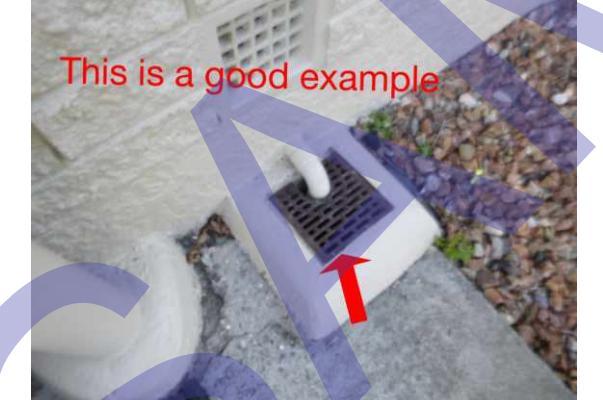
### Defects 3.01

Building:	Main Building
Location:	All Areas > All Areas
Finding:	Drain trap - Cover missing
Information:	At the time of inspection the cover/grill from this drain trap was missing.
	Drains are required to have good airflow in order to prevent them from becoming
	mouldy and remaining continuously wet. At the same time they must not allow water
	running into them from paths or gardens and the cover must be able to pop free if
	blockages occur.

Missing

A handy person or drain layer could be consulted to install covers at the clients discretion.

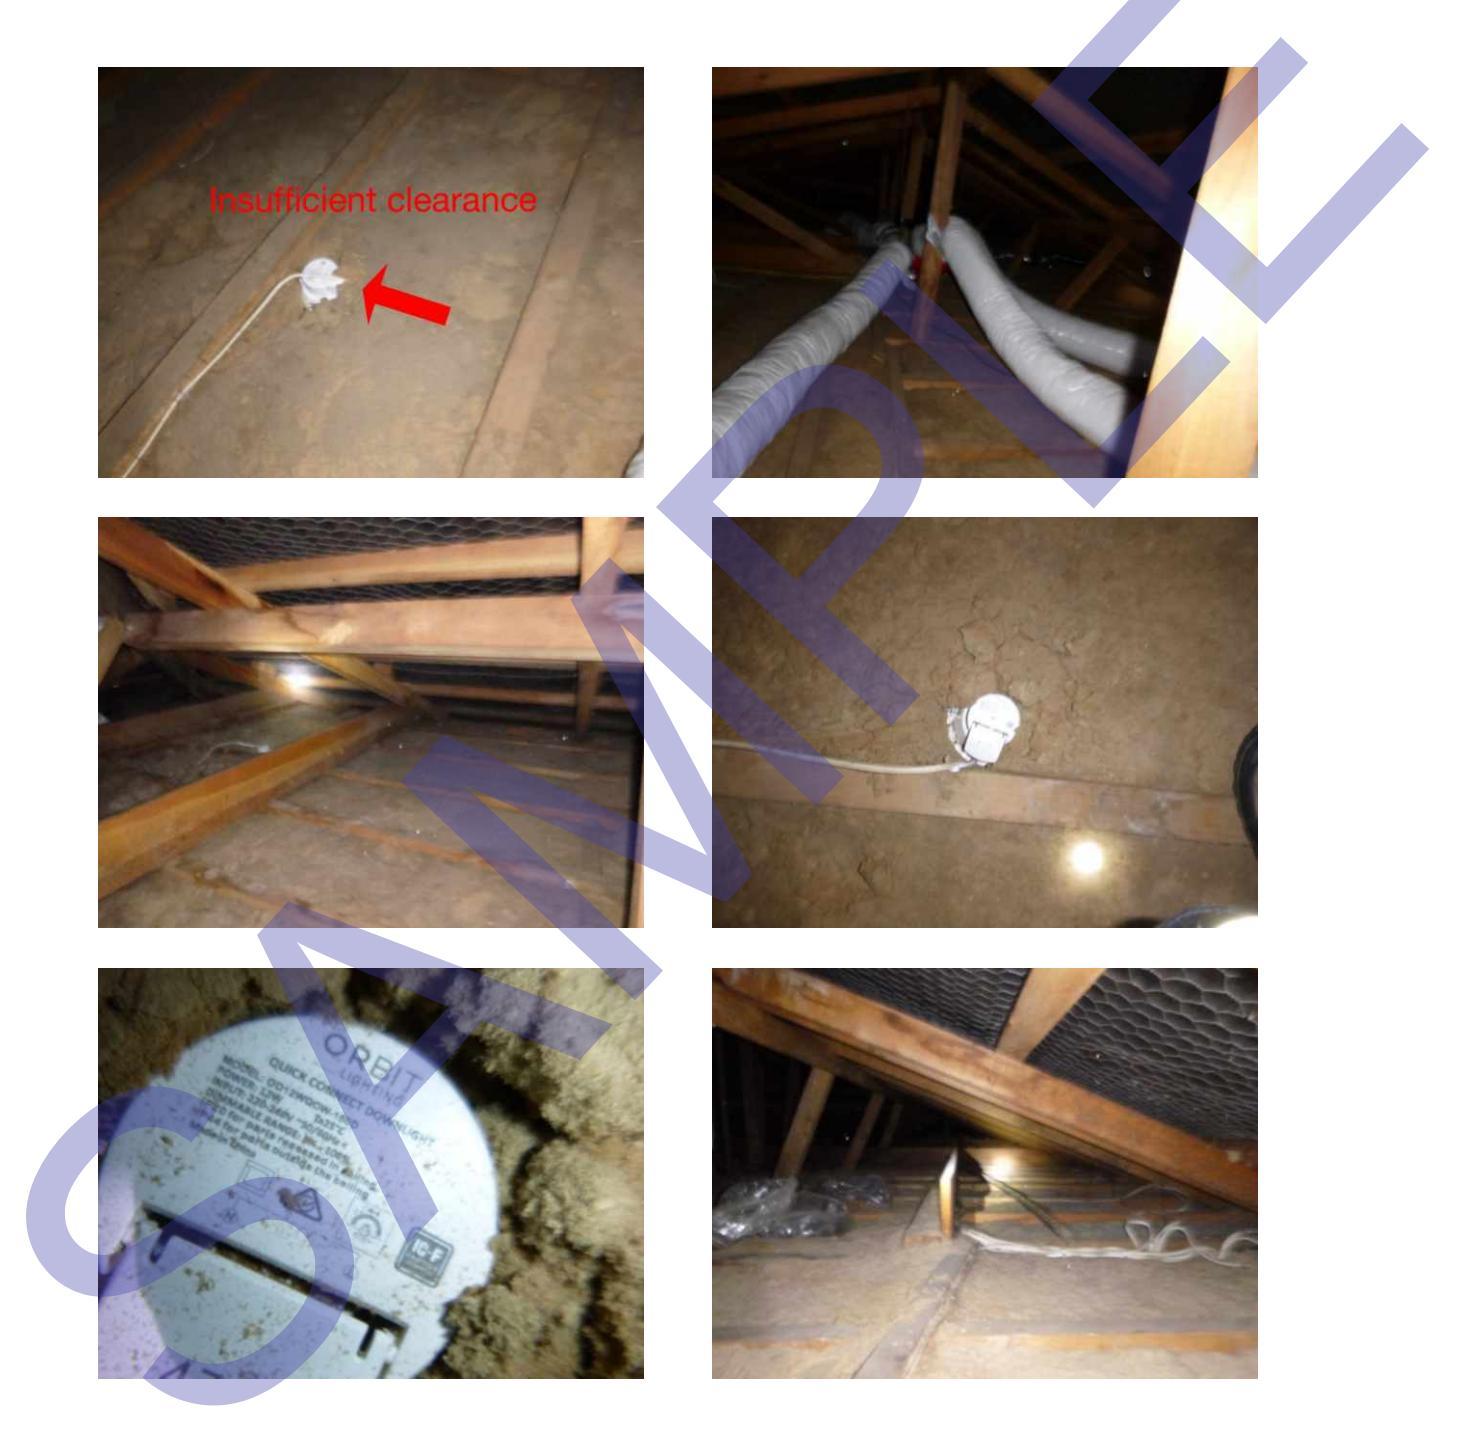
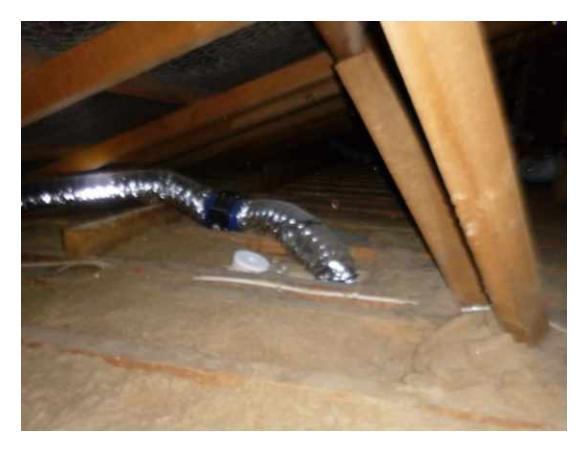
### Defects 3.02

Building:	Main Building
Location:	Roof Void > All Areas
Finding:	Insulation - Reduced in volume
Information:	Insulation is susceptible to settling and reducing in volume, detracting from its
	effectiveness and resulting in an overall loss of energy within the household. The

downlights in the home have been installed with out sufficient clearance. The Insulfluff should be cleared away from the downlights. If ignored, this could become a fire risk. It is recommended that the insulfluff is removed however, a profession insulation company maybe able to advise if this type of insulation could be left in place and be covered with a modern insulation.

An insulation contractor should be appointed to provide further advice on replacement options and to perform works as necessary.
