# NZ Residential Property Inspection Report

Inspection Date: Mon, 19 Aug 2019 Property Address: Christchurch, New Zealand

Original Inspection Date: Mon, 19 Aug 2019

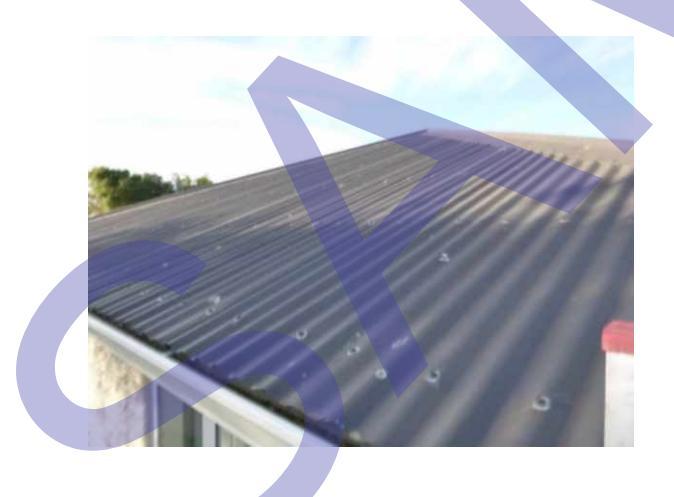
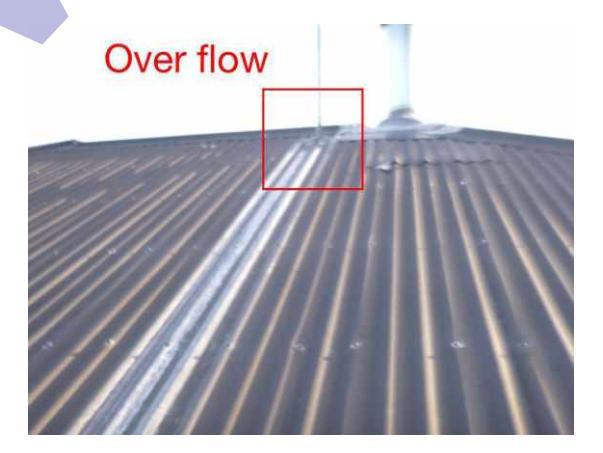
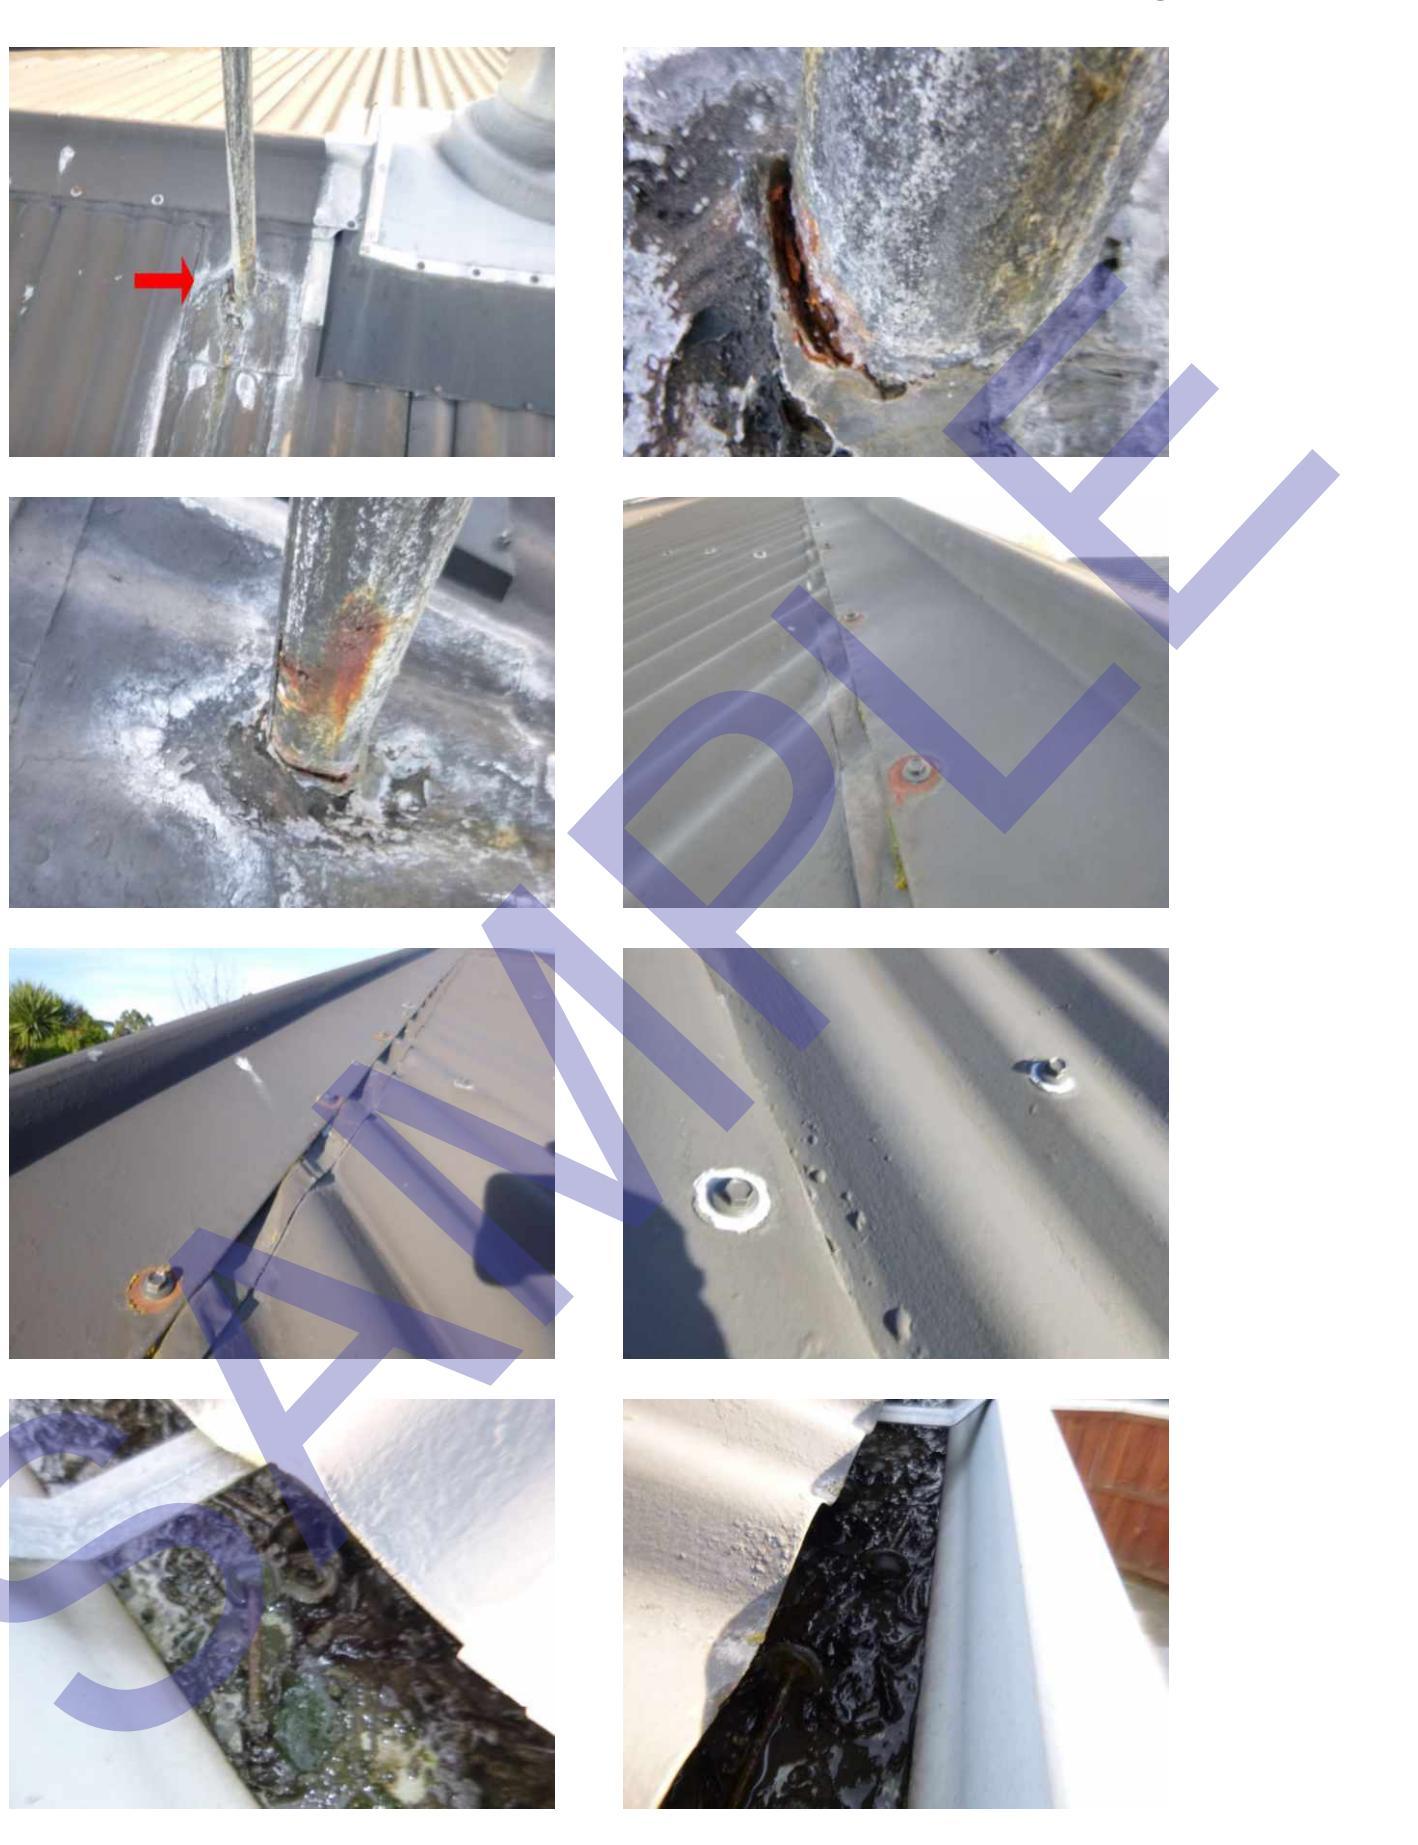
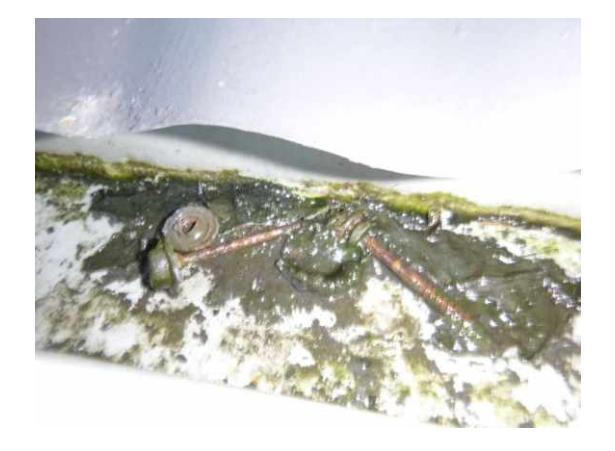
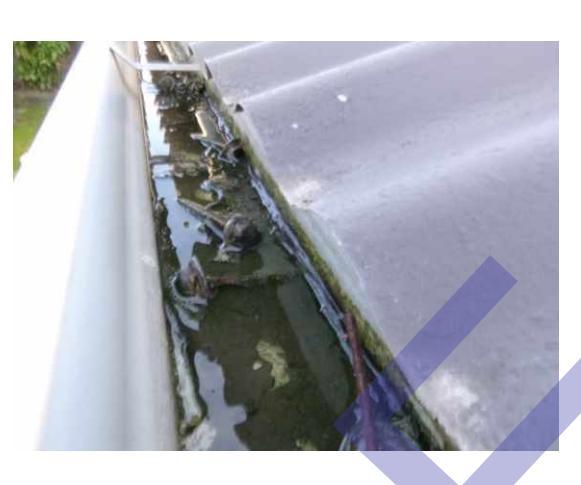
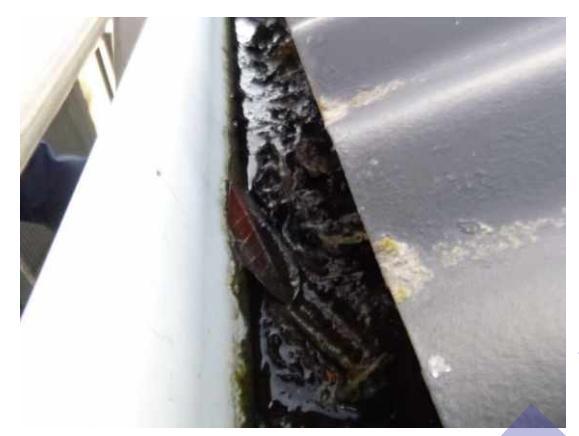
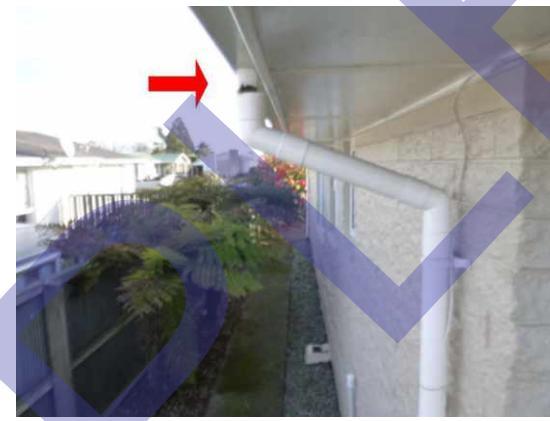
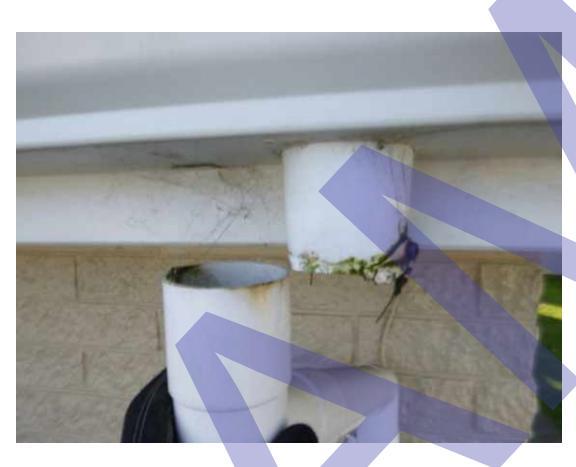
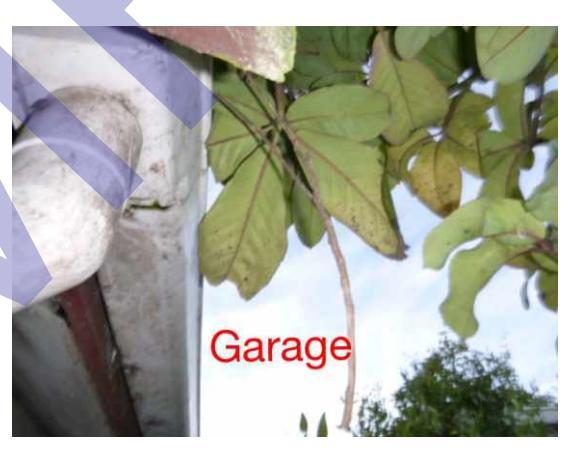
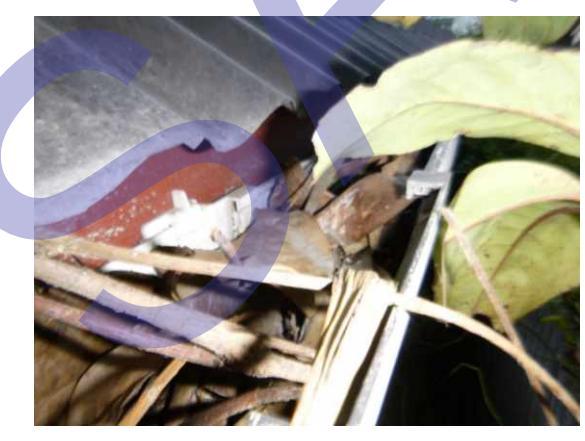
### Defects 3.03

Building: Location: Finding: Information: Main Building
Roof Exterior > All Areas
Roof - Condition
At the time of inspection the roofing nails had been replaced with roofing screws.
Some areas could do with repainting and rust treatment. This will ensure that these areas don't deteriorate at an accelerated rate.
The hot water over flow flashing has deteriorated and will need attention by a roofer or handy person. If ignored the roof will likely leak over time.
There was also nails and screws in the guttering through out. These will accelerate deterioration of the guttering hence the nails should be removed as soon as practicable.

The down pipe near the laundry is loose and will need to be fixed/glued to the gutter in order to ensure that it functions as it was originally intended.

Note: The garage gutter to the rear needs clearing of debris and leaves also.

The exterior roofing is generally in good condition and the old roofing nails have been replaced with roofing screws. This could indicate that there may have been moisture ingress due to loose fixings. This is only an assumption. Although, there were no historical indications of this occurring in the roof space. The over flow flashing will need attention.

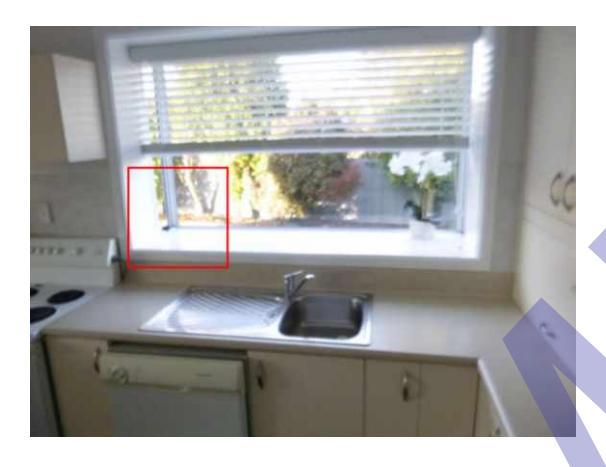
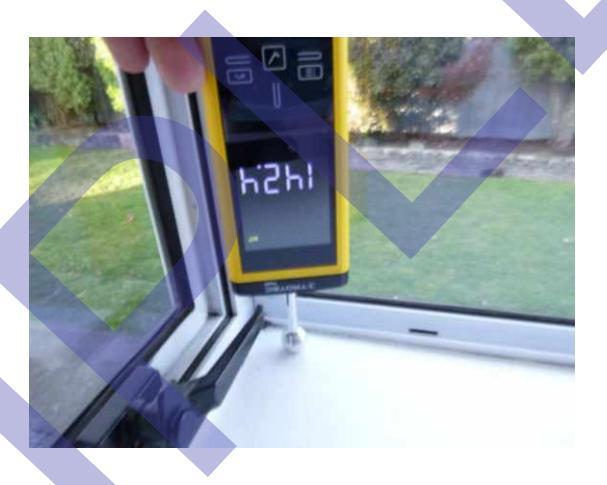
Defects 3.04

Building: Location: Finding: Information: Main Building Kitchen bay window > Front Left Bay window - Wet reading

At the time of inspection the bay window indicated wet readings in the far left corner. It is suspected that condensation is the cause. Areas like bay windows are susceptible to Moisture settling in the corners as they are hard to reach for regular cleaning. A weep hole maybe blocked in that area.

Swelling

The bay window in the kitchen also has a damp spot.

A licensed builder or window glazier could be engaged to asses the bay window for any damage/leaks in order to clear the assumption that the window itself is in good order. A hose held over the area for a few seconds may reveal an active leak. If there are no leaks then with regular cleaning of the area, it should dry out over time but the swelling will remain.

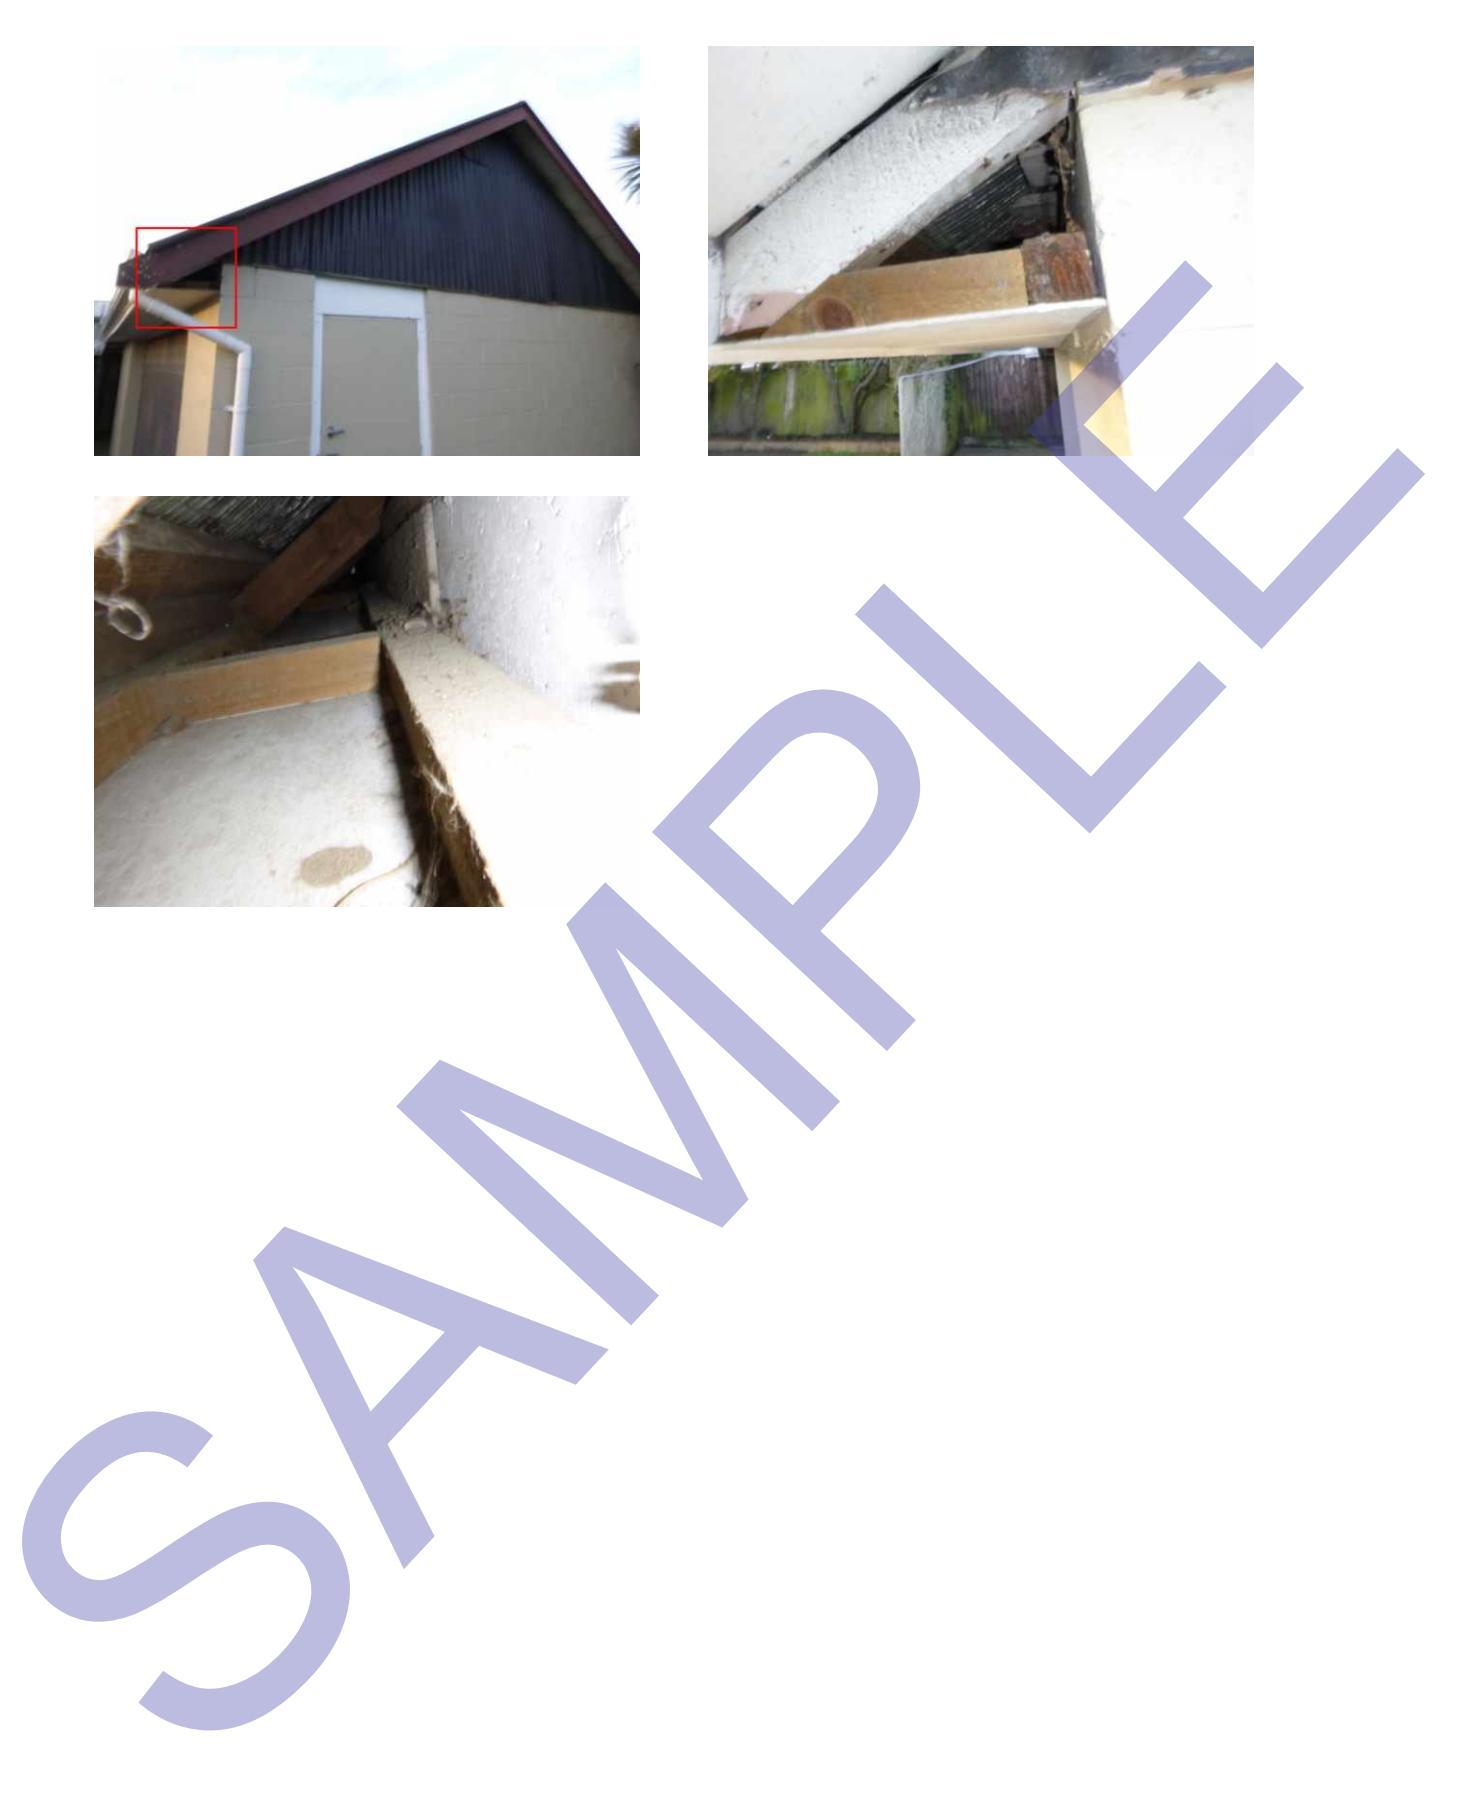
Defects 3.05

Building: Location: Finding: Information: Garage Eaves > Front Left Eaves - Gap

At the time of inspection there were gaps to the eave structure at both ends. These should be covered in order to keep water out of the structure. A licensed builder should be engaged to remedy this.

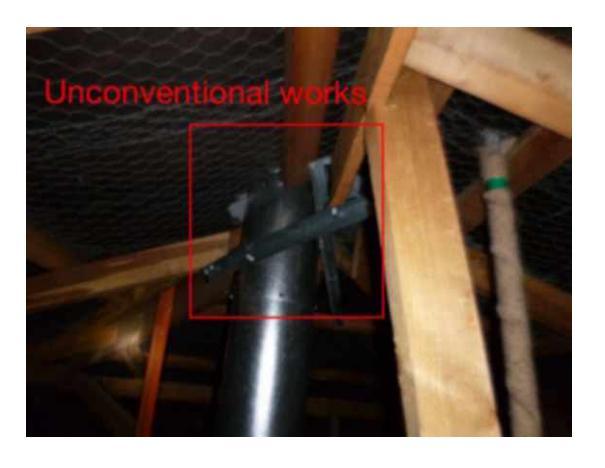
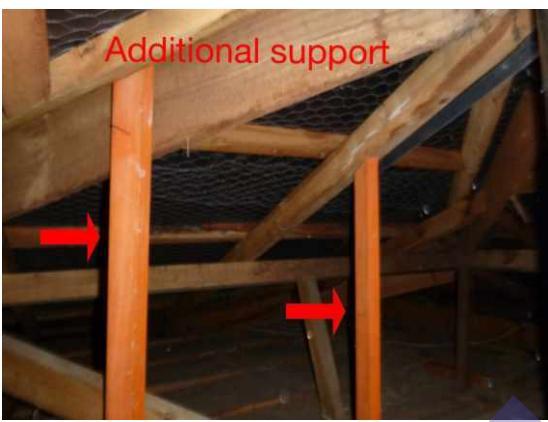
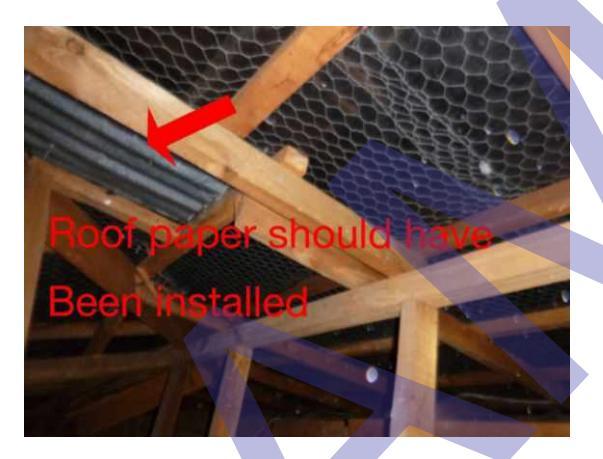
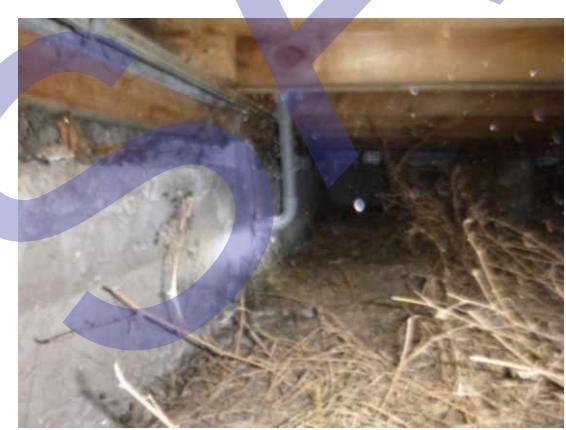
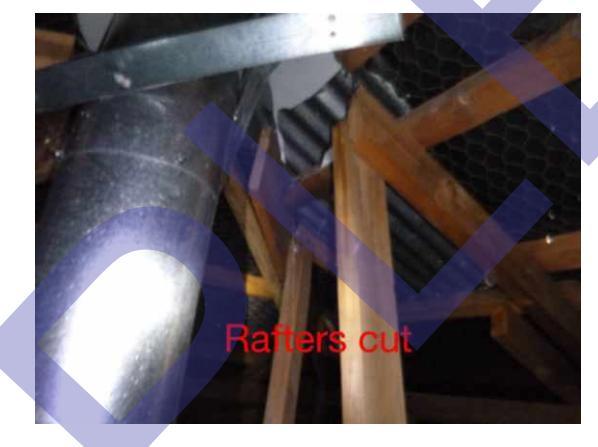
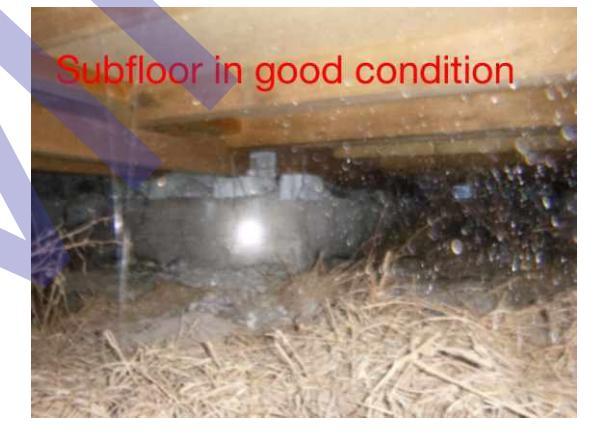
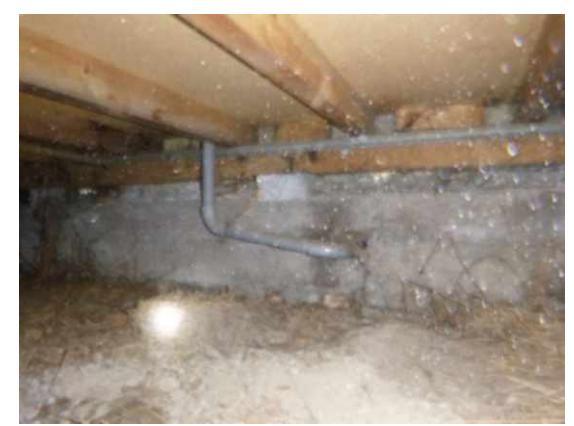
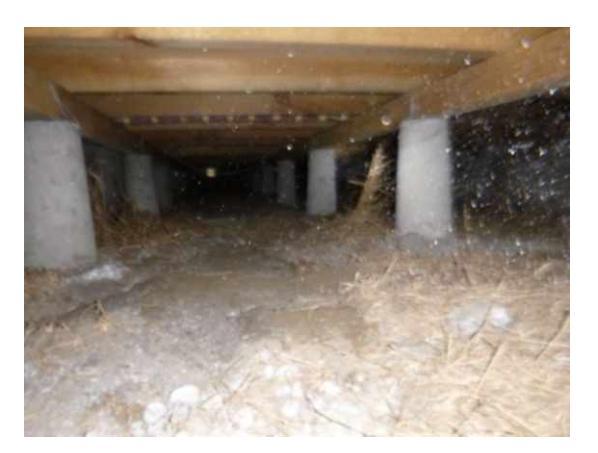
Historical Earthquake - Zone 2

There have been earthquakes in this area. Long term effects will only be visible over time, however evidence was observed at the time of inspection. Verification of a building being "earthquake proofed" is outside of the scope of this inspection. During the inspection it did appear as though subfloor works have been carried out in the past and the roof space has had additional structural support installed. The works have been completed to a good standard however clarification that the works have been completed to the building code by an LBP carpenter or engineer should be sort. The scope of works may reveal this.

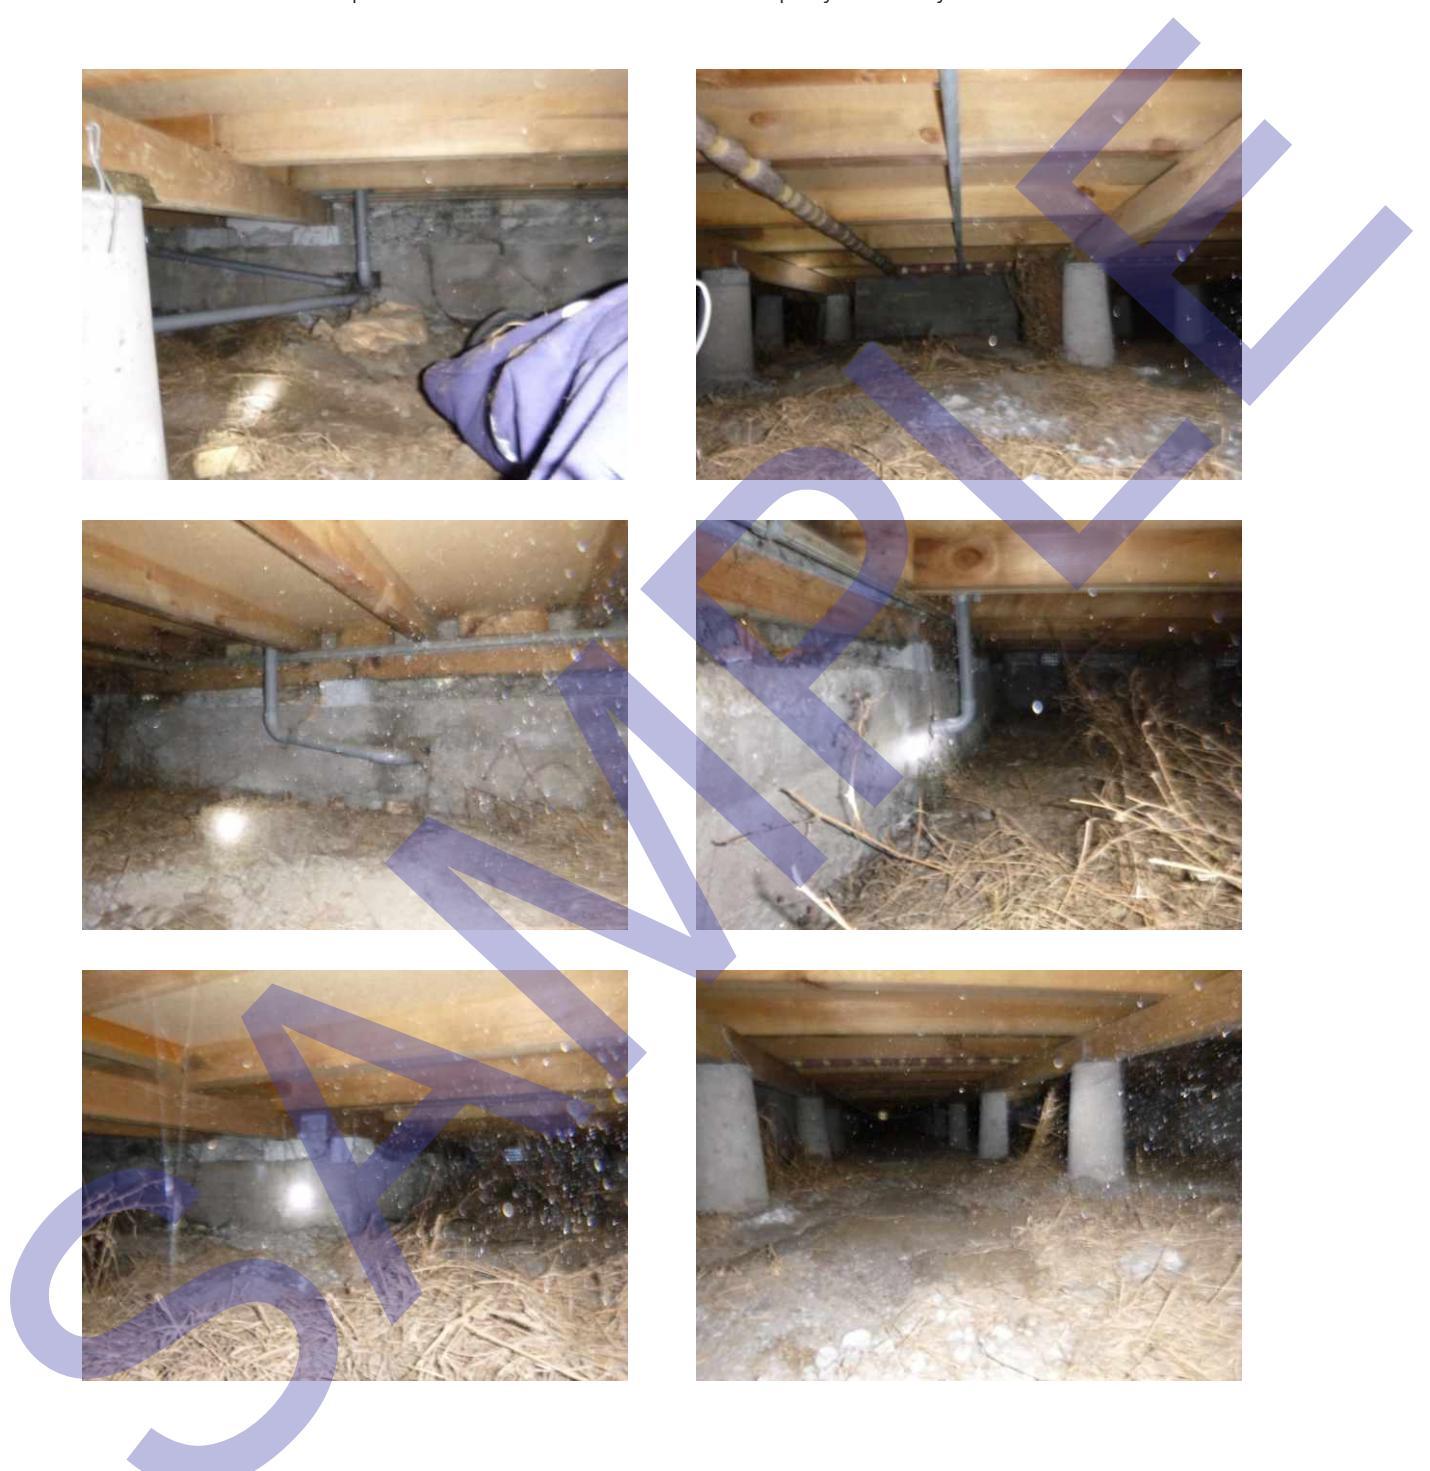
Finding:
 Subfloor - Condition

Information:
 At the time of inspection the subfloor was in good condition and there was no limitations to movement.

There was a minor leak to the shower waste pipe and has been referenced in the

This area appears to have had significant work carried out with possible re piling taking place. Floor levels a good throughout.

It is recommended that a vapour barrier is installed to prevent rising damp from the soil and underfloor insulation is installed to provide good heat efficiency in the home. A profesional under floor insualtion company can carry this out.
