BEFORE YOU BUY
BEFORE YOU BUILD

NZ Residential Property Inspection Report

Inspection Date: Tue, 20 Jun 2023

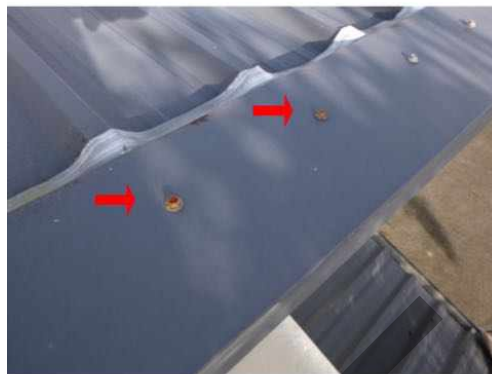
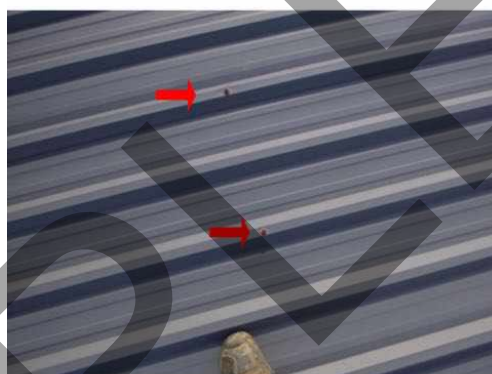
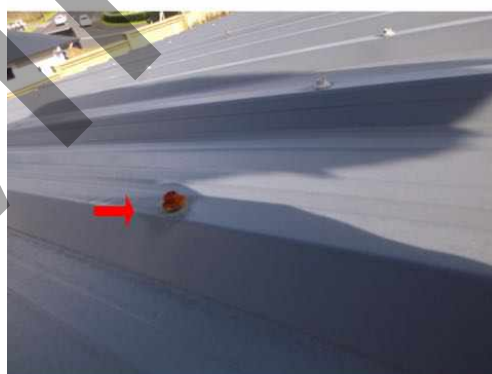
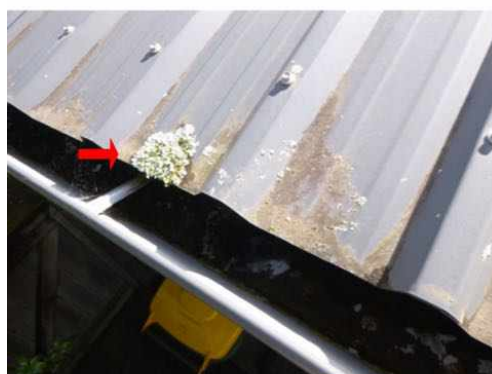
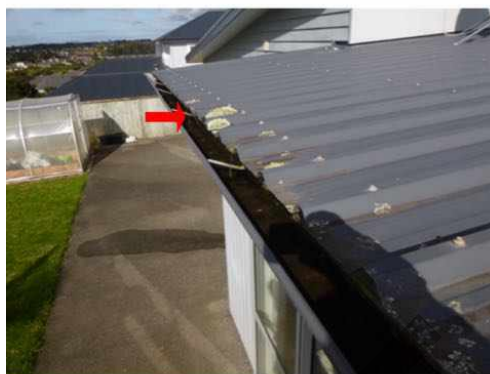
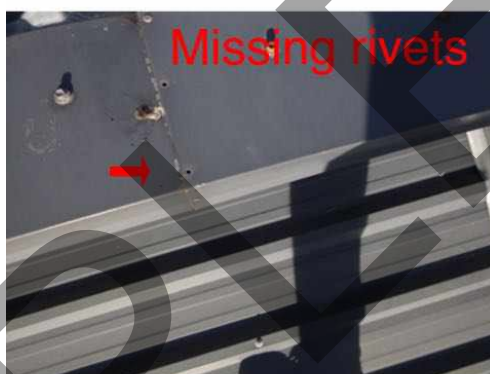
Defects 3.01

Building: Building 1
 Location: Various Areas
 Finding: Gutter & Roof Condition
 Information: At the time of the inspection it was observed that the coloursteel roof guttering and fascia was in good condition, generally clean and appeared to be functioning well and the downpipes were connected to the stormwater system and secured to the building. However there was debris in a few areas of the gutter that may be contributing to minor pooling.

There was a number of screw fixings that have rusted that over time could deteriorate to a point where failure of the fixings could occur. Some screw fixings appear to have popped which can affect the weather tightness of the fixing.

Some missing rivets were found on one of the roof flashings possibly allowing moisture access into the ceiling space where moulds or rots may begin forming.

Lichen, which affects the paint surface and can damage it, was affecting some areas of the roofing.

Roof plumbing structures, such as guttering and downpipes, should be free of all debris to prevent blockages, and gutters should have a fall to the downpipe. Blockages of the guttering and downpipes will lead to pooling and accumulated water overflows, which is likely to subsequently flood eaves and exterior walls. Blocked gutters and water pooling are likely to lead to high levels of moisture in the affected areas. Such moisture will not only cause rust and decay of the associated building materials, but can also provide conditions that are conducive to pest activity. Blockages in gutters should therefore be removed immediately.

It is highly advised that all gutters be maintained on a frequent basis to ensure the condition of roof plumbing. A chemical wash of the roof will help prevent lichen buildup and the screw fixings can be replaced by a Roofing Maintenance Company.

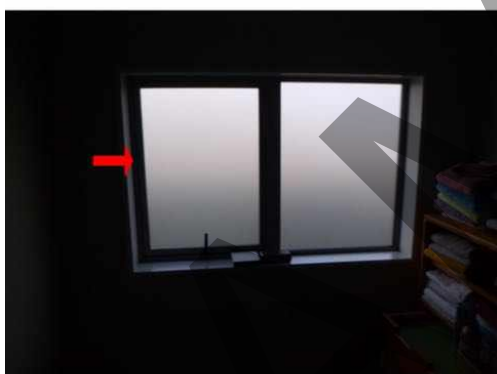
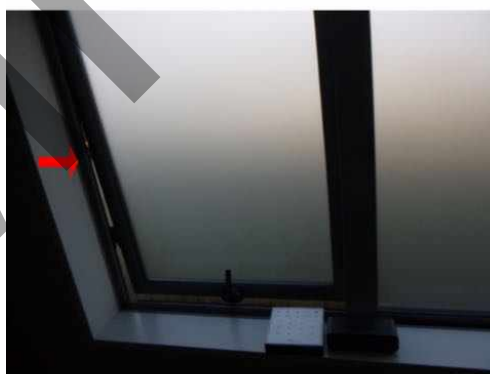
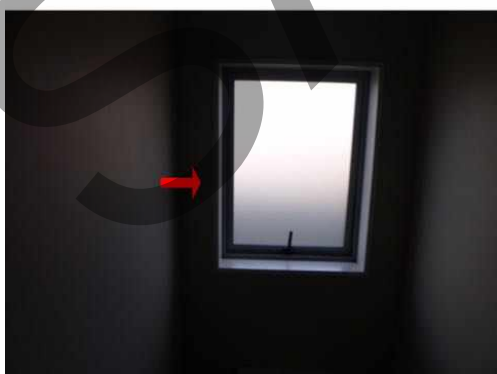
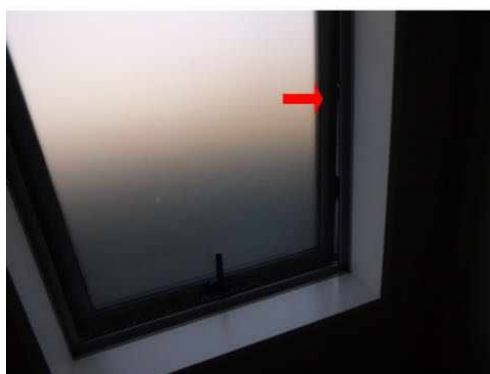
Defects 3.03

The window latch in the lounge north facing window left side was loose.

The family room ranchslider has a miss matched window latch and comes in contact with the sliding door unit. Minor timber rot was noted at the bottom left corner of this unit.

The front entry door had a slight bind on the top corner. This may damage the door or frame of the unit over a period of time.

All the above items could affect the full operation of the joinery unit and compromise the overall performance of the home.

An Aluminium Joinery Maintenance Person should be contacted to rectify the various items and ensure the joinery units are fully operational and functional.

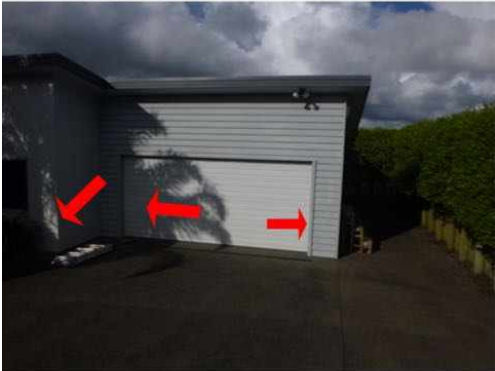
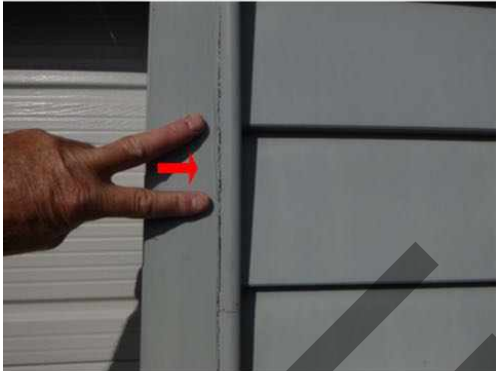
Building: Building 1
 Location: Cladding Areas
 Finding: Paint System- Aged
 Information: The painting on the exterior cladding surfaces was found to be aged. A repaint of the exterior is recommended to ensure the timber is adequately protected from the weather elements.

A Painter should be appointed as soon as possible to perform necessary works to aid the appearance of the affected area and to ensure that the area is protected against any possible deterioration. Alternatively, the homeowner following manufacturer instructions may be able to provide this service.

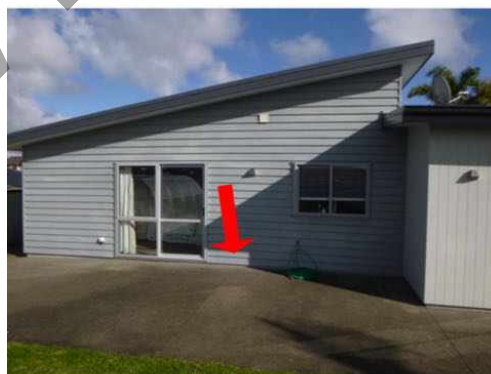
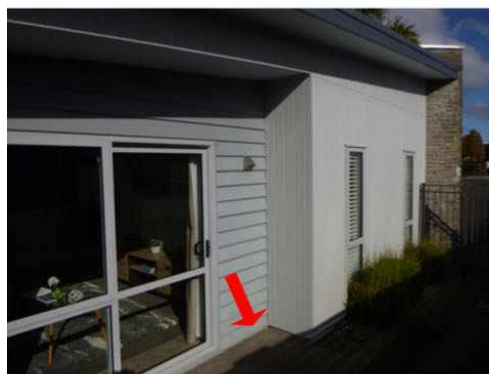
Building: Building 1
 Location: Various Areas
 Finding: Ground Levels
 Information: It was observed that the ground clearances throughout the property were at or more than the minimum requirement as per the Building Code. There were stormwater sumps and the site was well drained.

Ground levels should be 150mm below slab level, while paved areas should be 100mm below slab level. It is important that water does not lie against the base of walls and surrounding paths and that ground levels should be sloped to drain water away from walls.

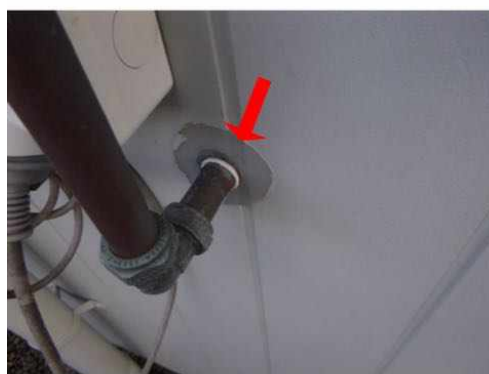
Information: The hot water califont system at the rear of the home was noted to have deteriorated seals around the pipework that was penetrating out from the wall cladding. These should be replaced to ensure the wall is adequately sealed to prevent moisture access behind the cladding. This is on the wall system that has a cavity behind the sheet cladding.

Reinforcing steel was noted to be exposed under the dining room ranchslider. This could over time damage the concrete area from the exposed steel rusting. A Carpenter could be contacted to ensure the steel is cleaned and protected to ensure no further deterioration of the area occurs.

A light fitting outside the rear garage door soffit appears to be affected with rust deterioration. We advise to contact an Electrician to replace the fitting before any further deterioration occurs.

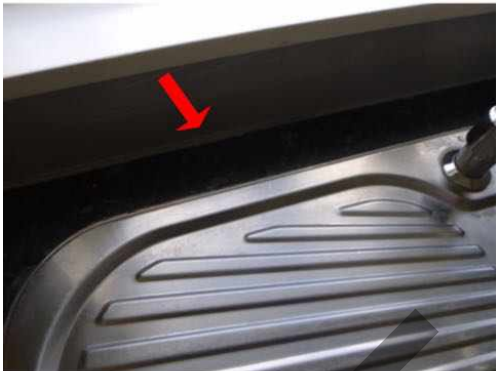
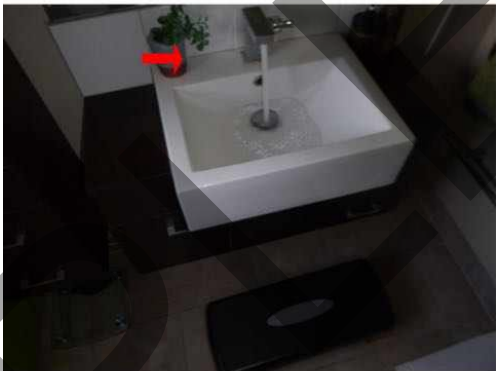
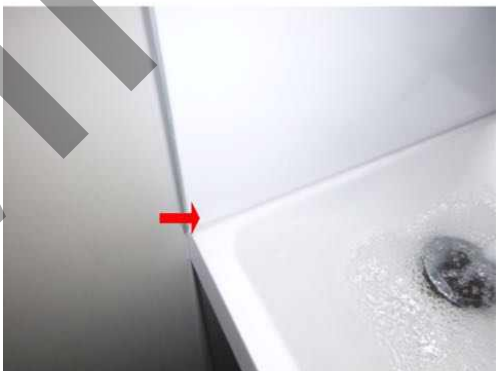
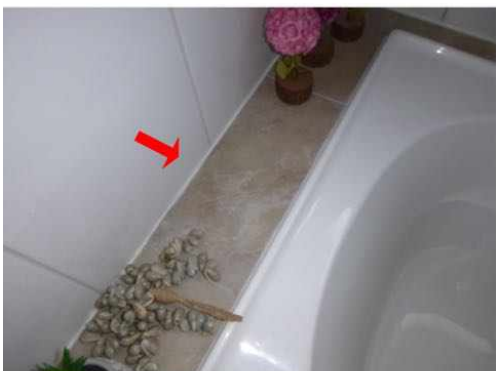
Regular maintenance and replacement of damaged, deteriorating or missing sealant is highly recommended every 3 to 5 years for the long term care of the property, as this is a regular wear and tear defect.

A Sealant Specialist should be appointed to rake out the old sealants and replace where and when required.
