NZ Residential Property Inspection Report

Inspection Date: Wed, 30 Oct 2019

Company Name: Jim's Building Inspections (Rolleston)

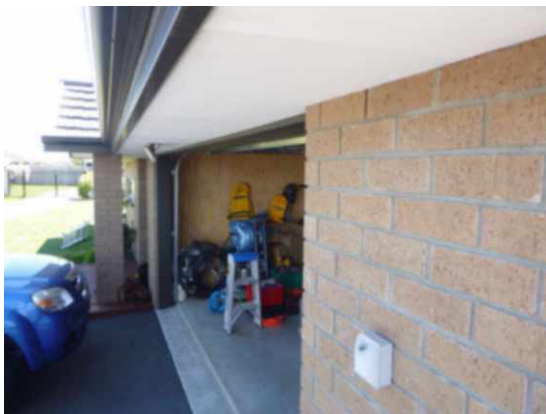
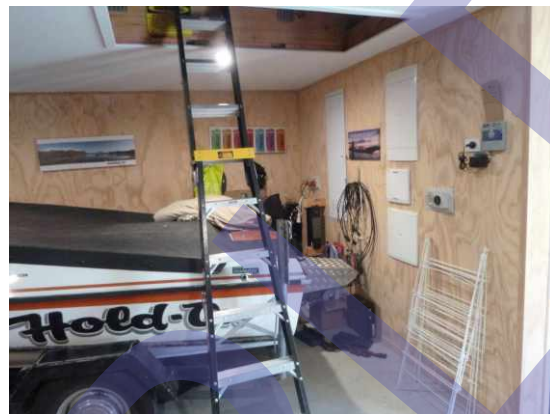
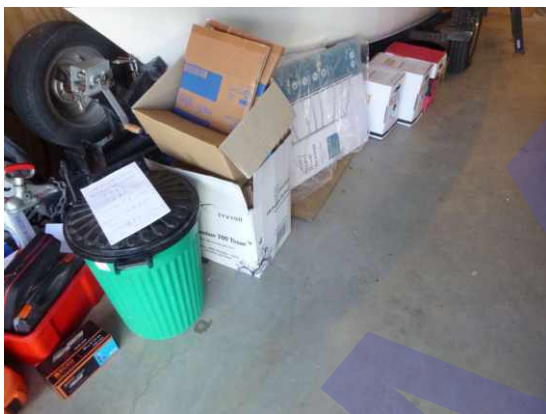
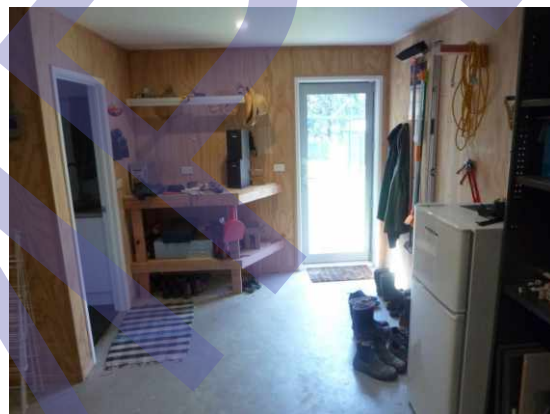
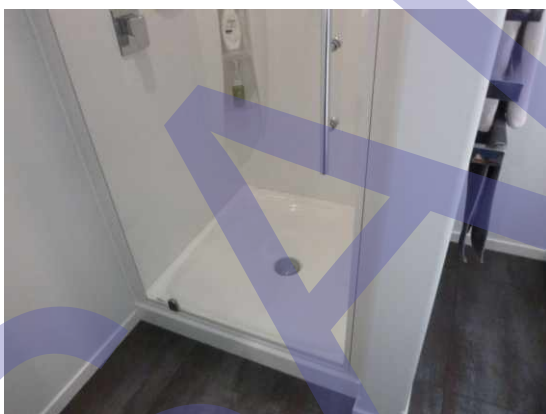
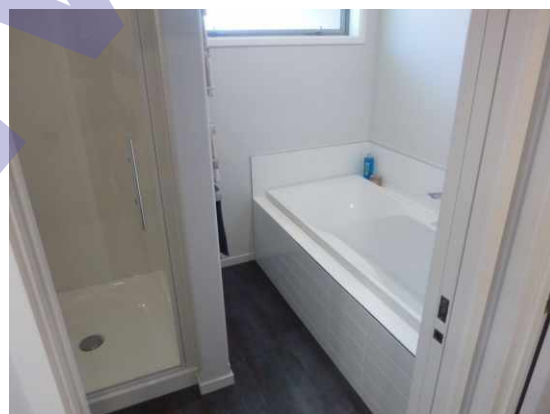
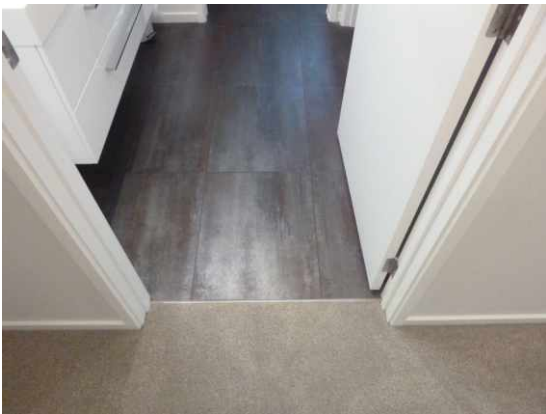
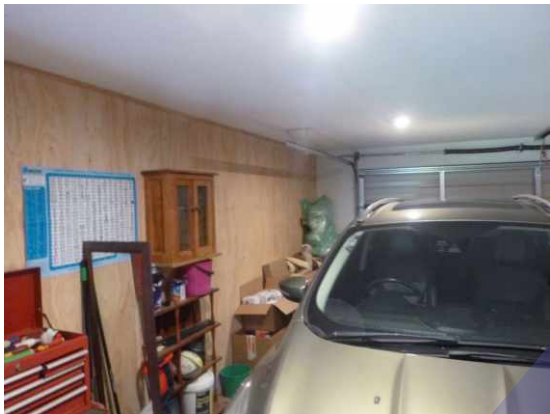
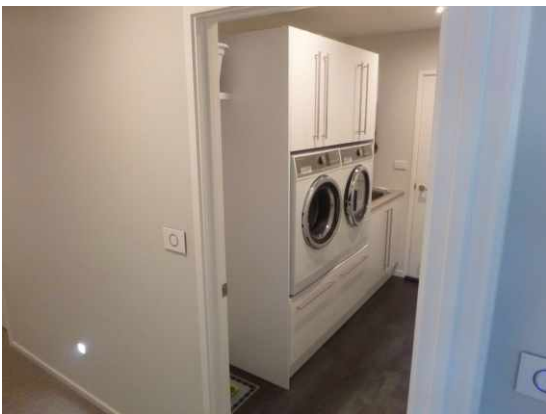
Building: Main Building
Location: Exterior > All Areas
Finding: Additional Photos - Obstructions and Limitations
Information: These photographs are an indication of the obstructions and limitations. These obstructions can hide an array of defects.

The presence of obstructions increases the risk of undetected defects. The client should make arrangement to remove obstructions where ever possible and re-inspect these areas as a matter of urgency. See also overall risk rating for undetected defects.

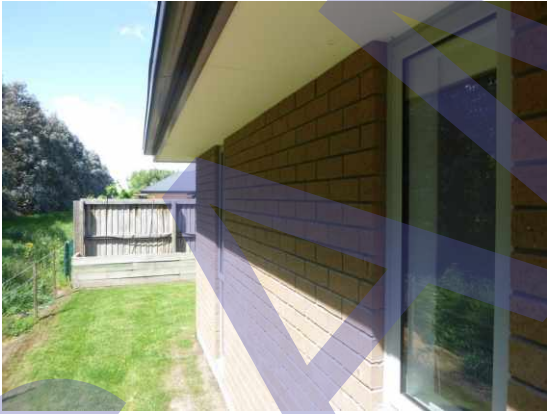
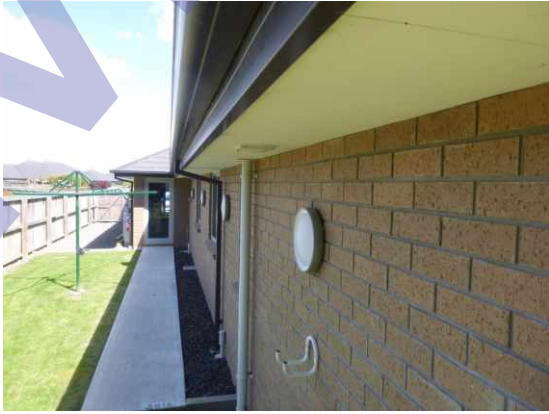
Building:	Main Building
Location:	NZ Only > All Areas
Finding:	General Weathertightness Risk - Low
Information:	<div><div>A. Wind Zone - Your risk rating is HIGH RISK</div><div>B. Number of Stories - Your risk rating is LOW RISK</div><div>C. Roof/Wall intersection design - LOW RISK</div><div>D. Eaves width - Your risk rating is MED RISK</div><div>E. Envelope complexity - Your risk rating is LOW RISK</div><div>F. Deck design - Your risk rating is LOW RISK</div></div>
