NZ Residential Property Inspection Report

Inspection Date: Mon, 08 Oct 2018

Property Address: Sample Inspection

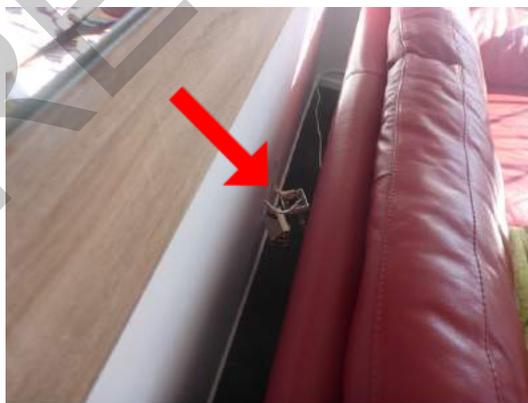
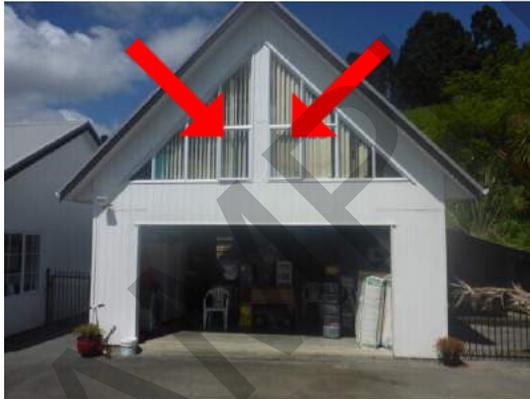
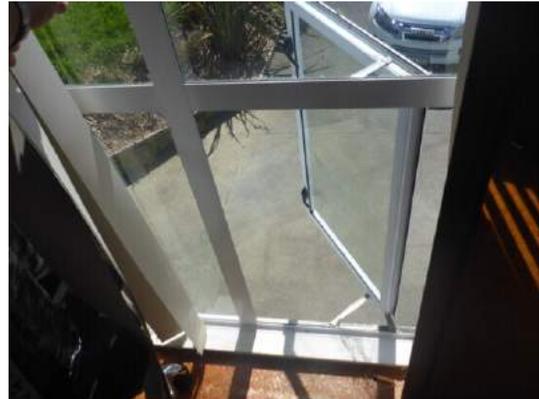
Defects 1.04

Building:	Garage
Location:	First floor - Window openings
Finding:	Unconventional window installation - missing fall restrictions/barriers
Information:	This unconventional installation of the windows on the first floor appears to have been completed to a substandard level and does not comply with regular building practices. The opening of the windows create a safety hazard where someone especially small children could slip/fall trough the window to the ground below.

It is highly recommended that fall restrictions/barriers be installed to prevent falling from the open windows. Other options to limit the opening to a safe opening size can also be investigated. However it should be noted that it is suspected that the unconventional installation of the windows could also allow excessive wear on the hinges as it is suspected that the hinges were not designed for vertical operation. A similar installation of a window on the rear wall above the stairs was installed in a similar manner is not a safety hazard, however it would be advised to install appropriate hinges on this window too to prevent excessive wear.

Works to improve this area are likely to increase the safety and the operation of the associated building elements.

The client should exercise care when coming into the immediate vicinity of the substandard works. Rectification works are advised as soon as possible by the appropriate trades.

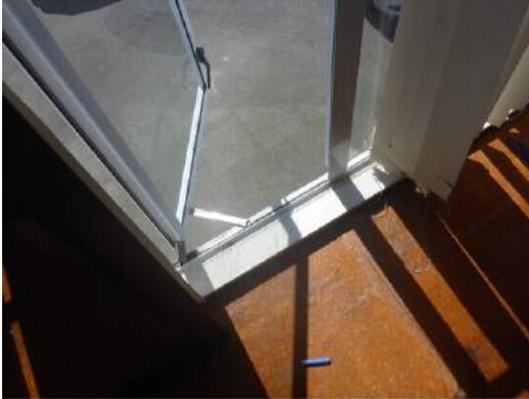
Defects 1.05

Building:	Garage
Location:	First floor landing area/access
Finding:	Low access height
Information:	It would seem that the low access height at the top of the stairs landing area could cause a head injury as the accessible area is somewhat limited. Even though it is suspected that the first floor will be used for storage, it is highly recommended that alternative solutions be investigated to make this area safer.

Some solutions could be to install soft attachments to the rafters, modifying the staircase or roof trusses to open up this area and allow safe access. It is recommended that access to this area be restricted until such time as an acceptable solutions are implemented. A registered builder/carpenter should be appointed to provide appropriate solutions as soon as possible.

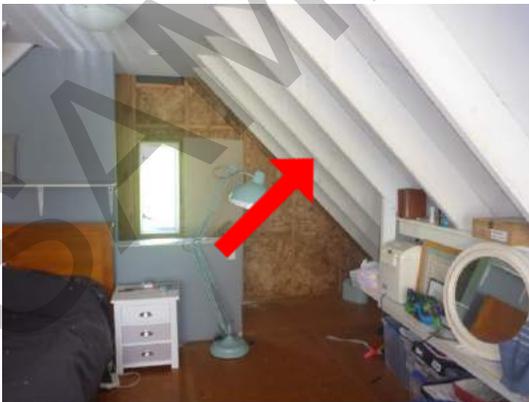
Defects 1.06

Where evidence of mould growth was noted, there may be environmental, biological or health issues associated with the report. A specialist inspection by a suitably qualified environmental health inspector is warranted, where mould is extensive or where any queries regarding air quality spores or other related issues apply.

Generally, the client is advised to ensure that the general environment is free of moisture and humidity to aid in the prevention of mould formation and development. Any mould found during the inspection should be cleaned immediately by a cleaning contractor or the homeowner as applicable.

Please note that severely affected building elements may require replacement by a registered builder or qualified carpenter.

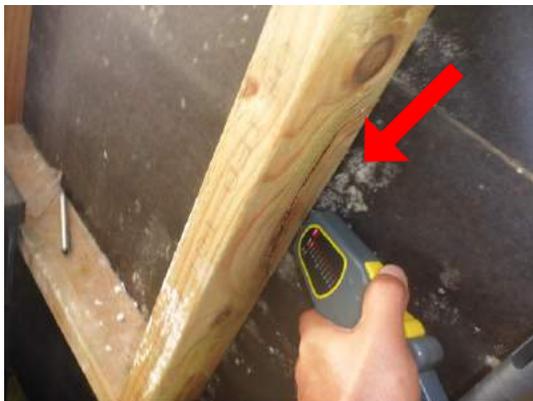
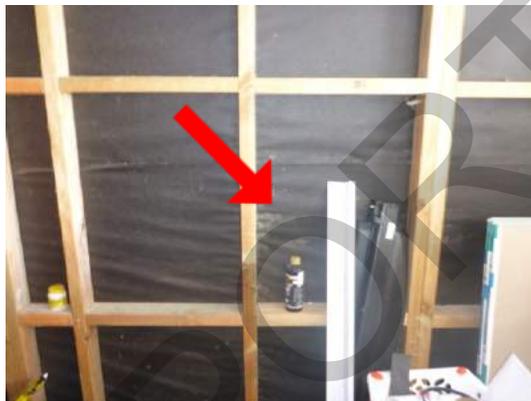
Defects 2.01

Building: Yard
 Location: Retaining wall behind garage
 Finding: Site drainage - Inadequate
 Information: Although significant efforts were made to install drainage, the site drainage in the side of the garage was found to be inadequate at the time of inspection, creating potential for subsequent water damage to associated building elements. The installation of the catchment trench seems to be done fairly well in most places however some moisture was visible between the catchment trench and the garage wall at one place. It would seem that the slope in this area does not allow water to be directed towards the trench but rather towards the wall.

A further solution could be to direct the water before it gets to the trench, by the installation of a further drainage trench adjacent to the retaining wall. Attempts to install a type of barrier seems to be failing as water can be seen seeping through the timber joints.

Where site drainage is inadequate, installation of an Agricultural (Aggie) Drain may be required. A qualified plumber should be appointed to further inspect the property and perform any remedial works as necessary. Water damage and secondary defects are likely to occur if left unmanaged.

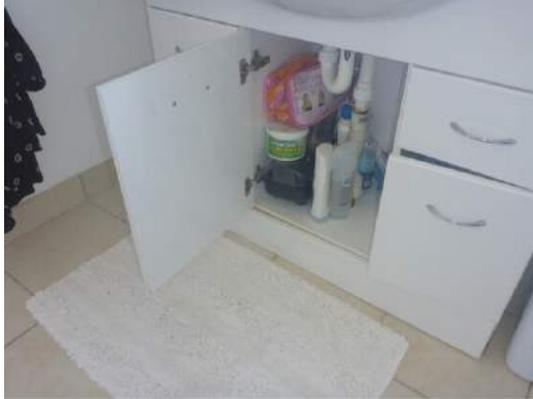
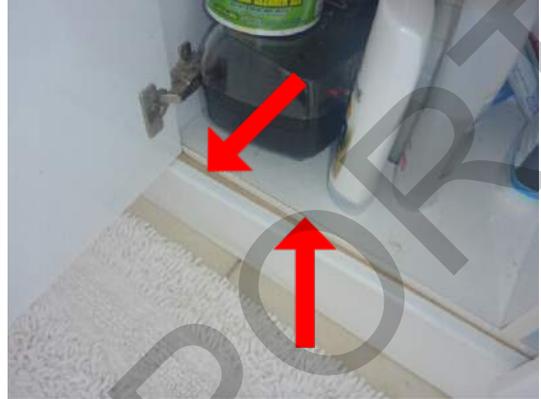
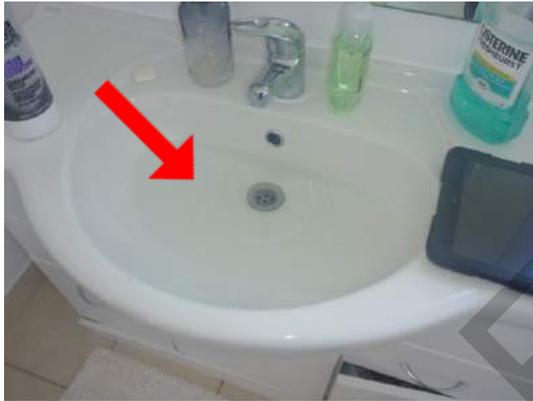
Defects 2.04

Finding: Tiles - Cracked or damaged

Information: Cracking was evident to the tiling in this area at the time of inspection. While the cracking appears to be minor, this area is frequently exposed to water, allowing potential for water penetration into adjoining sections of walls or flooring.

If left unmanaged, water penetration to these areas may lead to subsequent water damage, which is likely necessitate repair work to affected building elements.

Where water penetration has led to water damage, appointment of a relevant tradesperson may be required to repair damaged building elements.

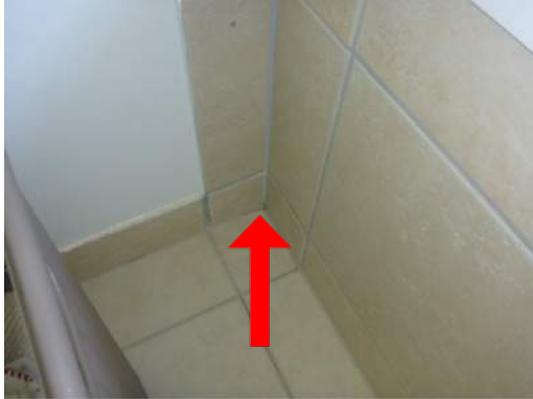
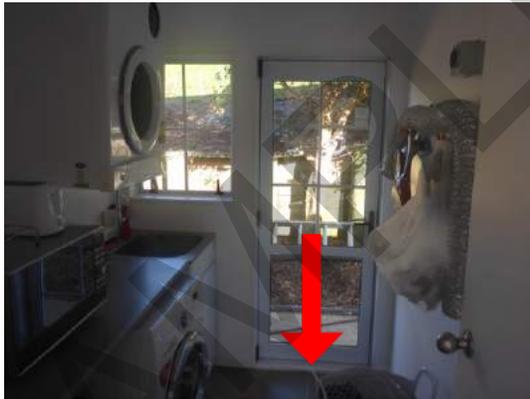
Defects 3.01

Information: Drummy tiled areas were identified at the time of inspection. The term `drummy` refers to tiles that have become detached from their fixing, despite otherwise being in relatively good condition. Such defects are generally caused by physical or moisture damage to the area. Drummy tiled areas may also be a direct result of poor workmanship during the construction process.

Tiled areas may swell and shrink with changes in air humidity if the area has sustained moisture damage. Any exposure to moisture is capable of causing tiled areas to become drummy and/or cracked over a prolonged period of time. Drummy tiled areas generally require removal and replacement of affected tiles, with adequate sealant and grouting.

Specialist trades are available for these types of services. A registered builder may be required to undertake works if damage is extensive or if secondary building defects have resulted. Otherwise, it is advised that a tiling contractor be appointed to perform works as necessary. Immediate action is recommended to ensure that no further damage is sustained in the affected area.

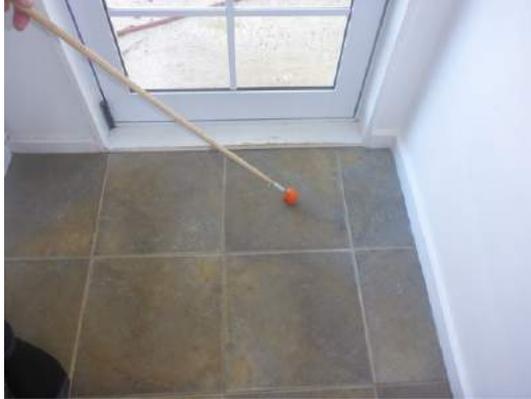
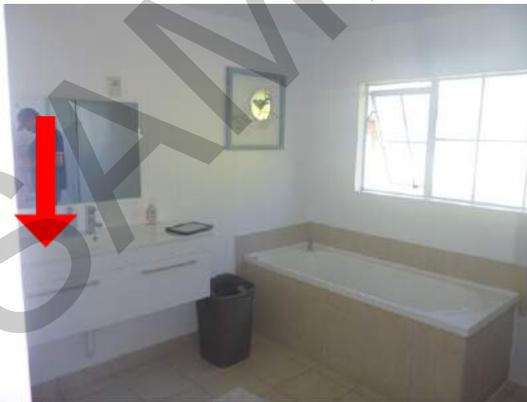
Defects 3.02

Finding: Bathroom vanity - Broken drawer

Information: The drawer of the bathroom vanity was found to be broken at the time of inspection. Breakage occurs generally when the building materials have either aged and decayed, or as a result of damage (accidental or deliberate).

Repair and/or replacement of broken elements is advised to ensure that additional secondary defects do not arise as a consequence. Such works are necessary, as all building elements play a key role in the operation and function of the overall structure and its performance.

A relevant tradesperson should be appointed to repair or replace the affected building element prior to any subsequent damage being caused.

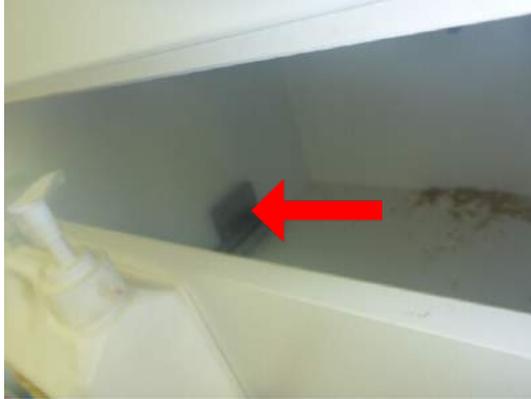
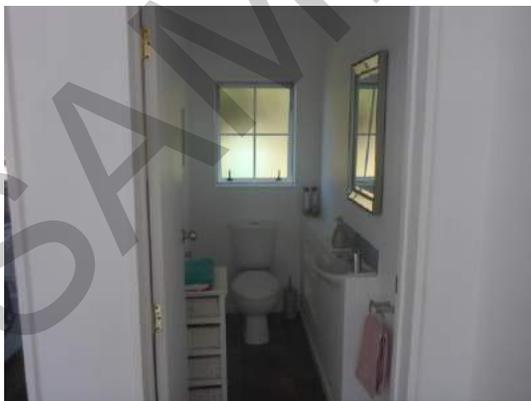
Defects 3.03

Finding: Toilet seat - Loose

Information: The toilet seat was found to be loose and relatively unstable at the time of inspection. It is suspected that this defect has developed due to general ageing of the toilet and associated materials. However, the loose fixing may also be a result of impact damage or have not been maintained.

If left unmanaged, the toilet seat could deteriorate further, leading to greater destabilisation and the potential for water leaks to surrounding building elements.

It is recommended that the seat be replaced/refixed to the toilet pan by a general handyman .

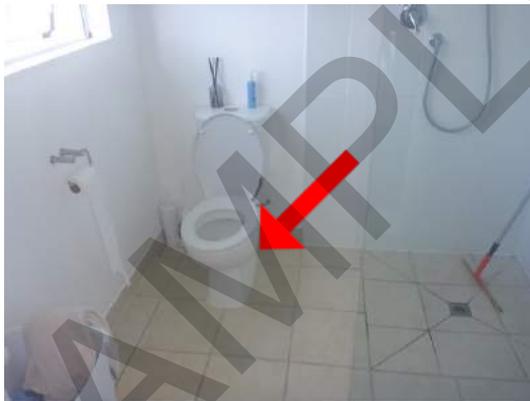
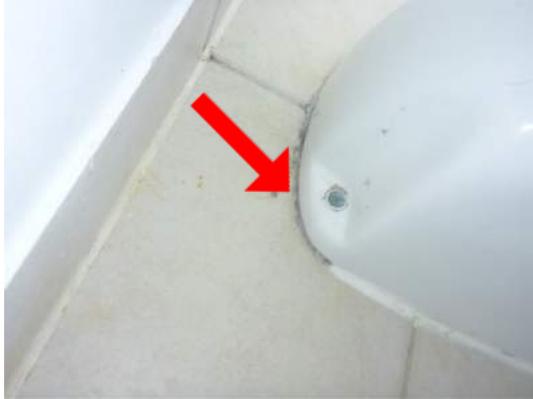
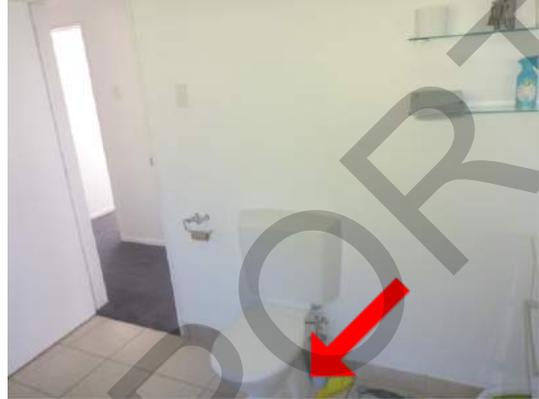
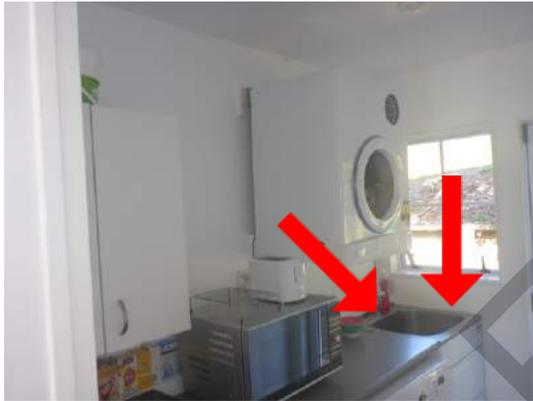
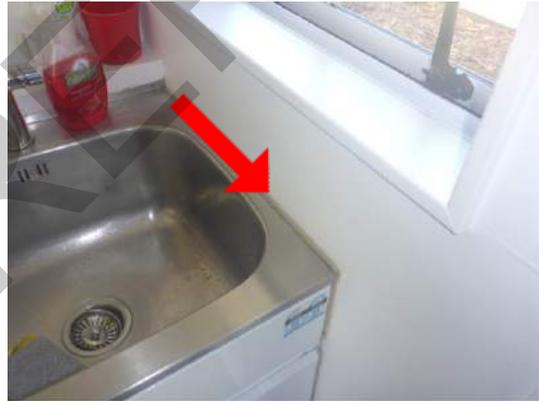
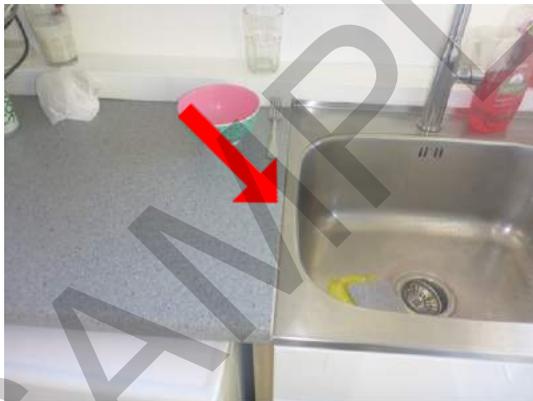
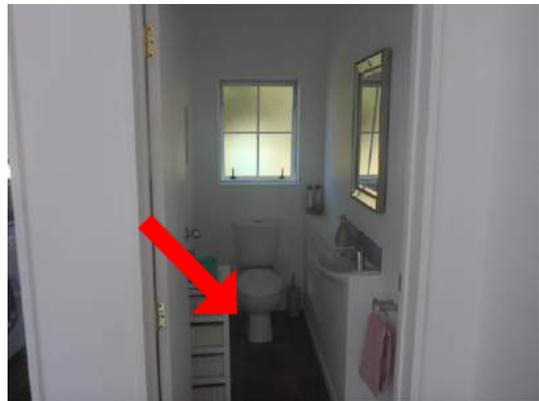
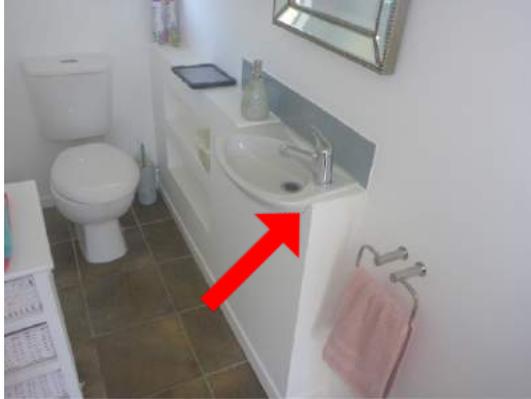
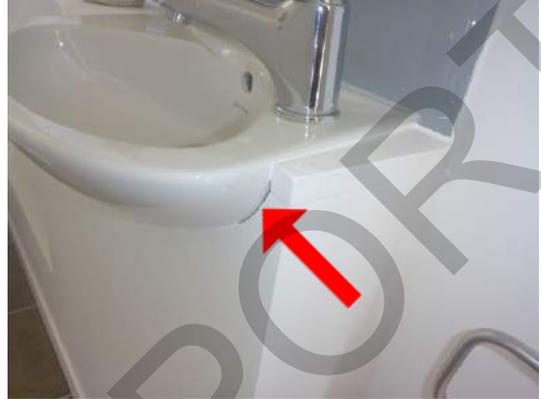
Defects 3.04

Building: Main Building
Location: Ensuite, Bathroom, Toilet, Laundry
Finding: Sealant and grouting - Missing or damaged
Information:

It was noted on inspection that sealant or grout is degraded or missing around the toilets in the ensuite, bathroom, and toilet. The grouting around the toilet basin was found to be missing and the grouting around the laundry basin was very deteriorated and mouldy.

Different materials and floor areas move at different rates, generally causing cracking to grout or sealant at this point. A flexible sealant is required to allow for expected expansion and contraction, while keeping the joint water tight and protective of all associated building materials.

There appears to be excessive mould to the sealant and grout which will likely require scraping out and replacement.

Flexible and mould resistant materials should be applied to affected areas to prevent any subsequent water damage that is likely to occur. Regular maintenance and replacement of damage or missing or damaged sealant and grout is highly recommended to the wet areas, as this is a regular wear and tear defect. Sealant and grouting in areas that come into regular contact with water should be maintained for the long term care of your property.

A sealant specialist or tiling contractor should be appointed to complete these works as soon as possible

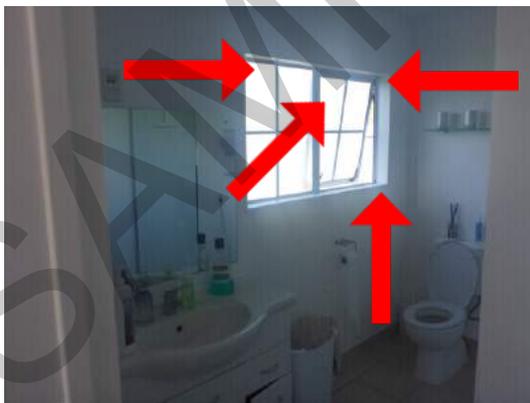
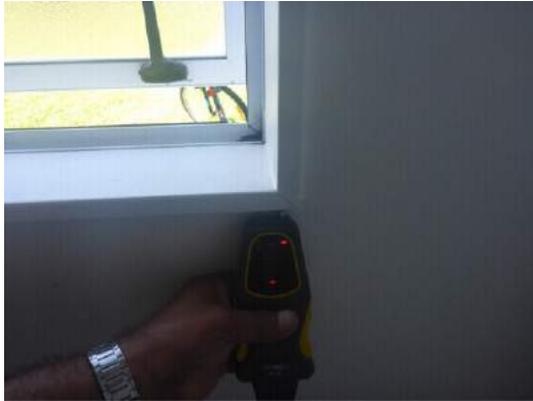
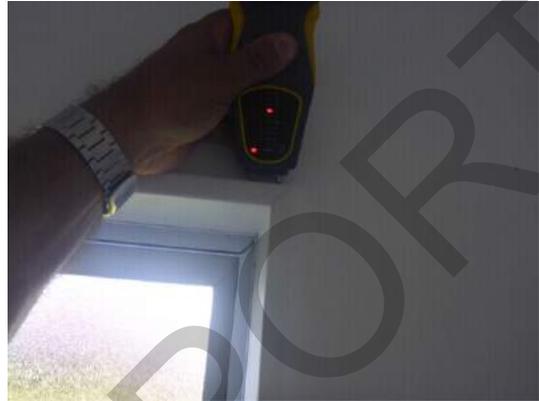
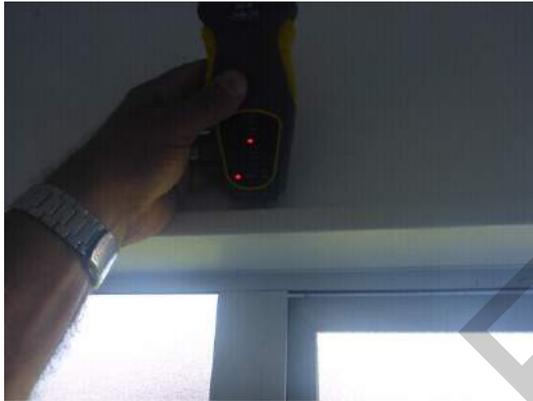
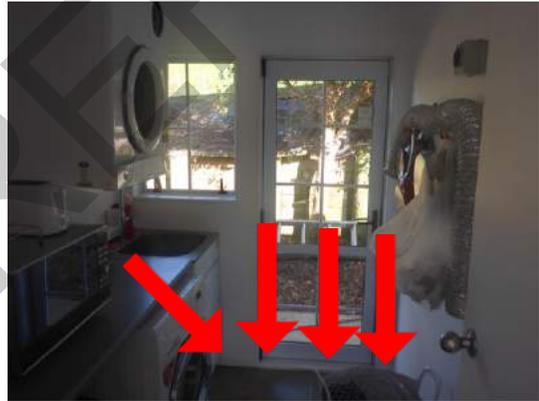
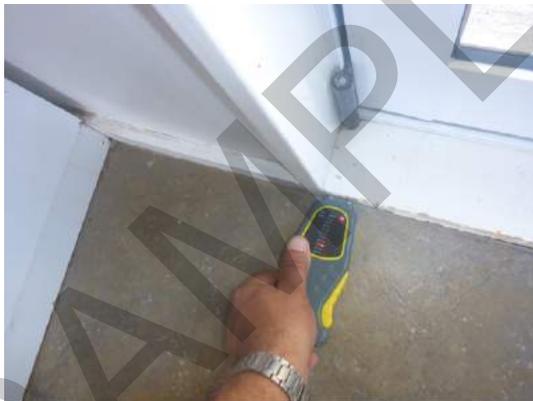
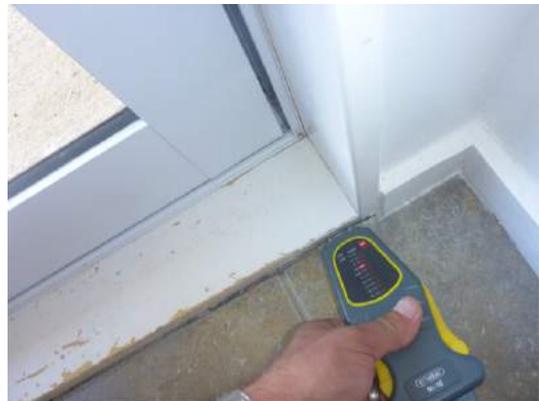
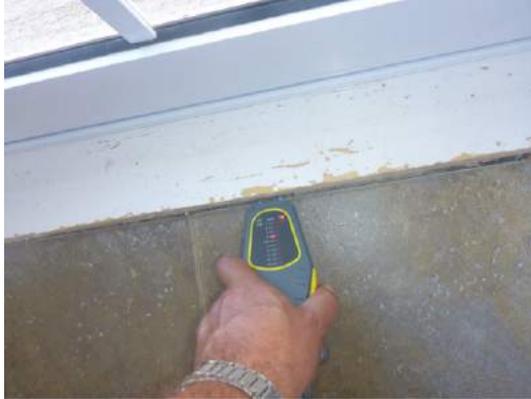
Defects 3.05

Building:	Main Building
Location:	Ensuite, Laundry
Finding:	Damp
Information:	Elevated readings was observed when the wall penetrations were tested for moisture. Damp (or structural damp) refers to the presence of unwanted moisture in the structure of a building, either as the result of intrusion from outside, or condensation from within the structure. Generally, structural damp is caused by rain penetration, rising damp, and leaks from plumbing pipes.

Unmanaged damp facilitates the formation and development of mould, fungi growth and wood rot, decaying associated building materials and compromising their structural integrity. Damage to finishes is also likely to occur, including lifting, bubbling, peeling and staining of paint, plaster and wallpaper.

The first step in addressing damp is to diagnose the cause. The identified cause should be addressed first prior to repairing the appearance and other defects which have resulted from the rising damp. If the original cause is not resolved, further cases of damp are likely to ensue, resulting in secondary defects.

Consultation with a qualified plumber is advised immediately to identify the cause of damp and perform remedial works as required. Where excessive mould growth is present, further inspection by a specialist environmental health inspector should also be considered.

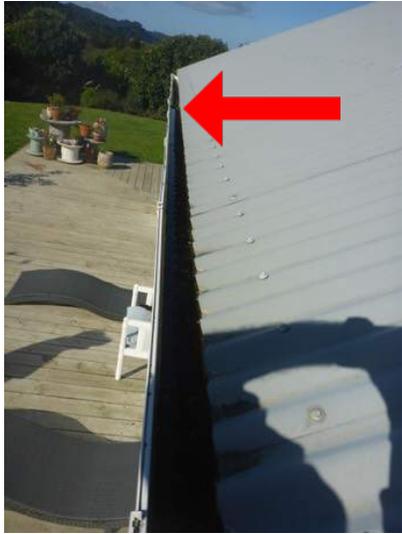
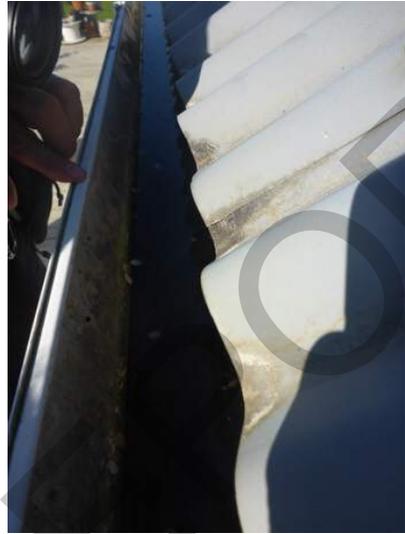
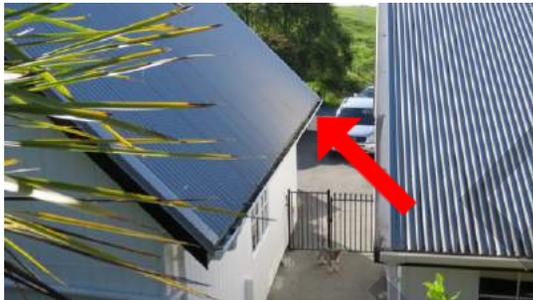
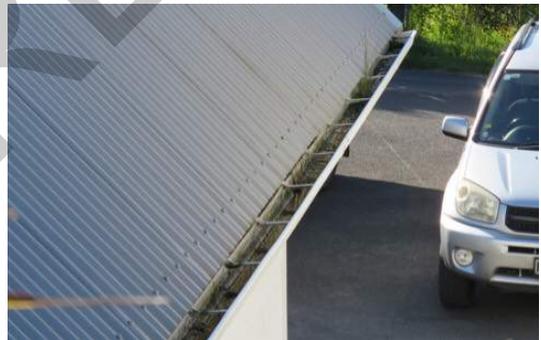
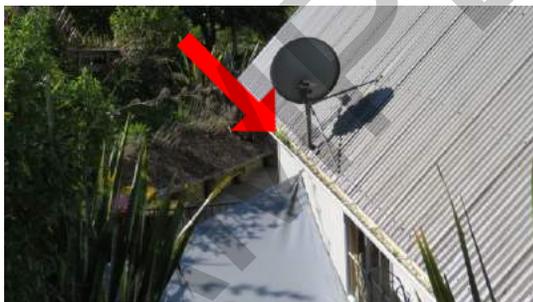
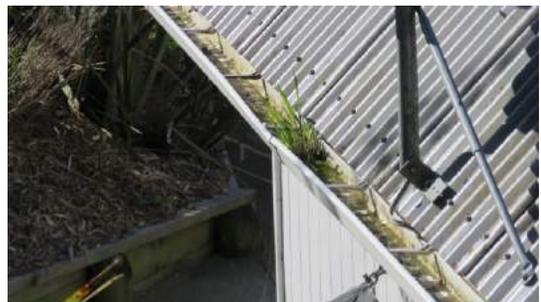
Defects 3.06

Building: Main Building
 Location: Roof Exterior
 Finding: Gutters - Blocked
 Information:

Roof plumbing structures, such as guttering and downpipes, were in general found to be free of debris. However some minor blockages were identified and would require cleaning. If not attended to soon further blockages can develop. Blockages of the guttering and downpipes will lead to pooling and accumulated water overflows, which is likely to subsequently flood eaves and exterior walls.

Blocked gutters are likely to lead to high levels of moisture in the affected areas. Blockages in gutters should therefore be removed immediately to ensure dry conditions are maintained.

Consult a Licensed Plumber for further specific advice on remedial works that may be required. In the interim, it is highly advised that blockages in the gutters be removed by the homeowner or a general handyperson as a matter of urgency.

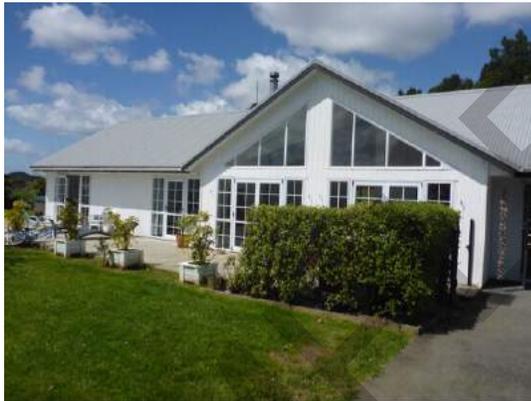
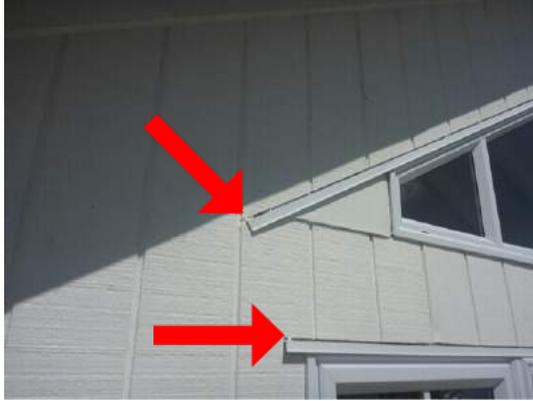
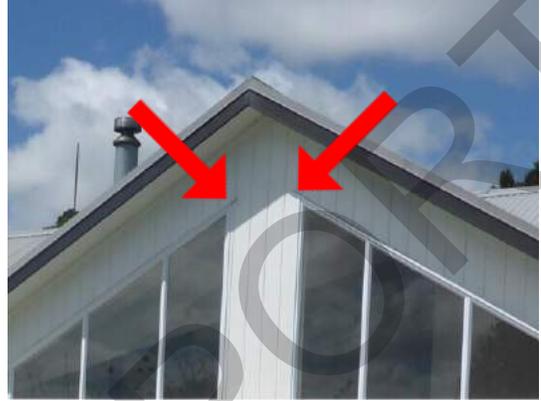
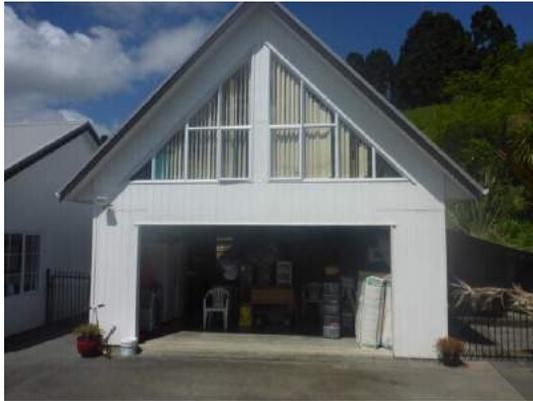
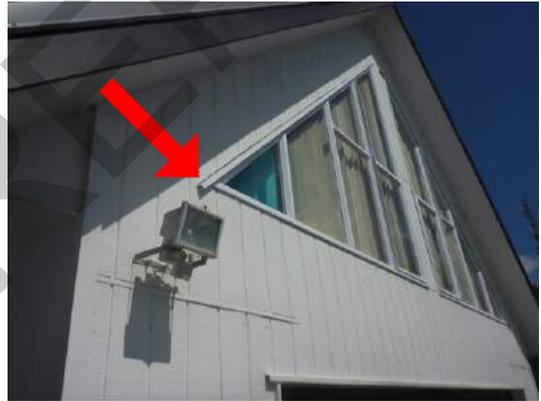
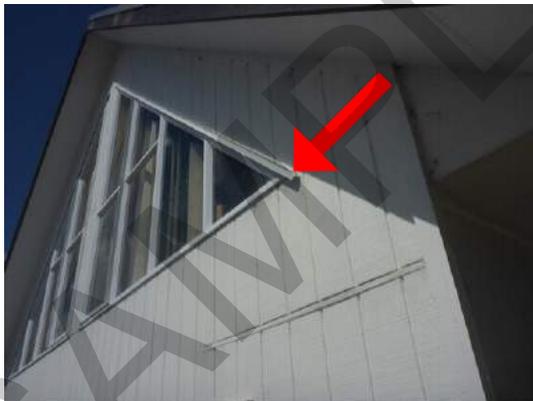
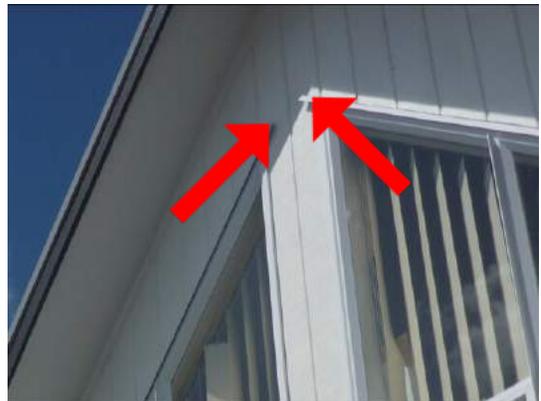
Defects 3.07

Finding: Window/door flashings - Inadequately sealed

Information: It was observed that the flashing above the windows and doors were not adequately sealed on the ends. It is suspected that the waterproofing is jeopardised and could allow water penetration to the internal timber frame in the cavity wall. It is suspected that some of the works was completed to a substandard level of workmanship or is incomplete. It should be noted that no damage was identified in the interior of the building at the time of inspection although some high moisture readings was observed above the window of the ensuite (as discussed elsewhere in the report). The photos in the report of the effected windows are indicative only and the particular defect was identified at most of the windows.

As such, associated building allowing water penetration to the cavity wall. are likely to deteriorate at an accelerated rate, and major implications are expected if these defects are left unmanaged. The holes around the flashing should be adequately filled using a suitable sealant or trimmings as soon as possible to prevent any further damage. Such works may be conducted by a general handyperson or registered builder.

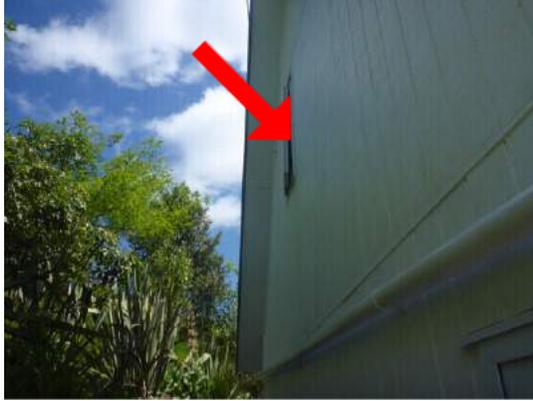
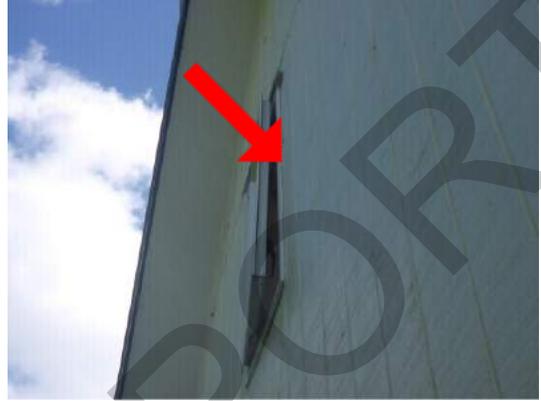
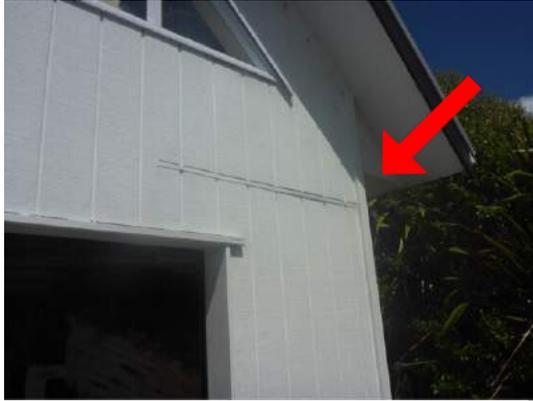
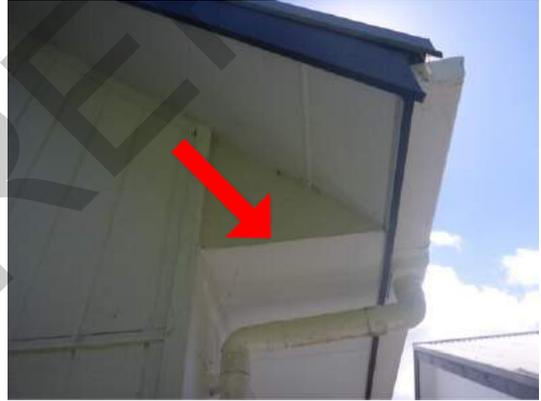
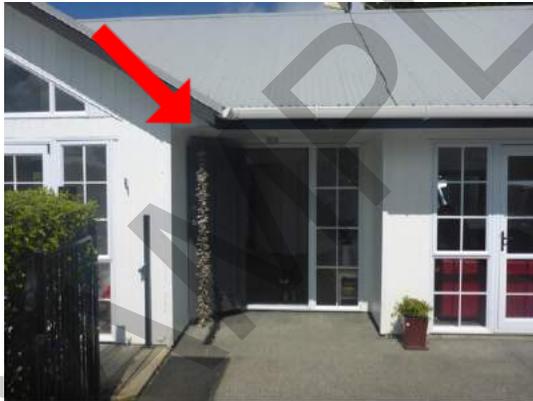
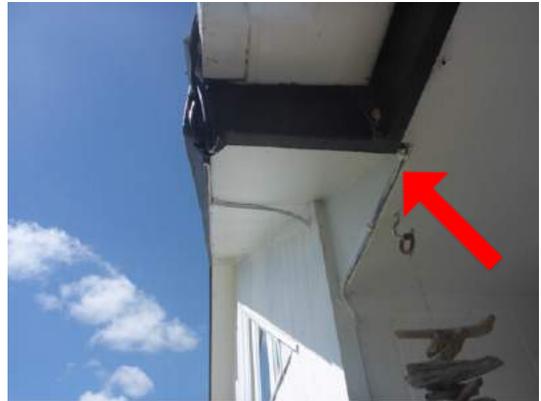
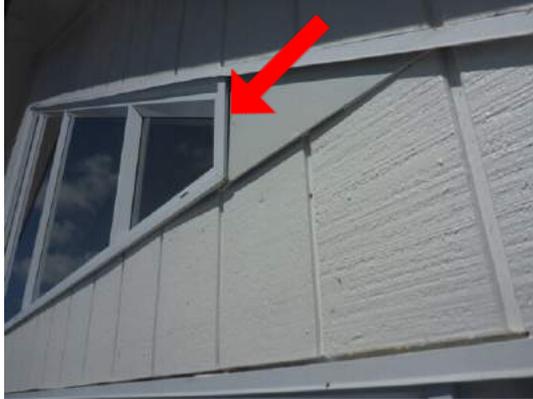
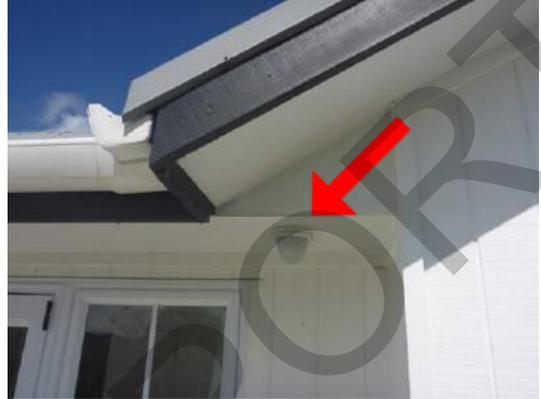
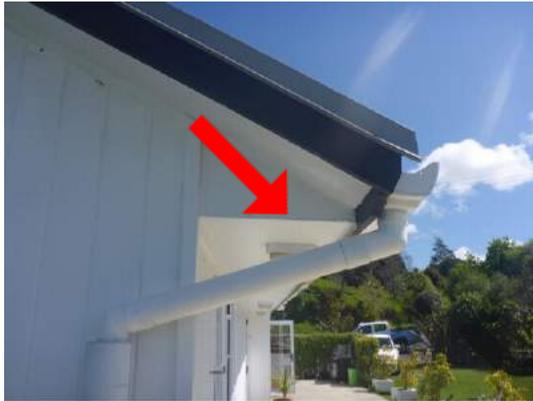
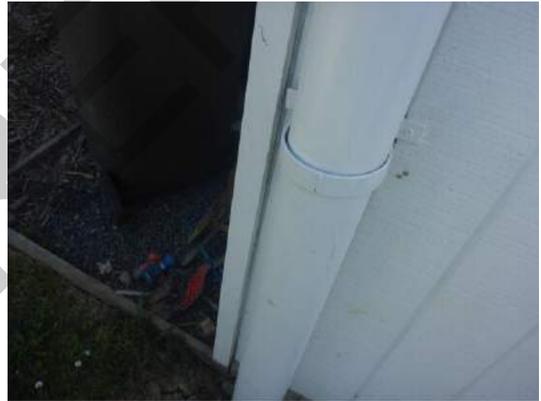
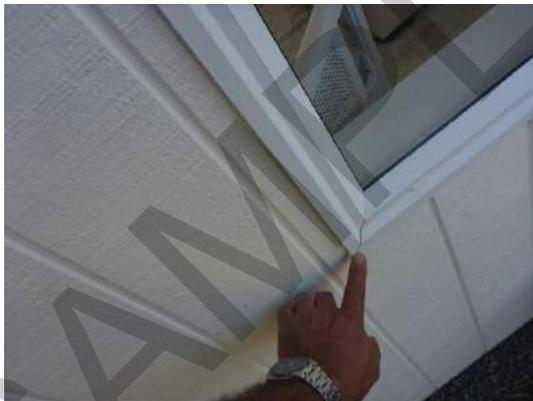
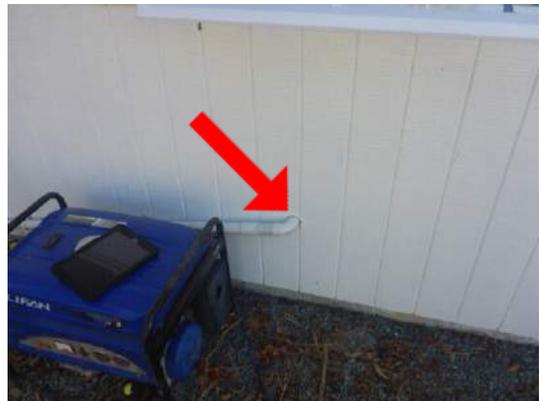
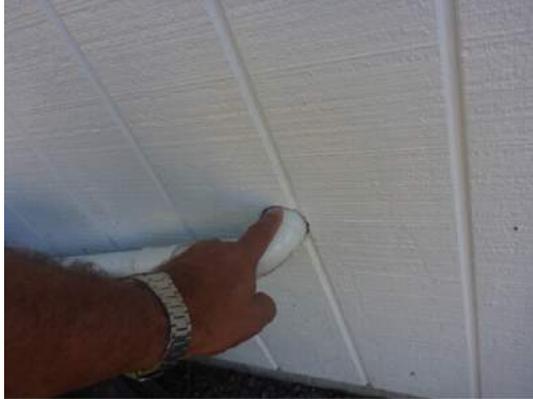
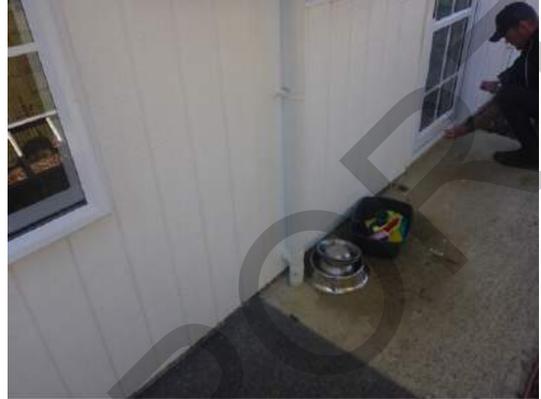
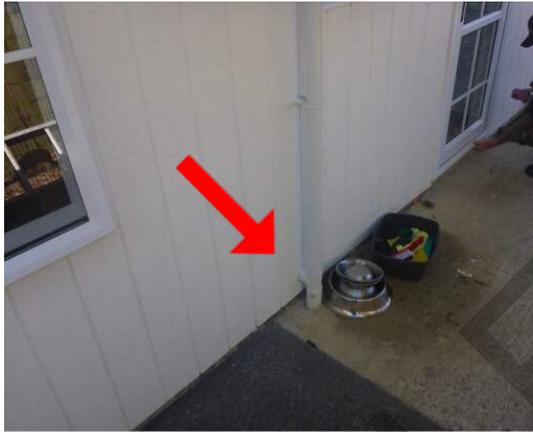
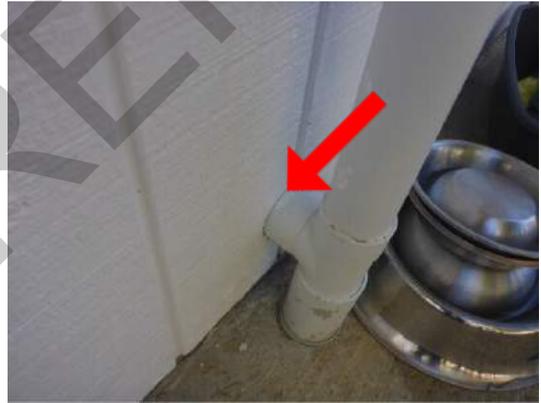
Defects 3.08

Building:	Main Building
Location:	Exterior walls
Finding:	Exterior walls - Cracks, gaps and holes
Information:	Some cracks, gaps or holes were found in the cladding including corner joints, eave flashings, around door and window frames, wall attachments and around wall penetrations for pipes. It is suspected that some of the works was completed to a substandard level of workmanship or is incomplete. Gaps and holes makes the areas susceptible to insect, vegetation and vermin ingress as well as allowing water penetration to the cavity wall.

As such, associated building elements are likely to deteriorate at an accelerated rate, and major implications are expected if cracks, gaps and holes are left unmanaged. All excessive holes, gaps or cracks should be adequately filled by using a suitable sealant or trimmings as soon as possible to prevent any further damage. Such works may be conducted by a general handyperson or registered builder and/or licensed plumber.

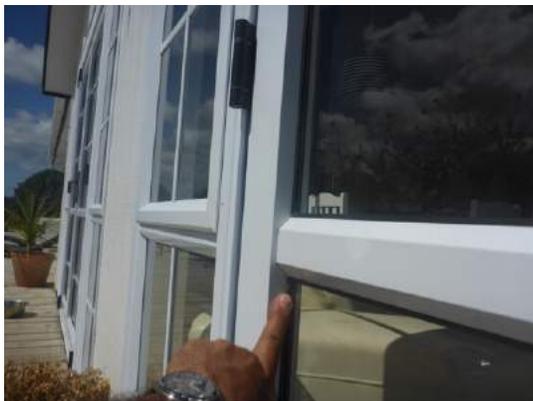
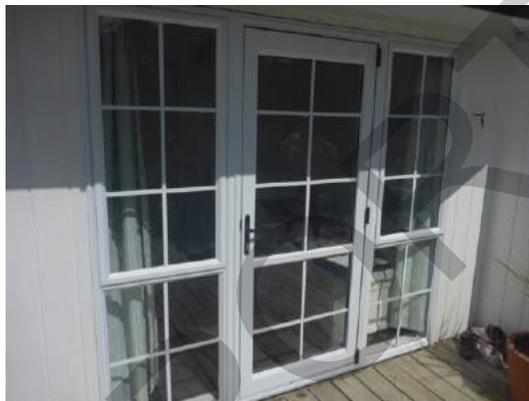
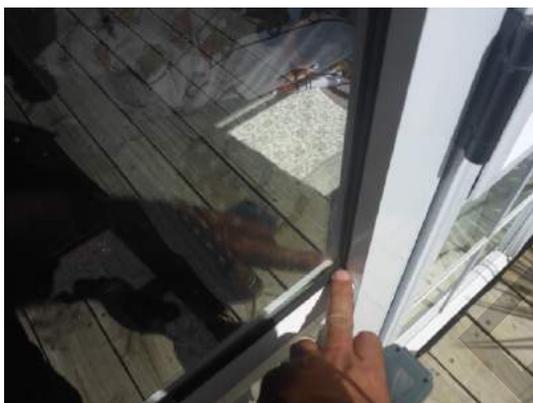
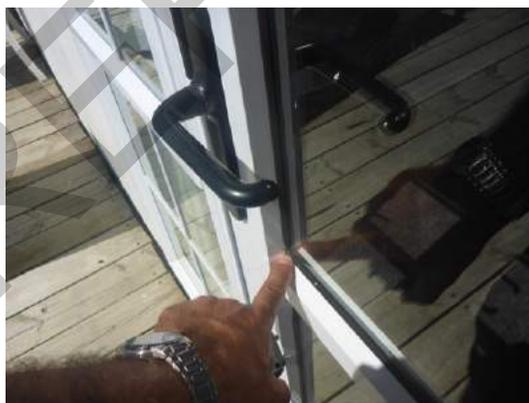
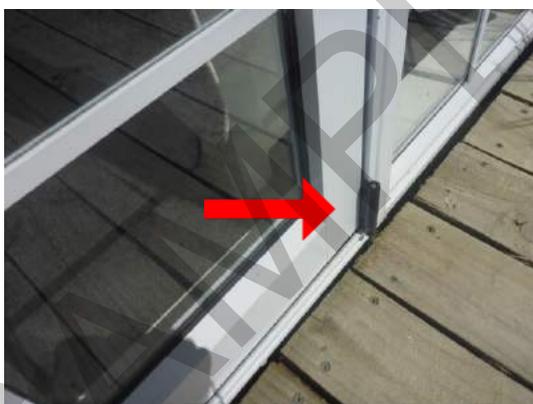
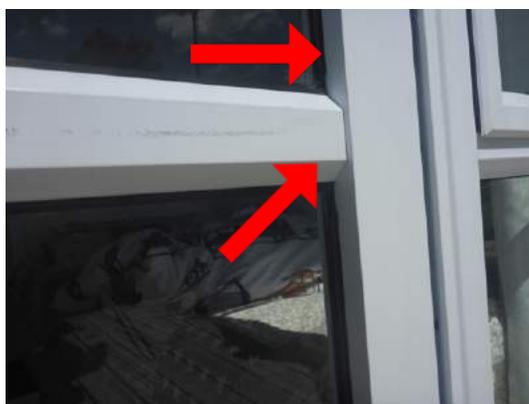
Defects 3.09

Building: Main Building
Location: All Internal Areas - Glass window and doors
Finding: Window/door Glass seals - incorrect installation
Information: Although the window seals does not look like it has deteriorated, it was found that some of the seals were installed incorrectly. Due to frequent exposure to weather conditions and subsequent moisture, deterioration of window seals could cause moisture ingress into the building.

Where window seals have been installed incorrectly, the window is no longer weather-tight; rain penetration and subsequent water damage is therefore likely to ensue. Insulation of the area against external weather conditions will also be compromised.

It is recommended that all the incorrectly installed window seals be replaced by a general handyman or sealant expert to prevent any further damage and to restore the window to a fully functional level.

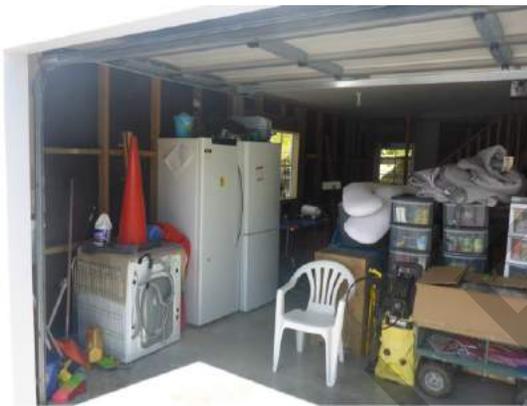
Defects 3.1

Building: Garage
Location: Garage floor
Finding: Crack in concrete slab - Category 1
Information: A crack coded as Category 1 was identified in the slab. A Category 1 crack is described as a fine but noticeable crack, with the slab at an otherwise reasonable level.

To be considered Category 1, the approximate width of the crack is $<1.0\text{mm}$, or a $<10\text{mm}$ change in offset when a 3m straight edge is placed over the defect.

Category 1 cracks should be monitored for a period of 12 months. At the end of the monitoring period, identified cracks that are rated greater than Category 2 are considered defects, and require rectification.

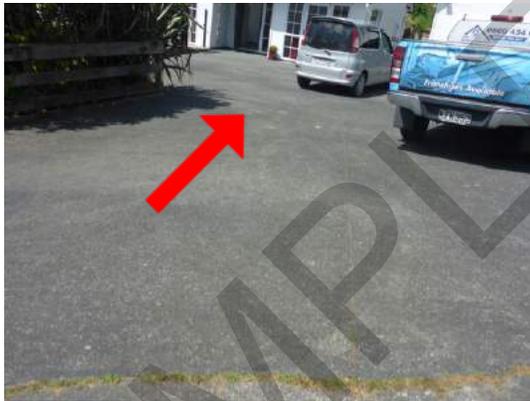
Defects 3.12

Building:	Yard
Location:	Driveway
Finding:	Cracking - External Concrete Paving Damage Category 1 - Fine (less than 2mm)
Information:	Fine cracks were identified in external concrete paving. Although fine cracks are quite noticeable, they are often only considered to be an appearance defect, and usually do not indicate any structural damage. To be considered a Category 1 or fine crack, the crack is found to be <2mm in width.

Generally the cause of a hairline crack in existing concrete paving such as driveways and pathways is indicative of the expansion and contraction of the concrete. Such causes are generally due to environmental factors, such as moisture levels, weather conditions, root systems of nearby trees or the soil types on which they are laid.

Fine cracks may also be due to poor original installation of the concrete. Factors such as poor compaction of the sub surface and/or inadequate reinforcing of the slab may create cracking and other secondary defects.

Monitoring of all cracking should be conducted frequently. Always contact a building inspector should cracks widen, lengthen, or become more numerous.

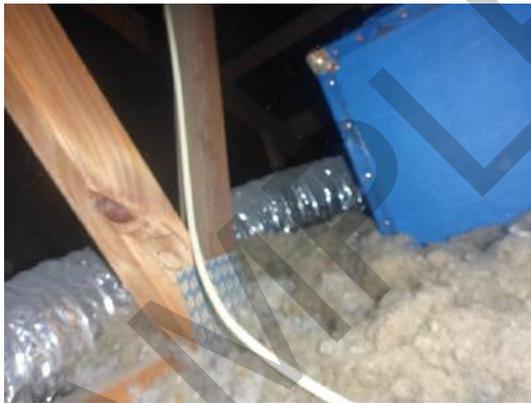
Defects 3.13

Camera access (hand) to the western side manhole indicated that some Insul-fluff insulation was installed. Insul-fluff is common in many older homes and is a loose form of insulation that is `blown` into roof voids. While this type of insulation was considered effective at the time of installation, modern materials have surpassed it as the preferred insulator.

This type of insulation is susceptible to settling and reducing in volume, detracting from its effectiveness and resulting in an overall loss of energy within the household. Additionally, the reduction in volume has led to an uneven distribution of insulation within the ceiling void, further detracting from its effectiveness.

It is advised that this insulation be removed and replaced with a more appropriate material. This will ensure that the property is adequately insulated and will promote an increase in energy efficiency within the property. An insulation contractor should be appointed to provide further advice on replacement options and to perform works as necessary.

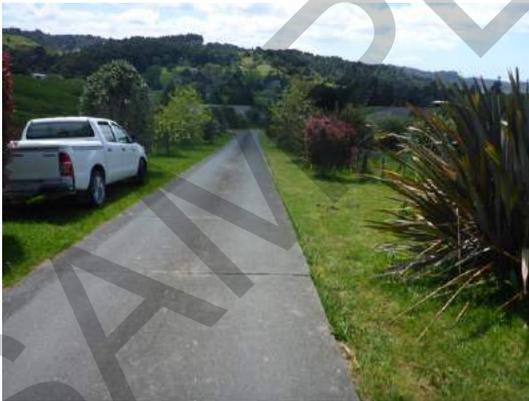
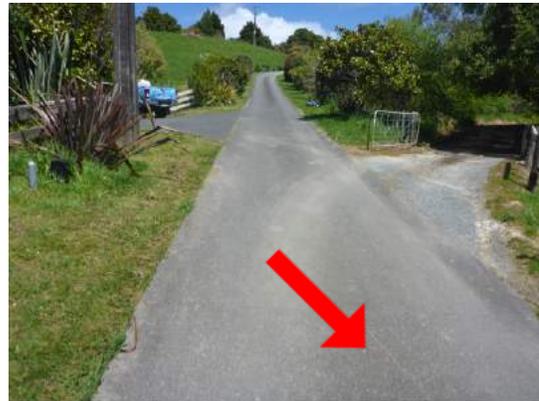
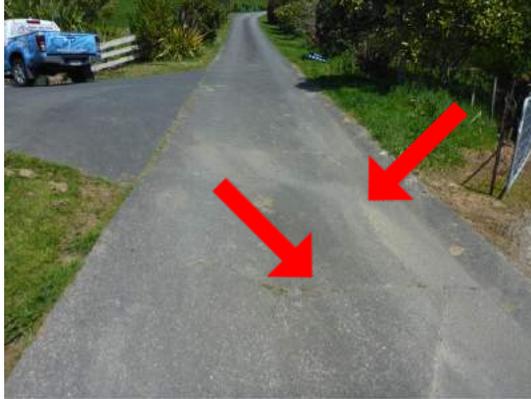
Building: Yard
 Location: Shared Driveway
 Finding: Cracking - External Concrete Paving Damage Category 4 - Gaps in Slab (4mm - 10mm +)
 Information: Inspection of shared construction or building elements outside the property is not included in the inspection, however gaps in the slab of the shared driveway were identified. Gaps in the slab are significant and are likely to lead to the development of safety hazards and secondary defects if left unmanaged, such as the creation of a trip hazard.

General age and expected deterioration of the paved areas is a common cause of this type of cracking. However, expansion and contraction of the slab may also have occurred due to environmental factors. Such factors include variable moisture and weather conditions, the presence of trees and their roots having a settling or lifting affect on the soil, or the effect of load bearing, e.g. heavy vehicles over a sustained period of time.

Cracking to this degree may also be due to poor original installation of the concrete. Factors such as poor compaction of the sub surface and/or inadequate reinforcing of the slab may create cracking and other secondary defects. Gaps in the concrete paving may also have a more significant structural cause, such as subsidence of soils.

Where gaps in the concrete paving are adjacent to structural elements of the building, the advice of a Structural Engineer is advisable before undertaking repairs. Significant repair and likely replacement of the concrete paving is probable.

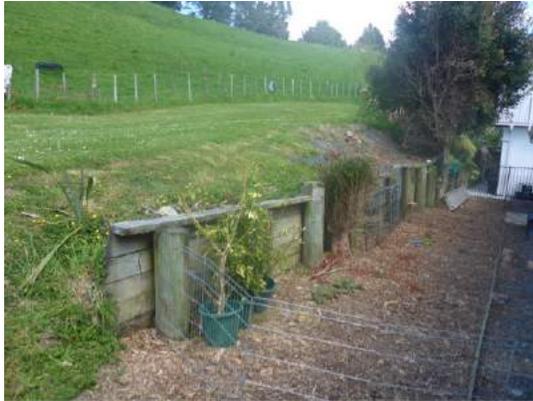
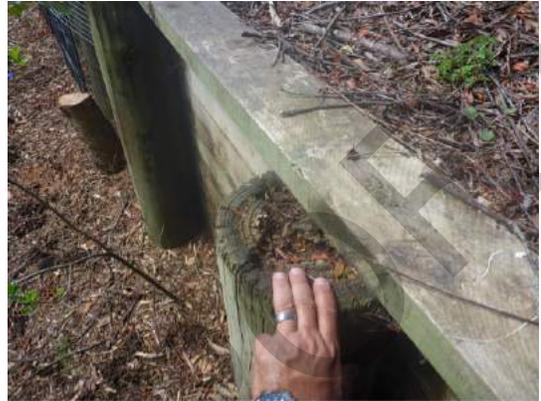
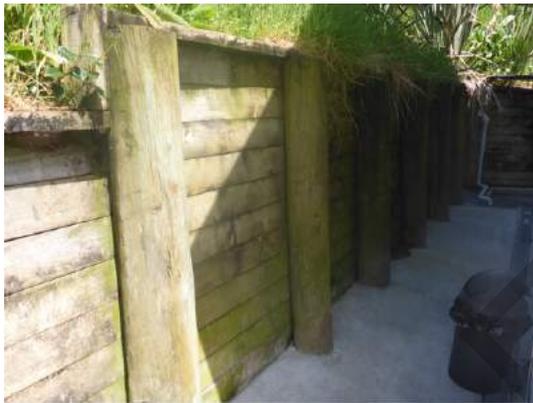
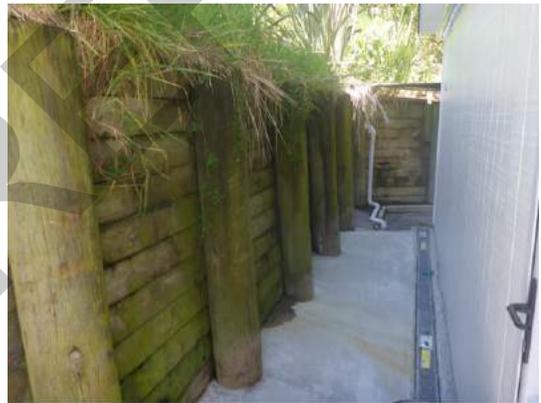
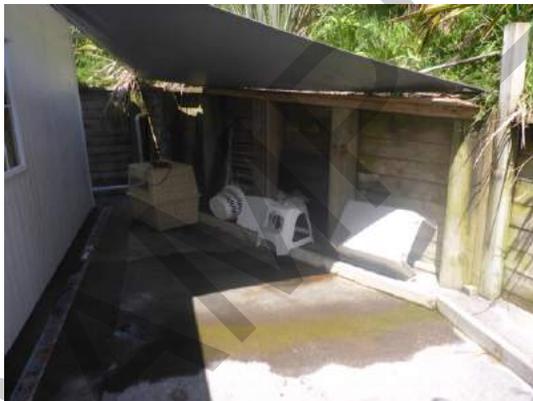
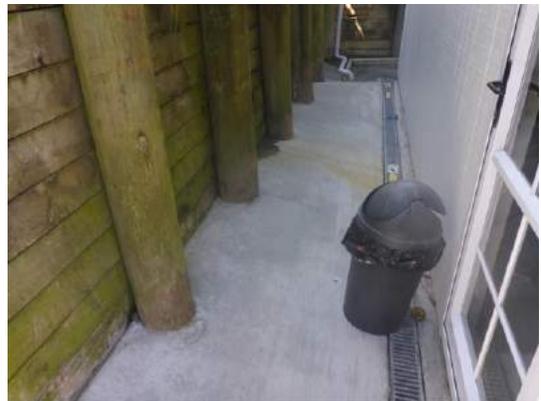
Building: Yard
 Location: Retaining wall behind garage
 Finding: Retaining wall - Adequate
 Information: The retaining wall in this area was found to be adequate and perform as expected at the time of inspection. No significant deterioration was identified at the time of inspection. Natural water trapped behind retaining wall seems to be seeping through the wall alleviating the weight pressures behind the retaining wall. If the trapped water is not managed properly it may cause the retaining wall to destabilise and it may become a safety hazard.

Some rotting of the structural poles have been identified and will have to be replaced in the medium term.

The inspection is not a structural verification, but merely a cursory inspection to identify any noticeable deterioration or inadequacies based on the inspector's experience. The retaining walls are considered structural walls, and should have been designed by a structural engineer. The client is advised to request confirmation from the current owner to confirm a CC (Compliance Certificate) was provided for the wall after construction. Significant repair or remedial works could be expected if the CC for the retaining wall was not issued previously.

The client is advised to monitor the wall periodically and to contact a building inspector for further inspections if any deterioration has been occurred over time.
