NZ Residential Property Inspection Report

Inspection Date: Mon, 08 Oct 2018

Property Address: Sample Inspection

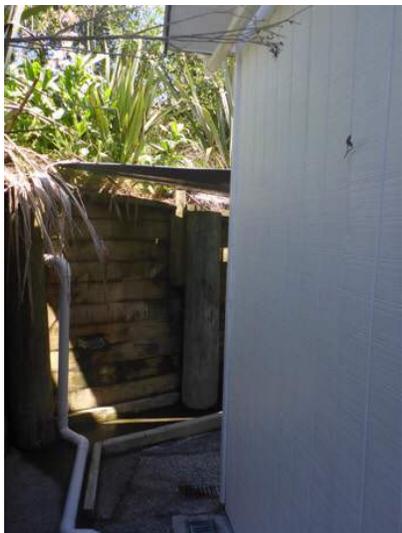
Building:	Yard
Location:	Shed
Finding:	General condition - fair for it age and use
Information:	The shed was found to be in fair condition for its age and use however, no roof plumbing and stormwater management was installed. It would also seem that the ground clearance of the structure is inadequate. It is recommended that the shed only be used for storage items/ materials that won't be effected by moisture/damp/rust.

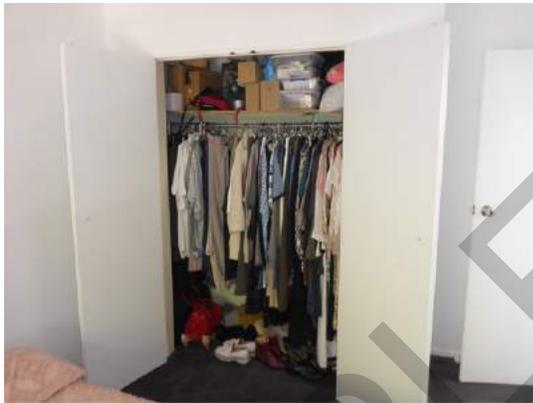
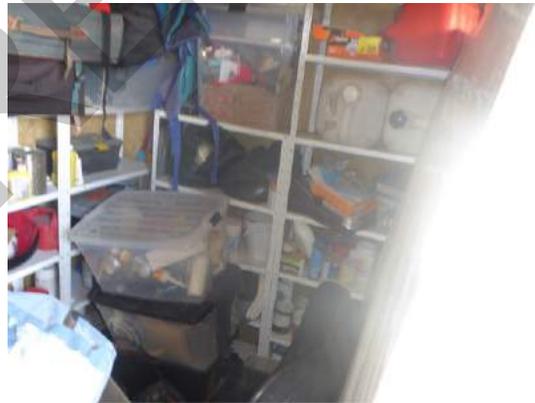
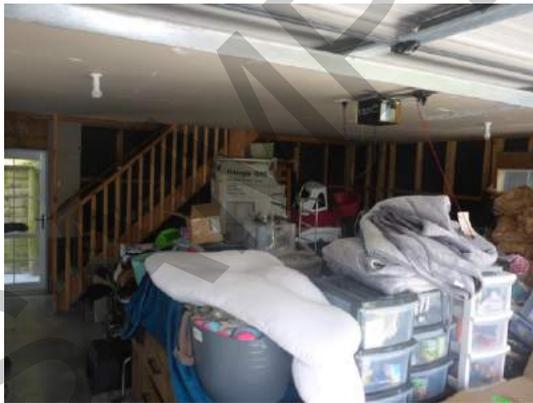
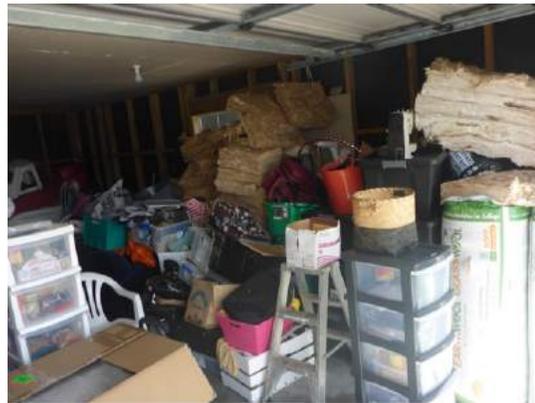
These photographs are an indication of the obstructions and limitations which impeded full inspection of the property at the time of inspection. These obstructions can hide an array of defects and should be removed to allow full inspection to be carried out.

All access to the roof void was restricted at the time of inspection. The roof access on the western side of the house was blocked by stored items and the room was used (sleeping person) in the eastern side access.

A re-inspection is recommended once the areas are made accessible.
