BEFORE YOU BUY
BEFORE YOU BUILD

NZ Residential Property Inspection Report

Property Address: 1 Sample Way, Rolleston 7614, New
Zealand

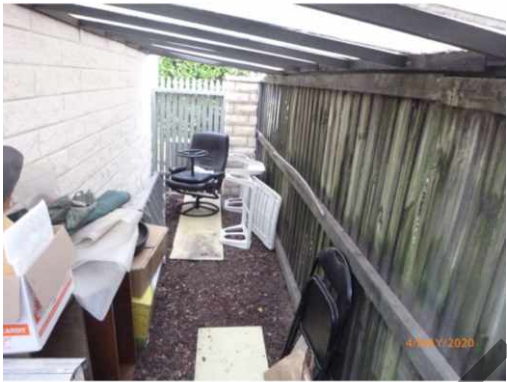
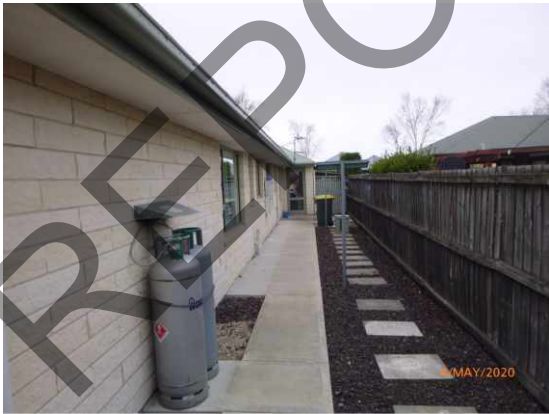
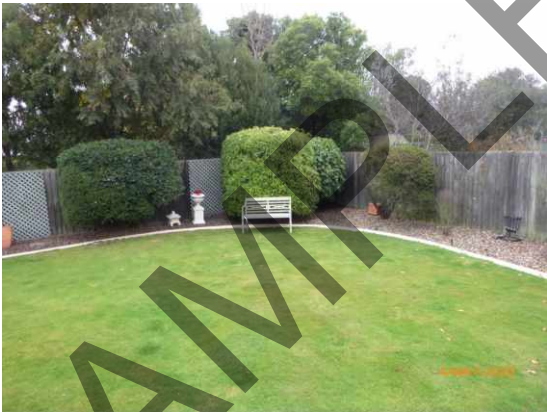
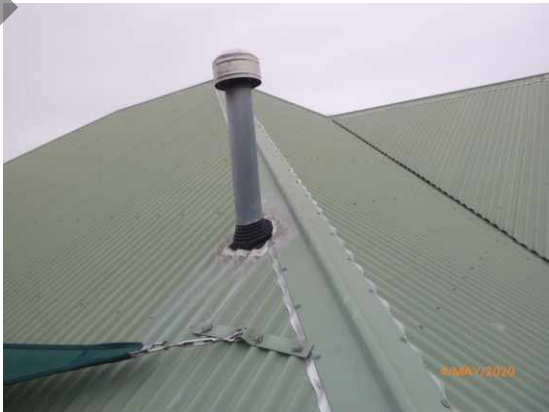
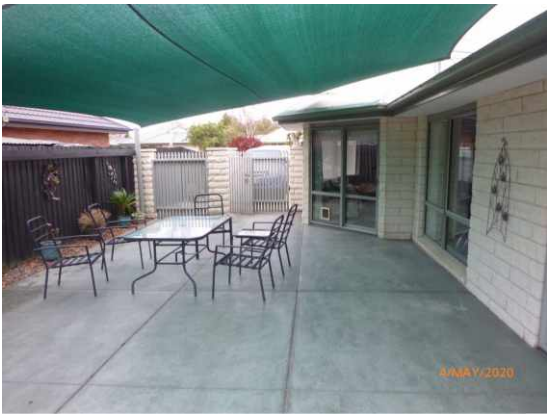
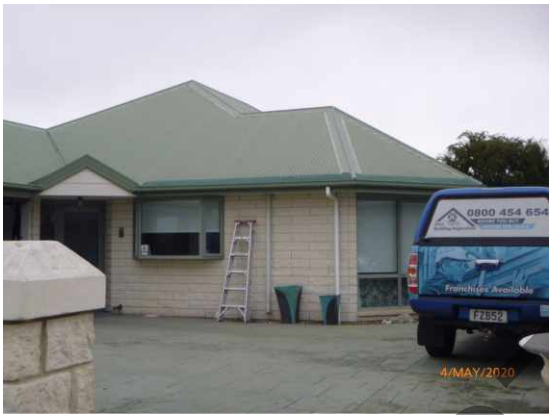
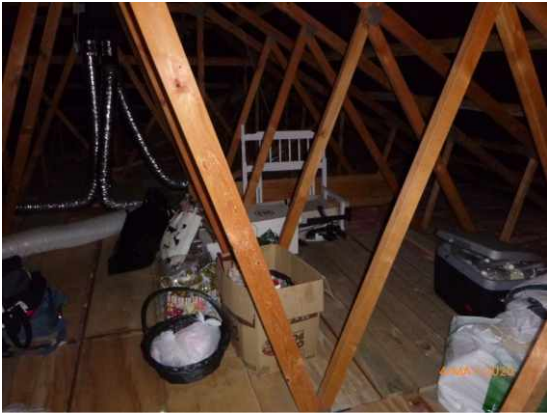
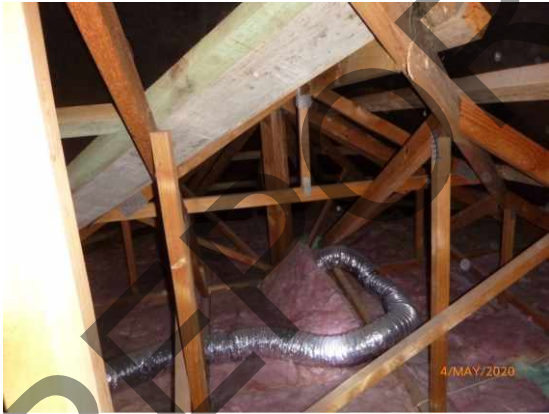
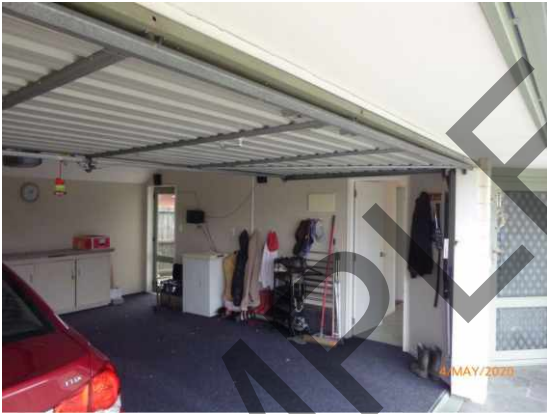
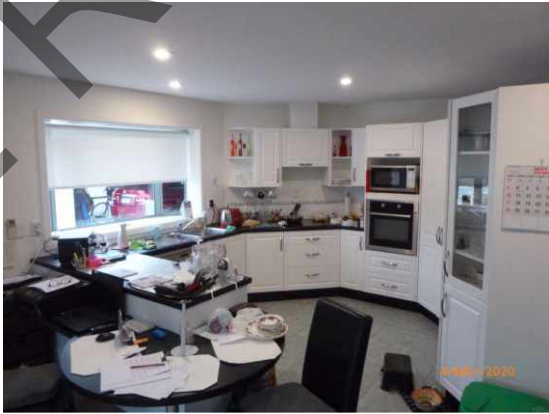
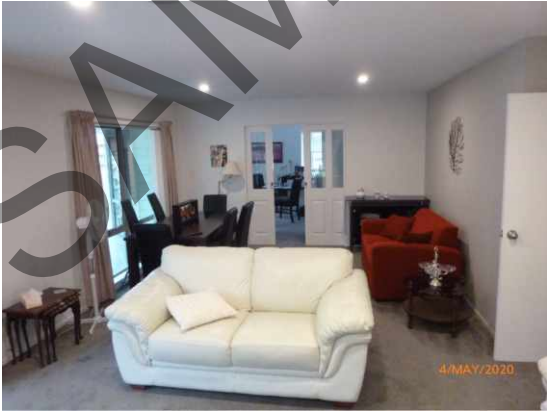
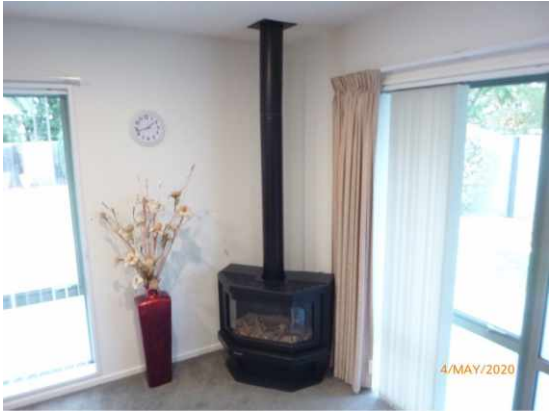
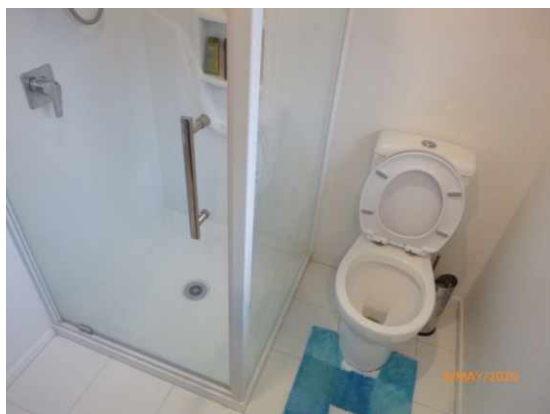
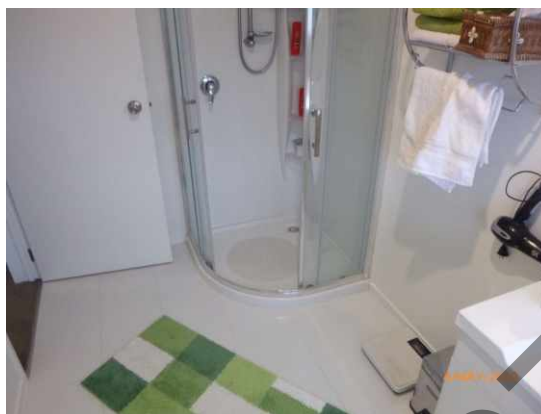
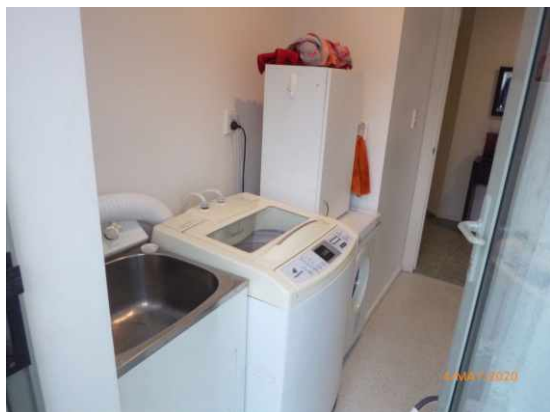
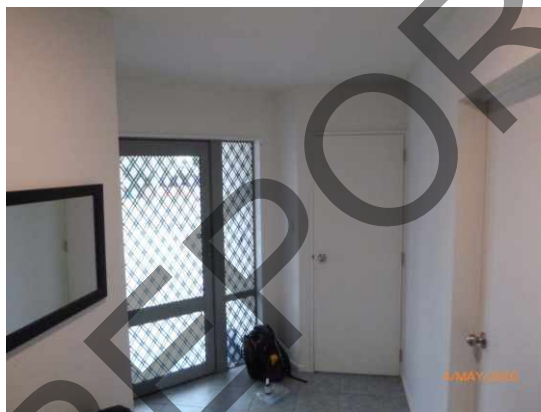
Building: Main Building
Location: All Areas > All Areas
Finding: Additional Photos - Obstructions and Limitations
Information: These photographs are an indication of the obstructions and limitations which impeded full inspection of the property at the time of inspection. These obstructions can hide an array of defects.
